# Route 5/Virginia Capital Trail

## Pedestrian Safety and Operational Assessment

### Henrico County, Virginia

**July 8, 2016**

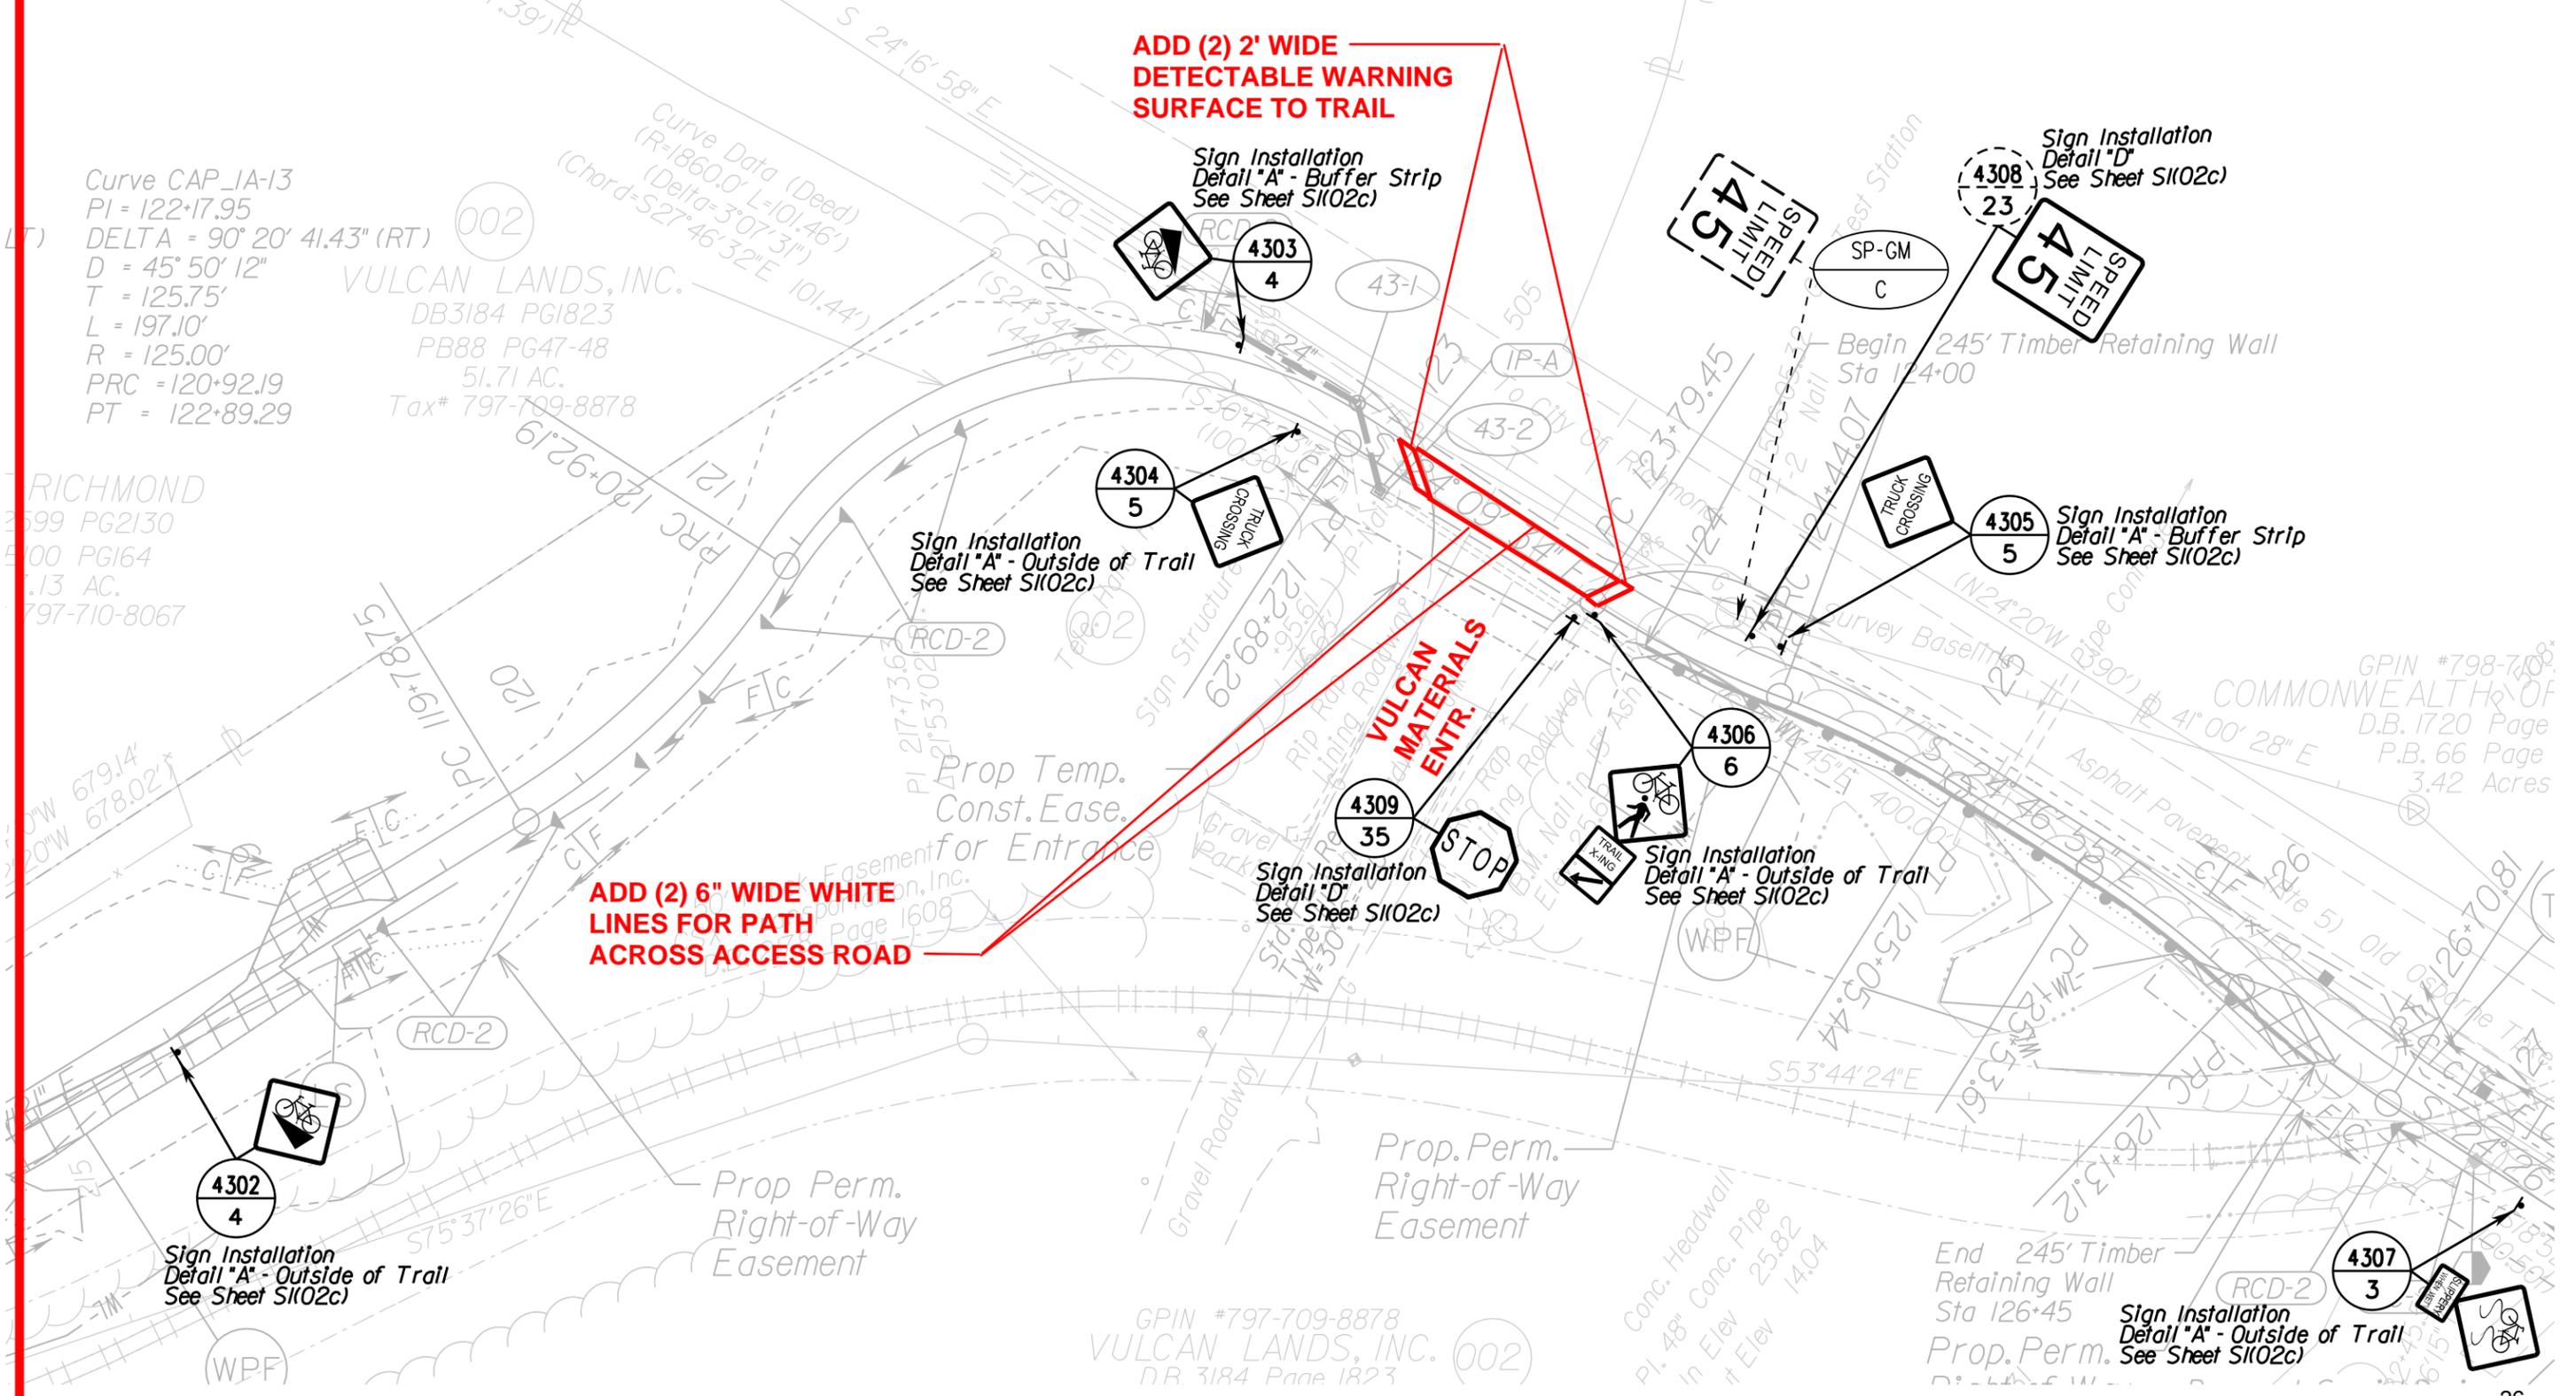
# VULCAN MATERIALS ENTRANCE SITUATION

- Users of the trail come out of the wooded section from the City of Richmond ascending up a steep incline and come upon the Vulcan Materials Entrance. The Vulcan Entrance is an industrial intersection with a large percentage of trucks.
- While the users of the trail have the right of way in crossing the private drive, we recommend adding detectable warning surfaces on each radial return to raise awareness of the trail users.
- We recommend that white lines be considered across the entrance to raise awareness of the vehicular users of the access road.

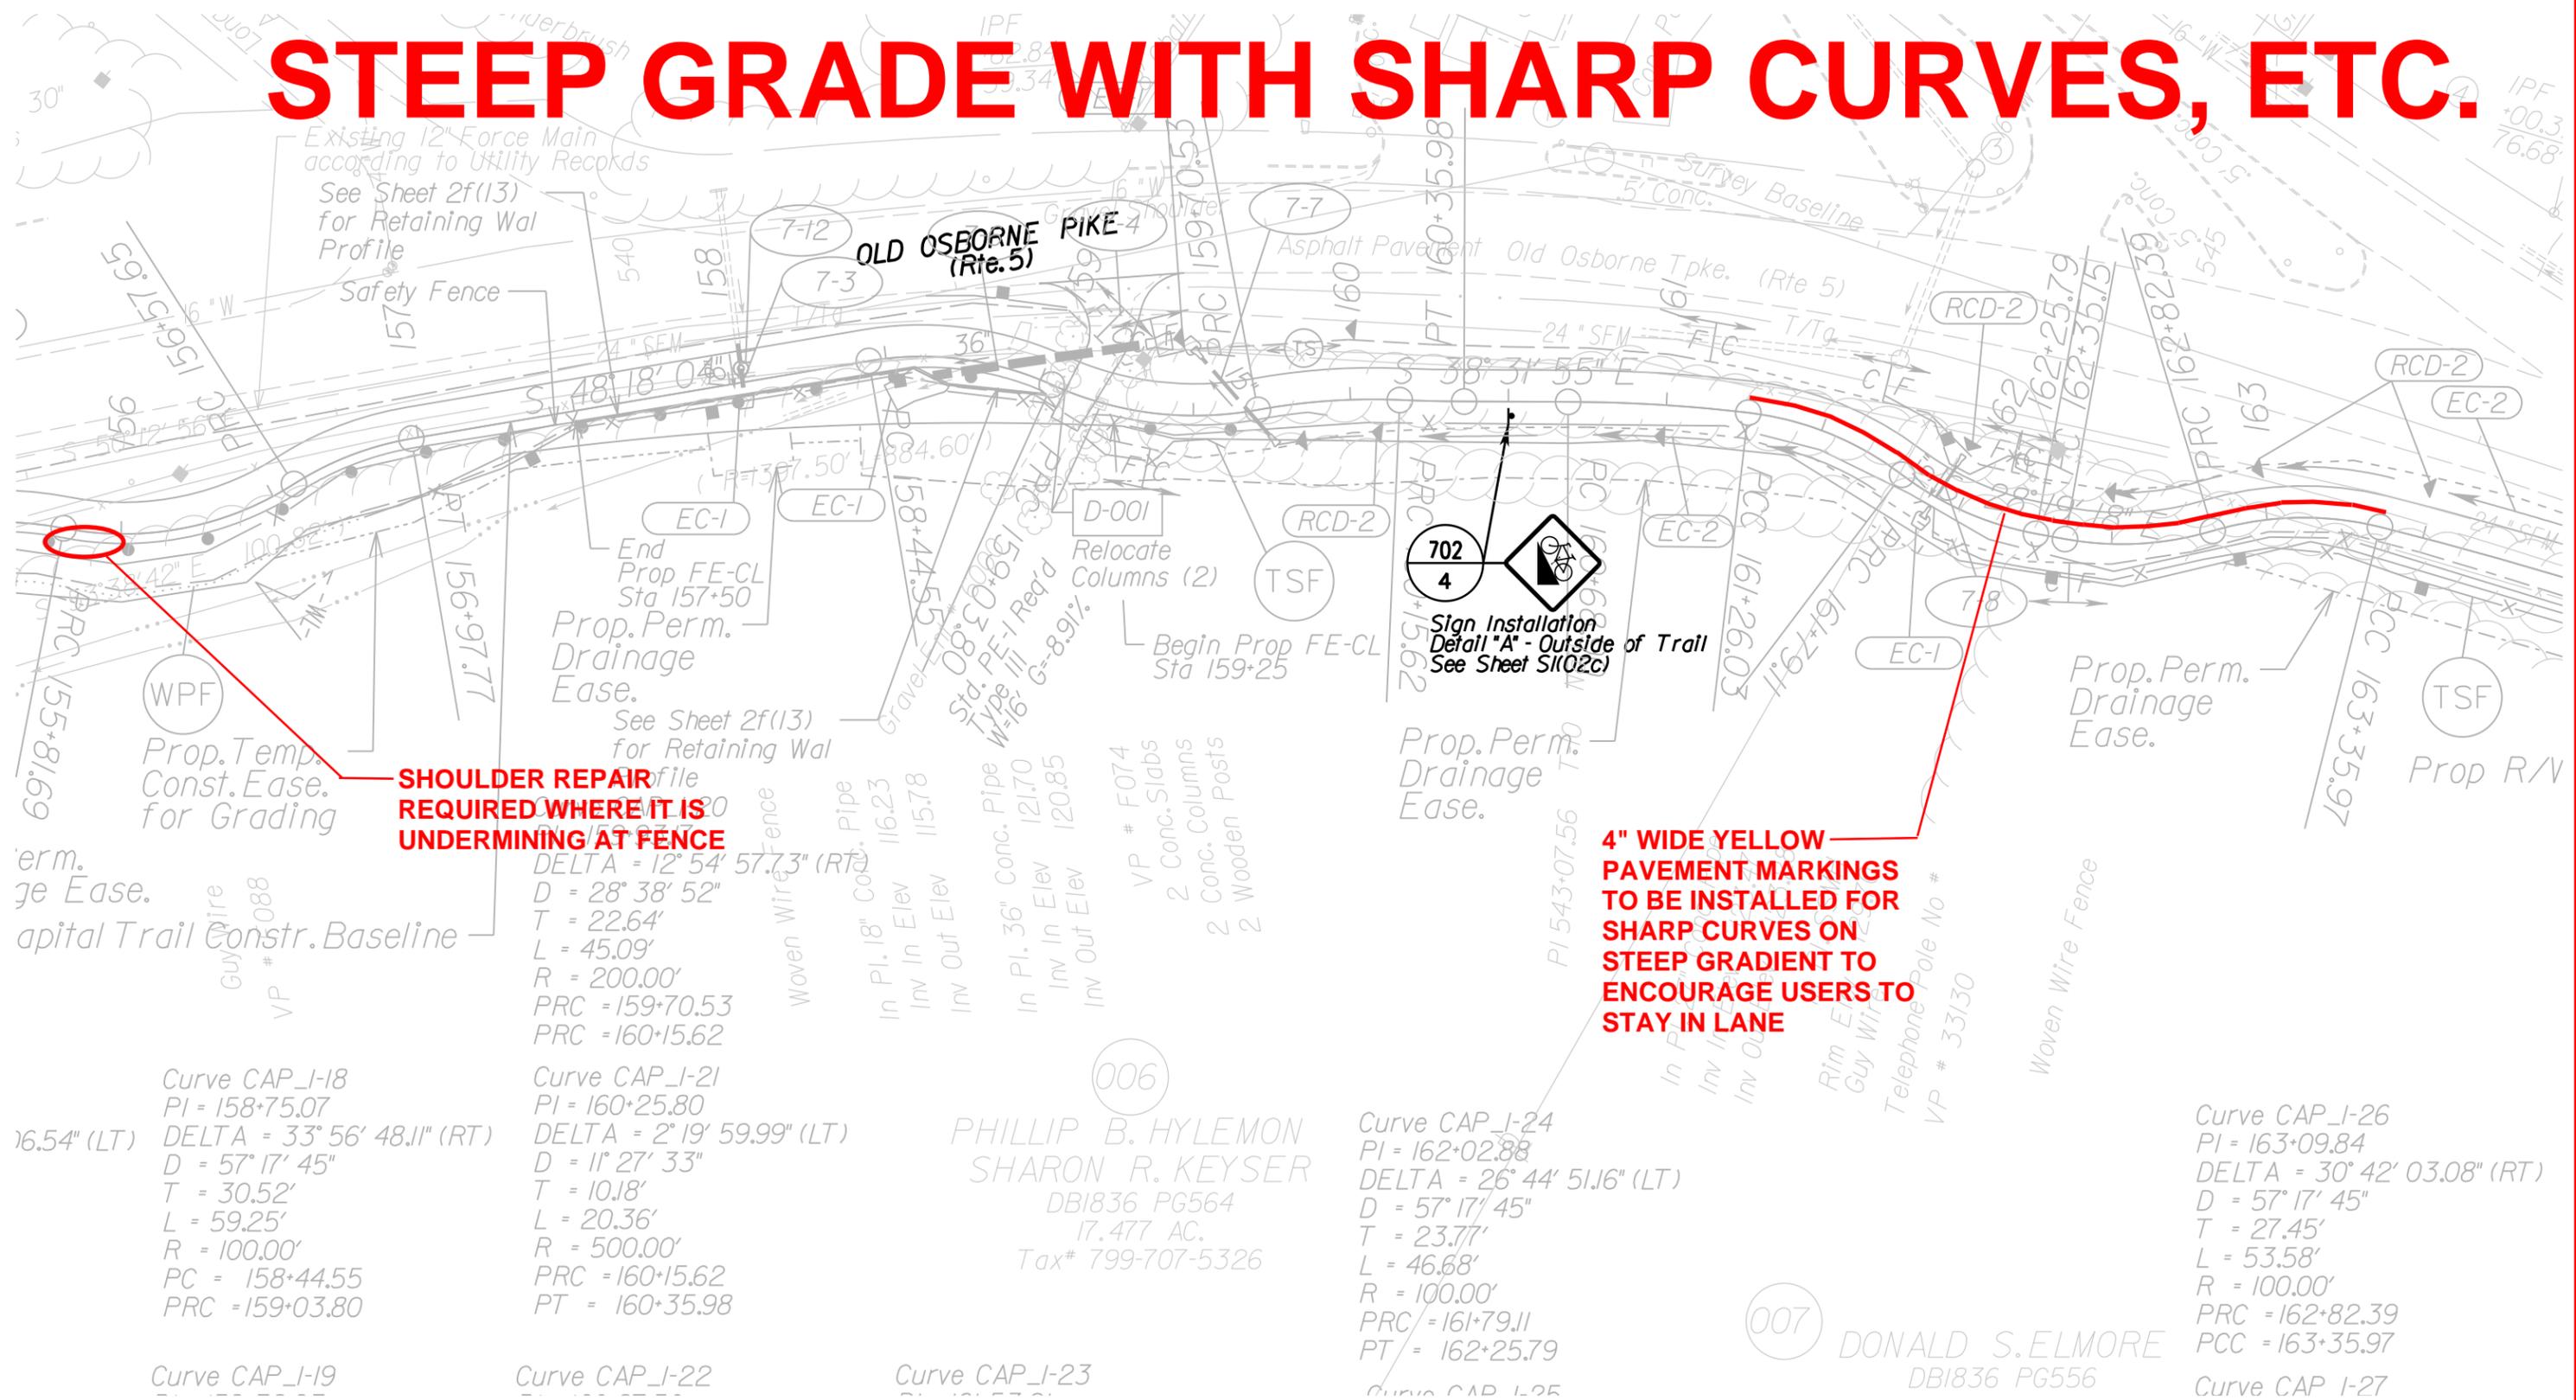
# STEEP GRADE WITH SHARP CURVES, ETC.

- It appeared that there was some undermining of the shoulder of the trail under a portion of the safety fence that was coned off indicating that the area was being considered for repair. We recommend that this area be repaired so as not to continue to erode which could result in more costly repair if left unattended.
- We recommend that a center yellow stripe be added to the meandering portion of the trail where users working to climb the steep incline could pass with higher speed users coming in the opposite direction on the steep decline.
- One private driveway has a retaining wall right up to the interface with the trail limiting sight distance for vehicles egressing to Route 5. We suggest adding shark teeth on the paved driveway to increase awareness of the vehicles as they approach the trail.

- We recommend that a center yellow stripe be added to the meandering portion of the trail where users working to climb the steep incline could pass with higher speed users coming in the opposite direction on the steep decline.

**SHOULDER REPAIR  
REQUIRED WHERE IT IS  
UNDERMINING AT FENCE**

**4" WIDE YELLOW  
PAVEMENT MARKINGS  
TO BE INSTALLED FOR  
SHARP CURVES ON  
STEEP GRADIENT TO  
ENCOURAGE USERS TO  
STAY IN LANE**

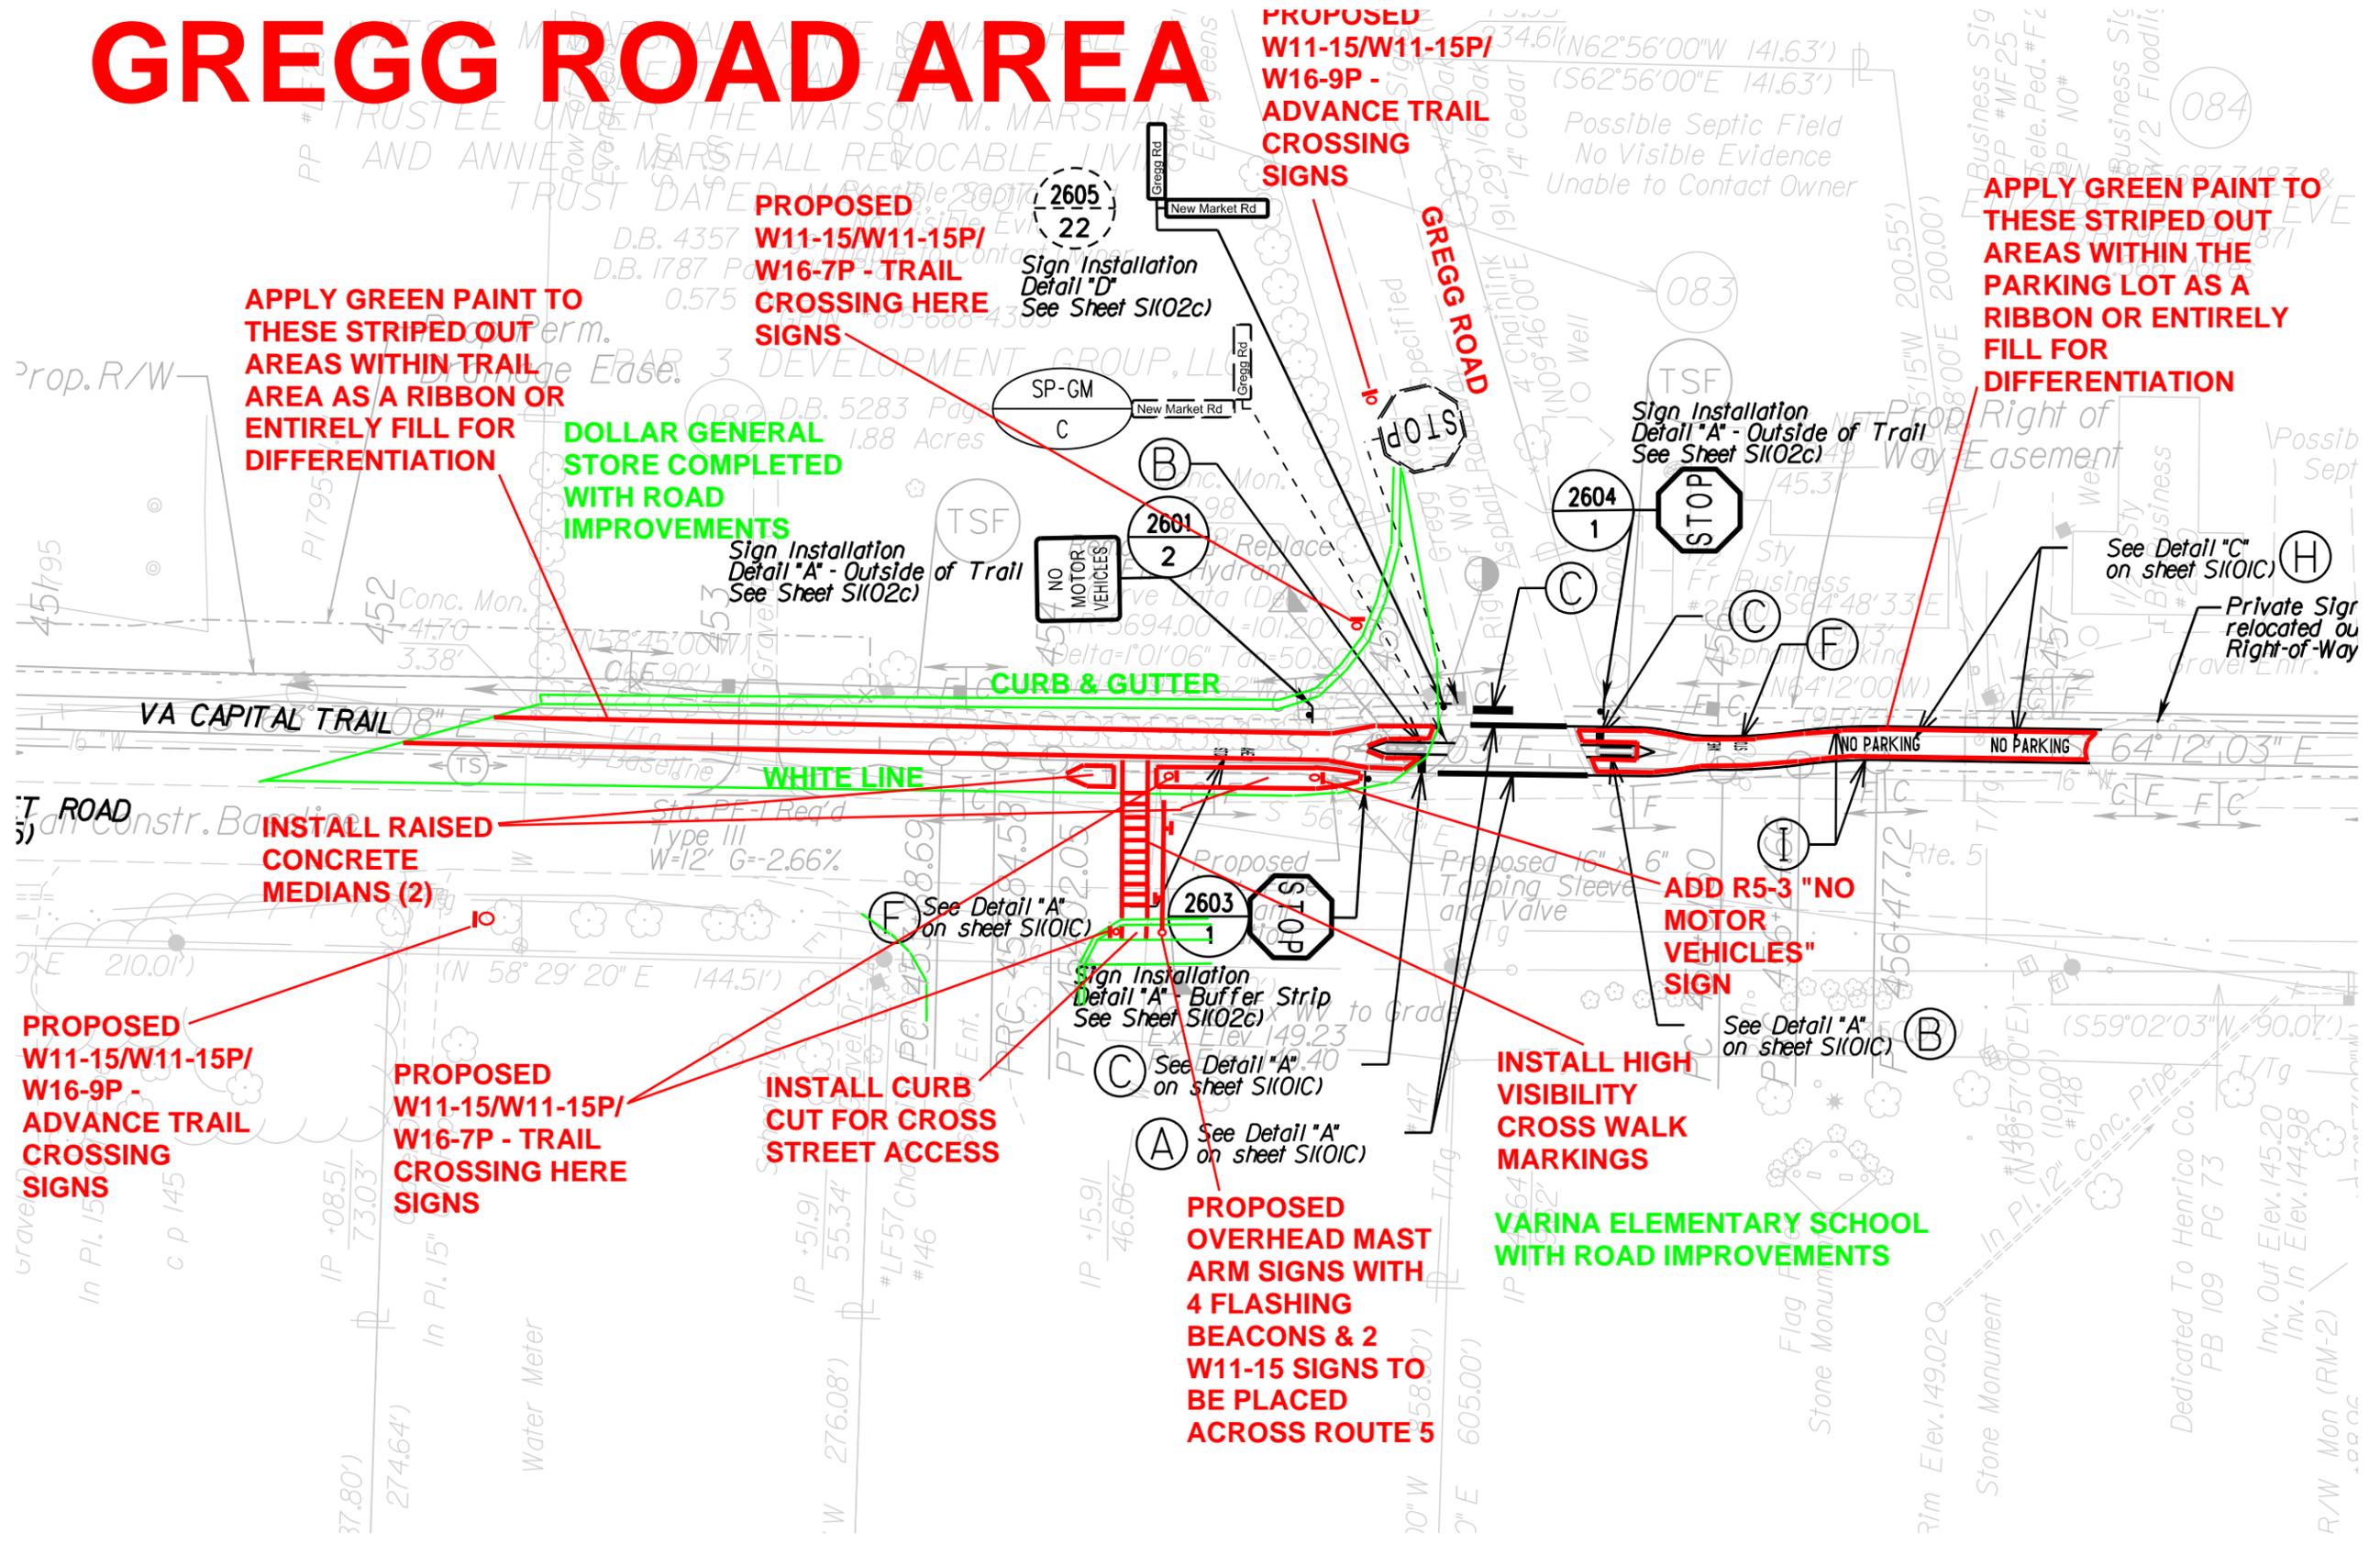
# GREGG ROAD AREA

- As you approach the intersection on Gregg from the east (and the commercial uses), there is no indication that you are coming to a trail crossing. We recommend that trail crossing ahead and trail crossing signs at the crossing be installed to increase awareness.

- We recommend that the white skip lines approaching the flush median be replaced with solid yellow lines to keep users of the trail in their lanes. On heavier usage time periods like weekends, bicycle users stack up as observed.

APPLY GREEN PAINT TO THESE STRIPED OUT AREAS WITHIN TRAIL AREA AS A RIBBON OR ENTIRELY FILL FOR DIFFERENTIATION

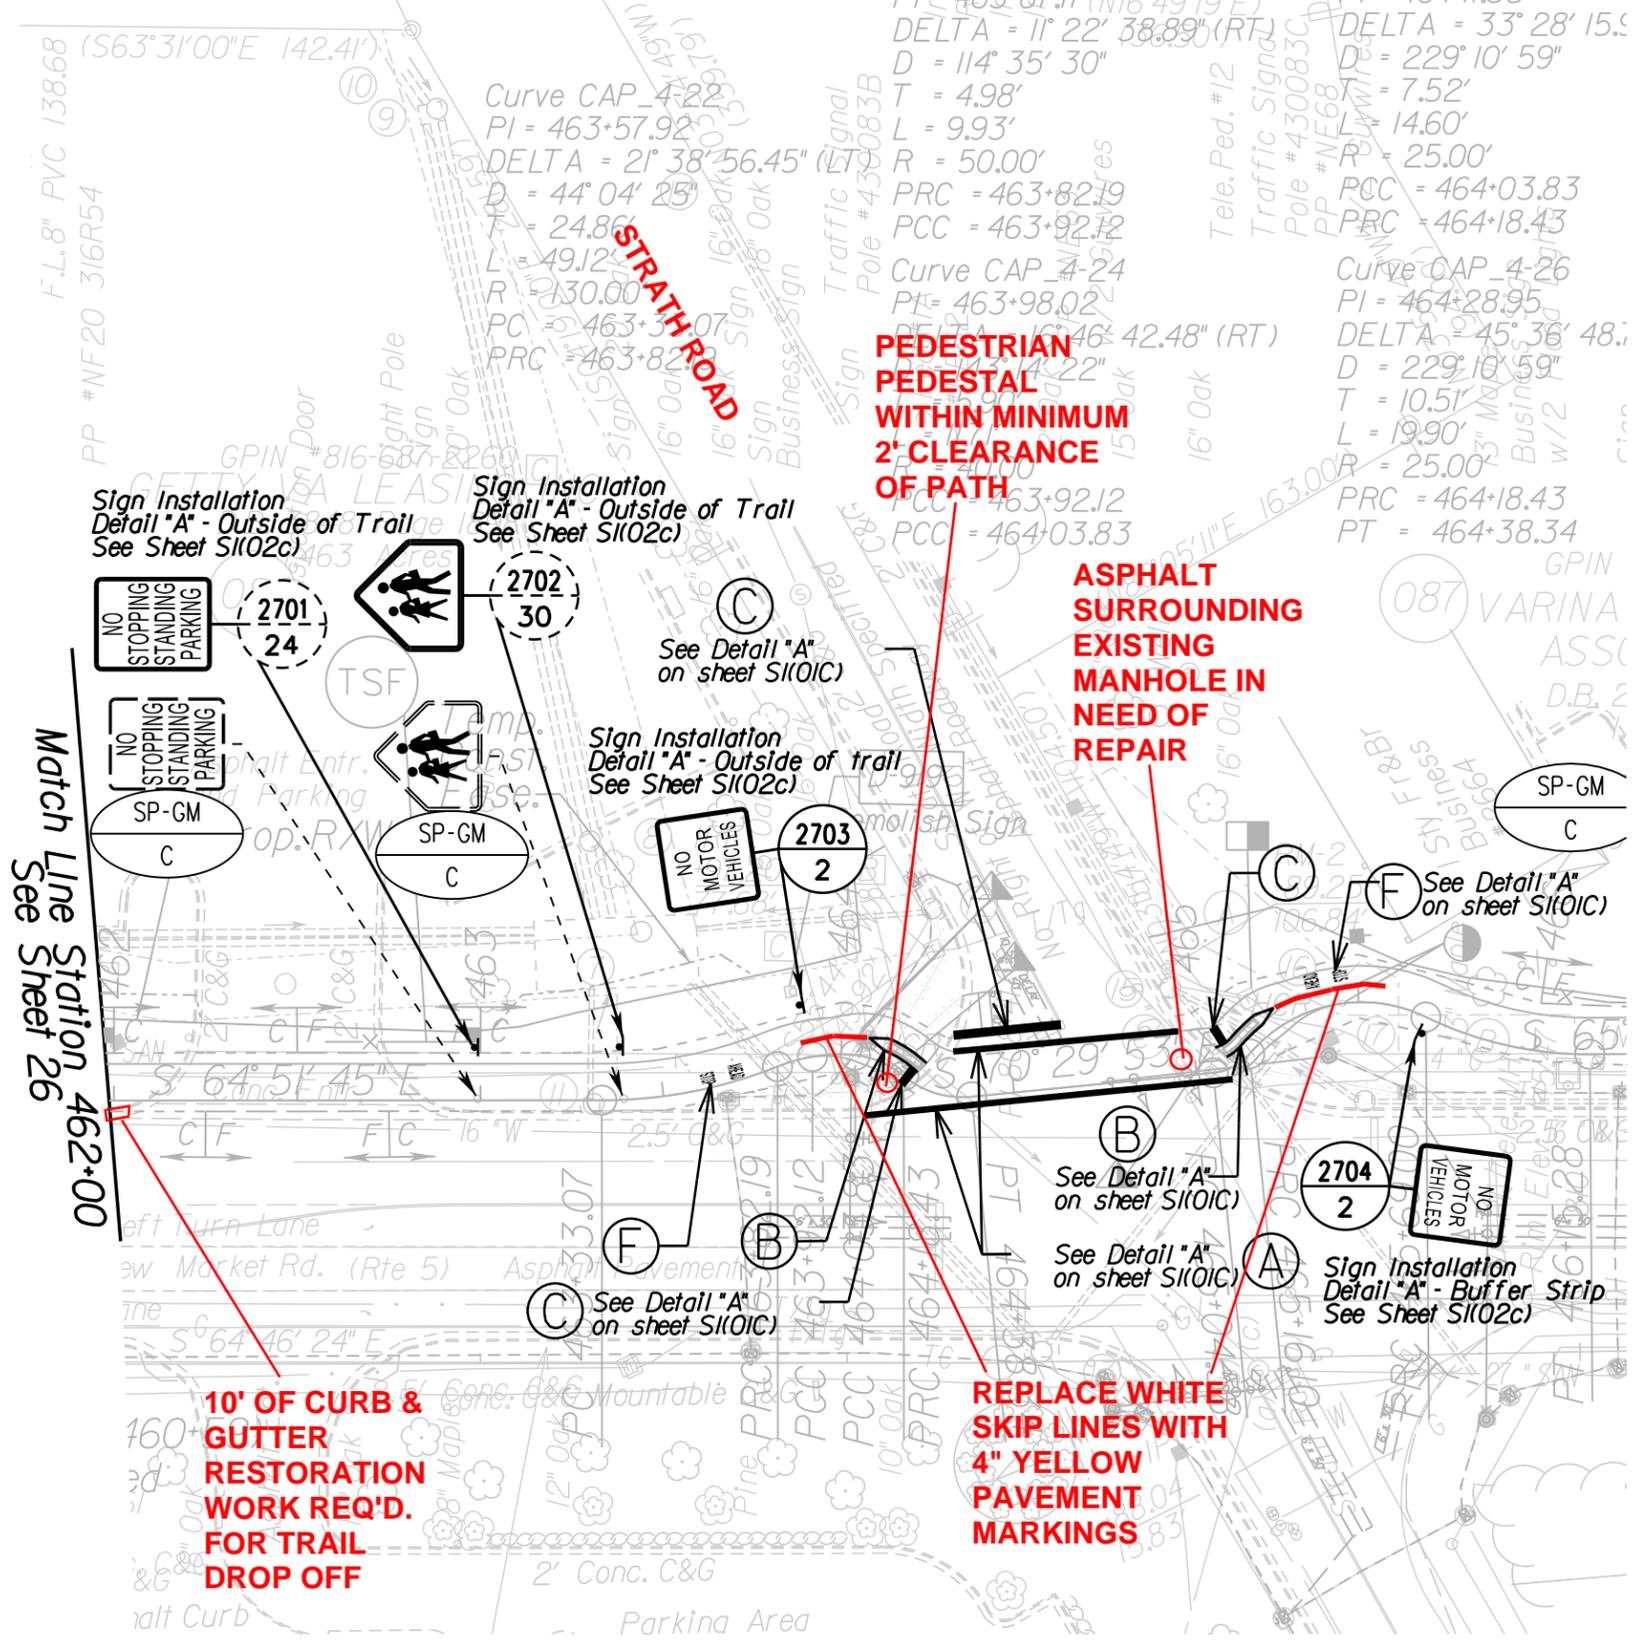
# STRATH ROAD AREA

- In the SE quadrant of the intersection as you enter the roadway pavement from the trail, there appears to be a large pothole or loose asphalt section surrounding an existing manhole. It is right in the crossing of the trail and should be repaired to reduce the likelihood of a tire or ankle falling in.

- We recommend that a short piece of curb & gutter be constructed just north of Strath Road where the 2' minimum shoulder area/clear zone is not achieved for the trail.

- As you approach the intersection on Strath Road from the east, there is no indication that you are coming to a trail crossing. We recommend that consideration of trail crossing ahead and trail crossing signs at the crossing be installed to increase awareness.

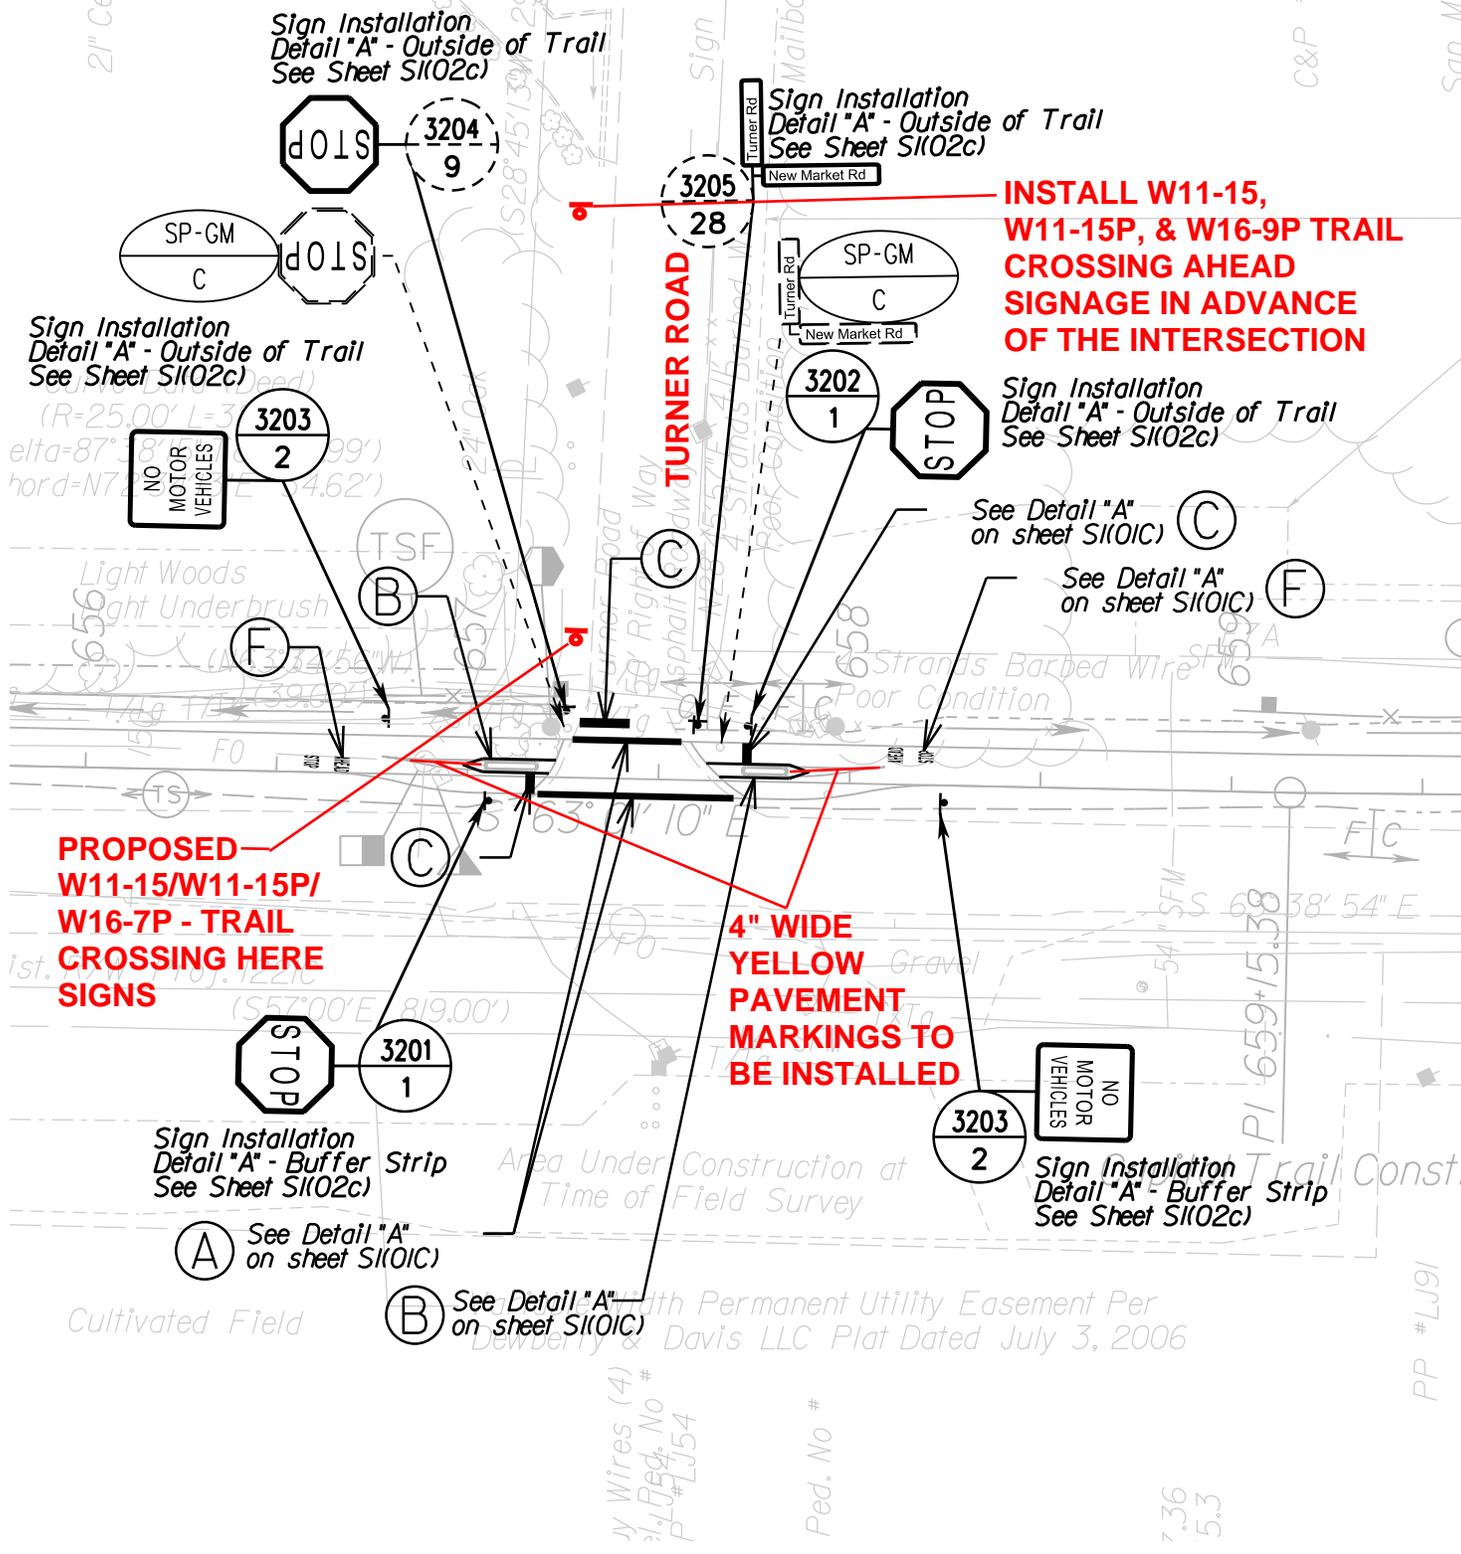
# TURNER ROAD AREA

- As you approach the intersection on Turner Road from the east, there is no indication that you are coming to a trail crossing. We recommend that consideration of trail crossing ahead and trail crossing signs at the crossing be installed to increase awareness.
- We recommend that the white skip lines approaching the flush median be replaced with solid yellow lines to keep users of the trail in their lanes.
