**John G. Lewis Memorial Bridge
Route 673 (Featherbed Lane)
Bridge over Catoctin Creek in
Loudoun County**

**Presentation March 26, 2015, July 23, 2015
& September 16, 2015**

Current Structural Issues

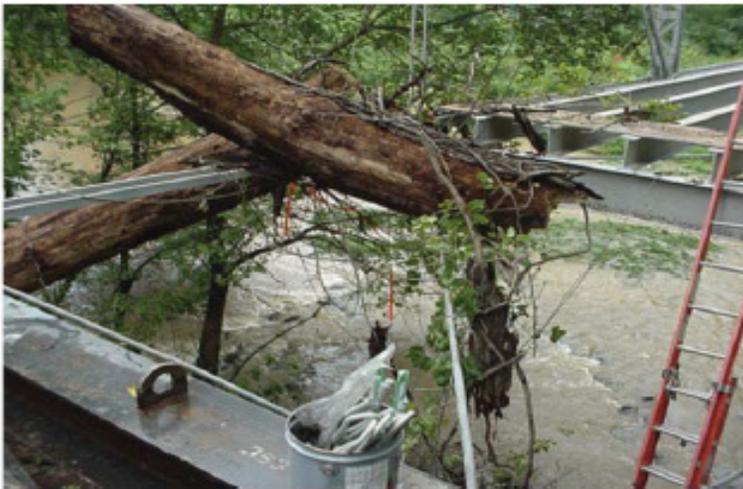
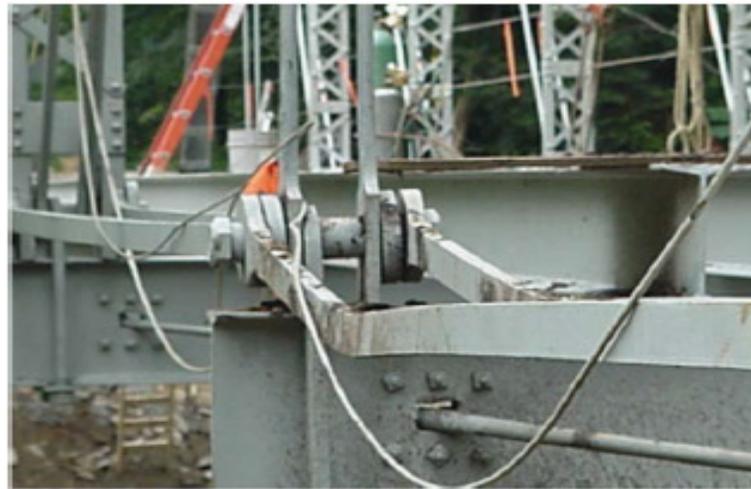
Tree Impact on Metalized Truss
(Reconstruction in 2003)

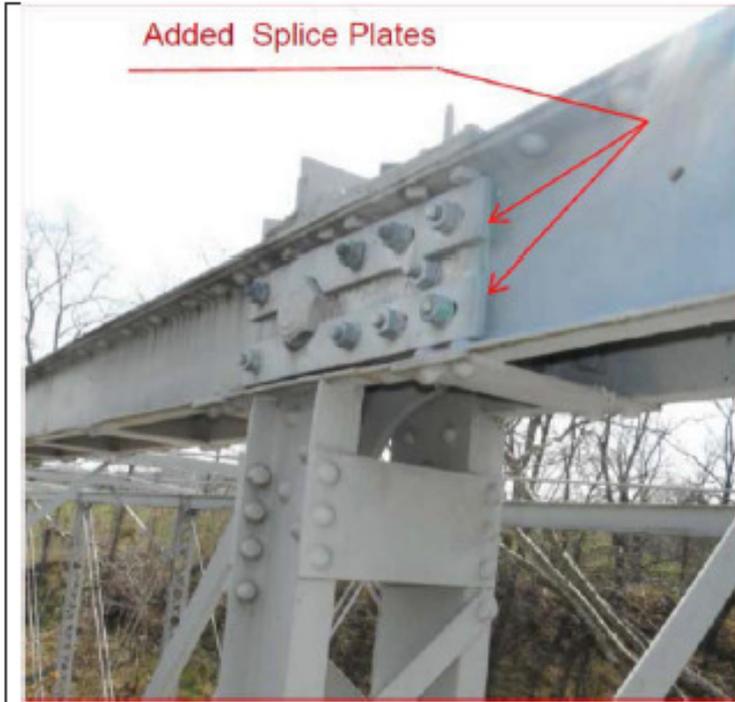
Added Splice Plates

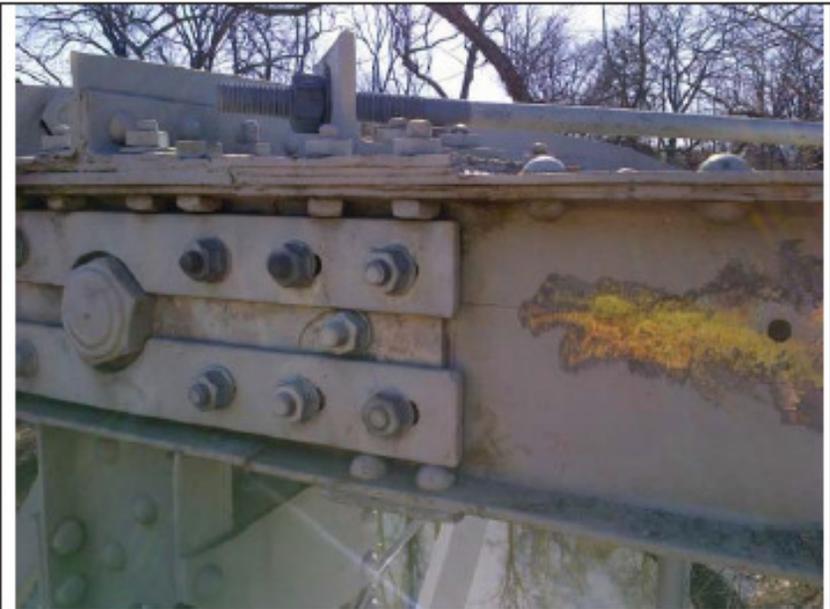
Horizontal Crack at Retrofitted Joint U2
(Hole drilled to prevent crack propagation)

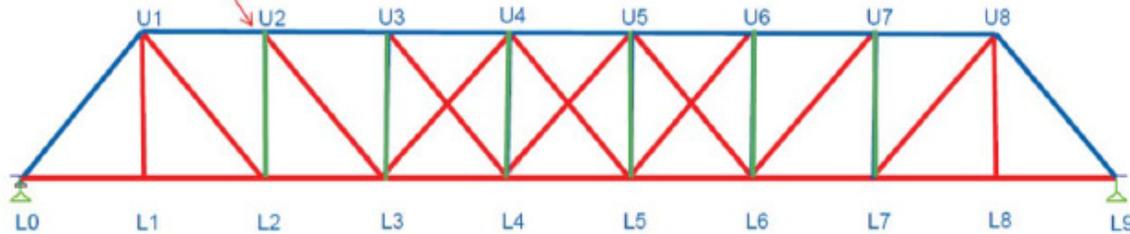
Exhibit 11. Cracking in Upper Chord

Location of Crack

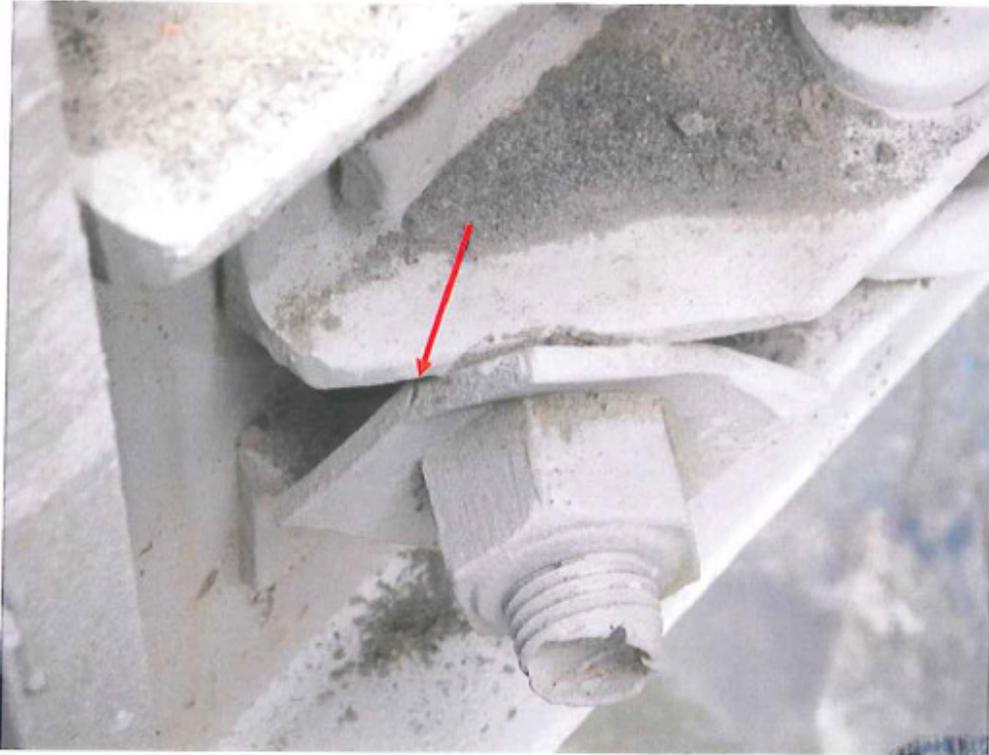
PHOTO 27 - CRACK IN LATERAL BRACING CONNECTION WASHER AT L4, UPSTREAM

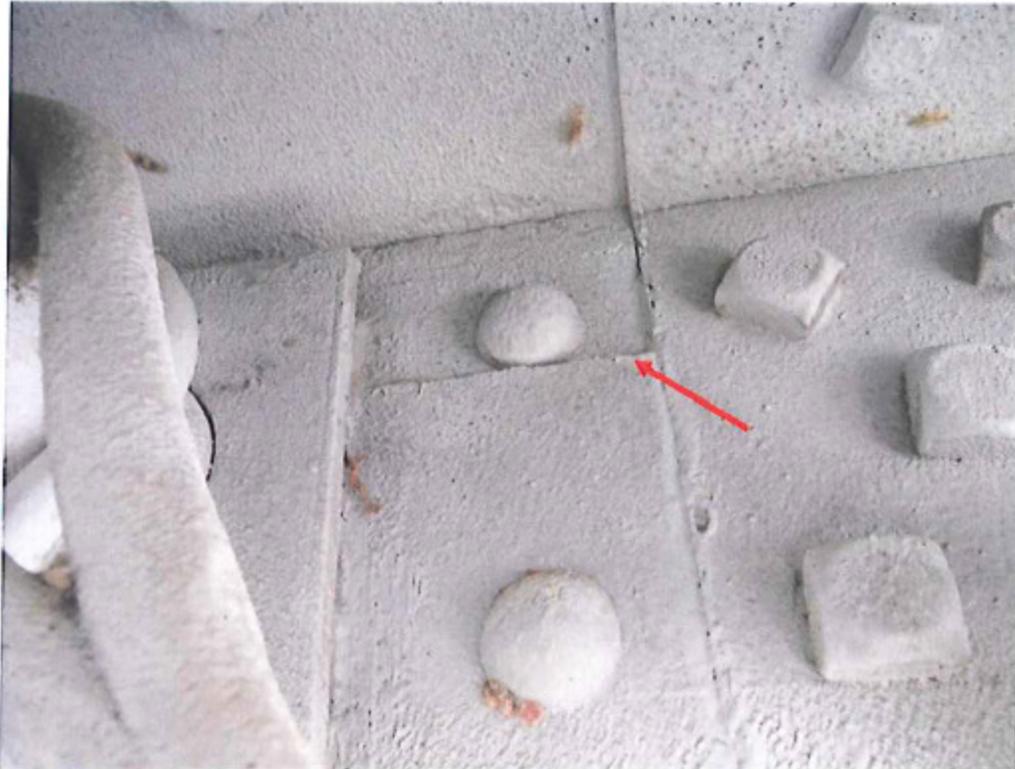
PHOTO 12 - CRACK IN UPPER CHORD OUTER WEB NEAR U5, DOWNSTREAM
