**Wilson Boulevard over Arlington Boulevard (Route 50)  
Fairfax County  
Bridge Rehabilitation**

**Project No. 0613-029-380; UPC 111320**

**SCOPING MEETING  
Wednesday, October 25, 2017**

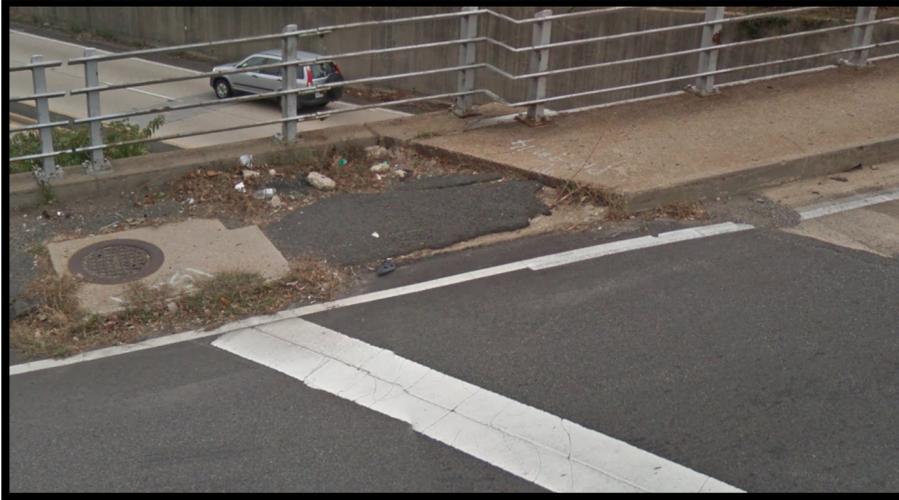
No proper transition from approach roadway to bridge sidewalk

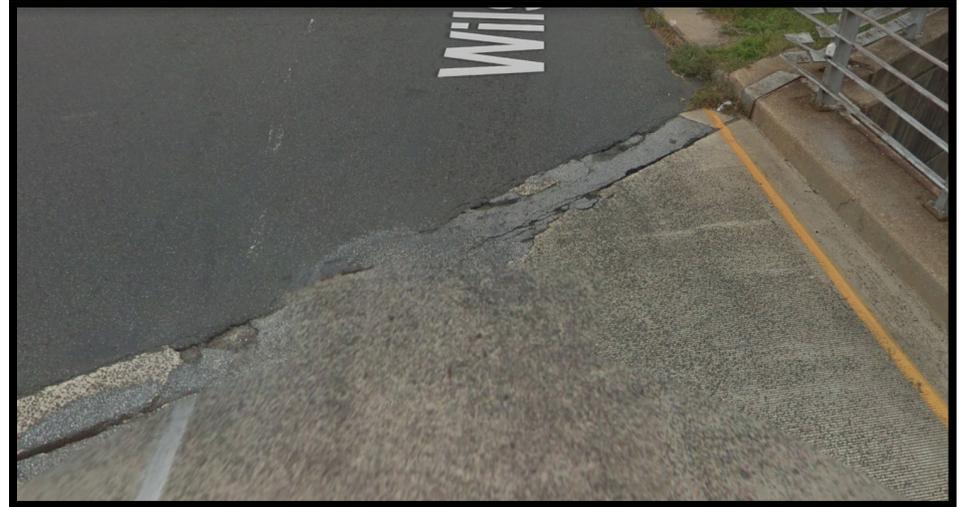
Deck joints in poor condition with broken concrete edges

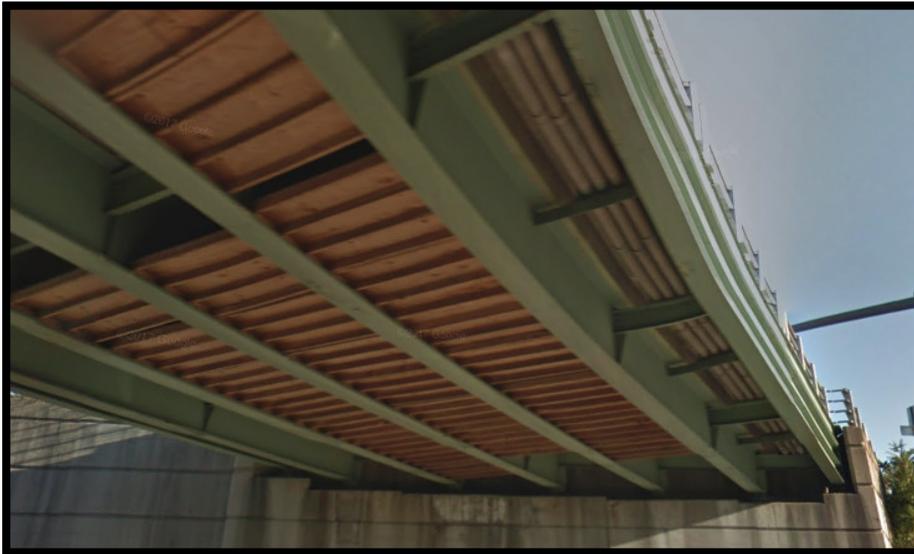
Existing utility conduits. Owner to be determined.

- Temporary Utility Relocation will be needed for three (3) 6" conduits supported under the bridge deck. Owner to be determined.
- ACM survey confirmed Asbestos in Transite Utility conduits, weep hole piping and joint caulking.

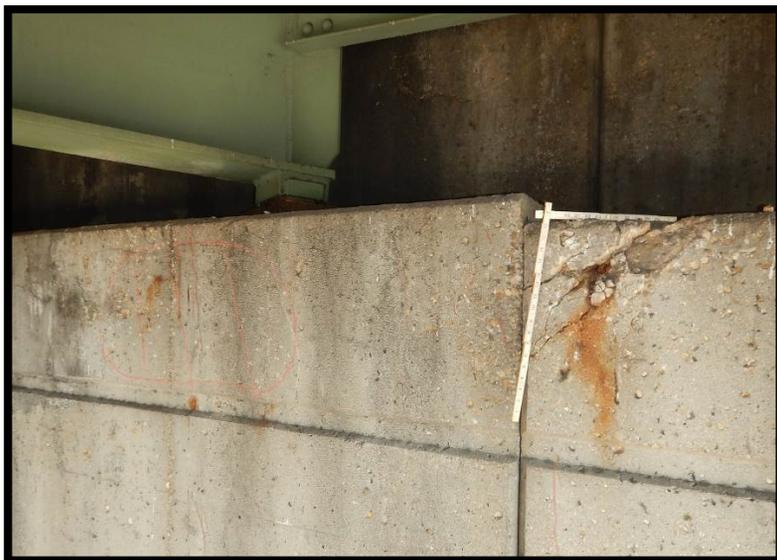
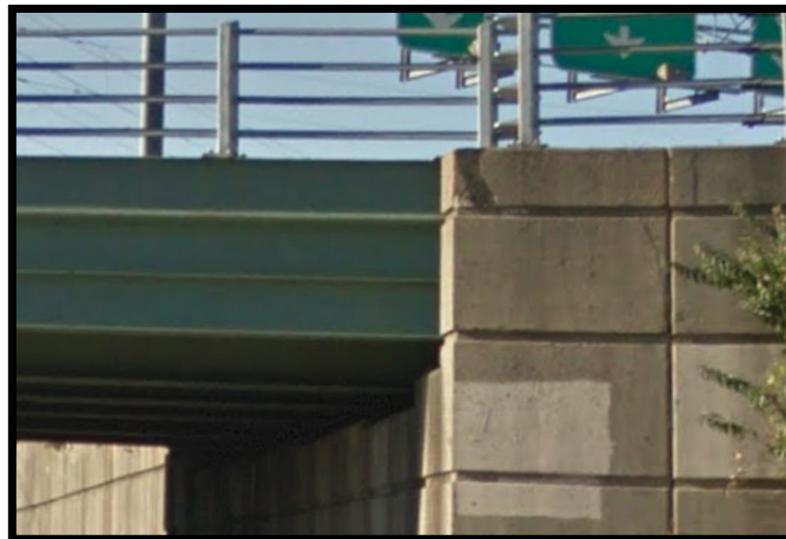
- Condition Rating 6 (Fair Condition)
- The abutment walls are in fair condition with spalls, cracks and delaminated concrete areas.

Spalled and delaminated concrete,  
hairline cracks and exposed rebar  
at Abutment Breastwall.

- Design modular (pre-fabricated) steel beam and concrete deck units for quick delivery and installation.
- Multiple nighttime single lane closures on Route 50 will be needed before the weekend closure to construct new bearing pedestals and repair concrete at abutments, and on Wilson Blvd. after the weekend closure to repair approach curbs, sidewalks, pavement and railings.
