**Wilson Boulevard over Arlington Boulevard (Route 50)  
Fairfax County  
Bridge Rehabilitation**

**Project No. 0613-029-380; UPC 111320**

**INFORMATION MEETING  
Wednesday, February 7, 2018**

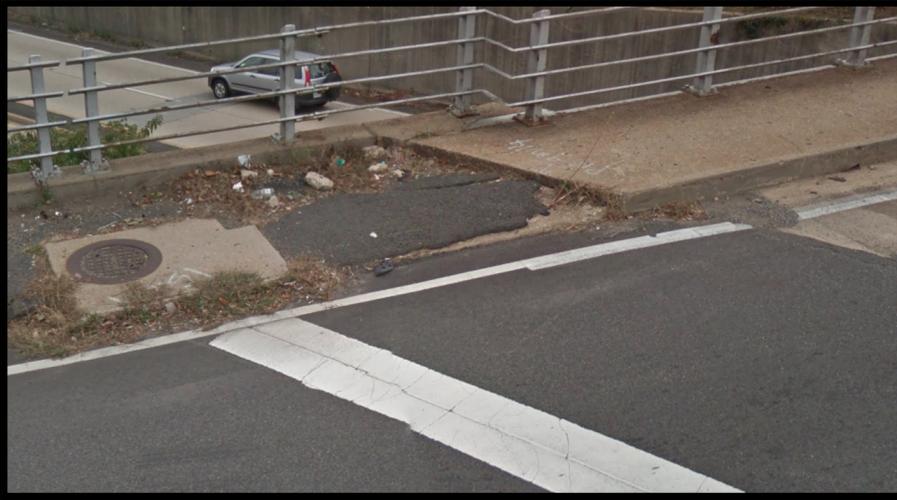
No proper transition from approach to bridge sidewalk

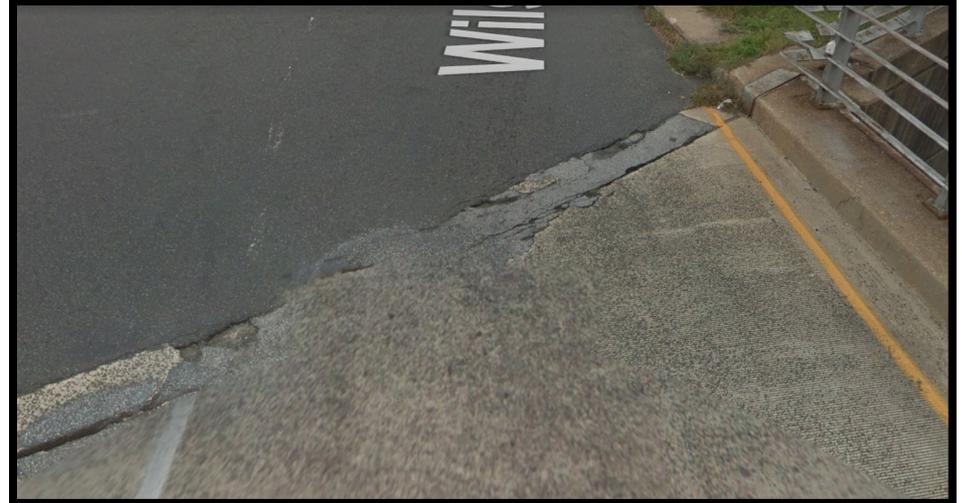
Deck joints in poor condition with broken concrete edges

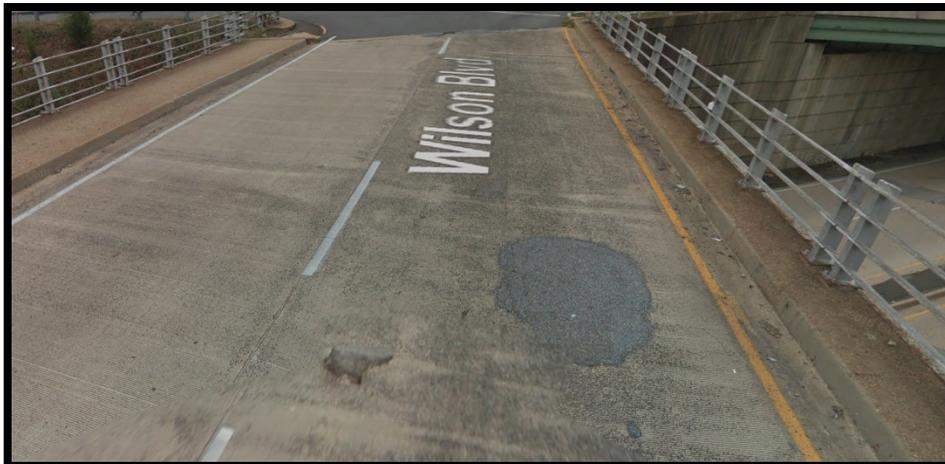
Original Non-crash tested bridge railings

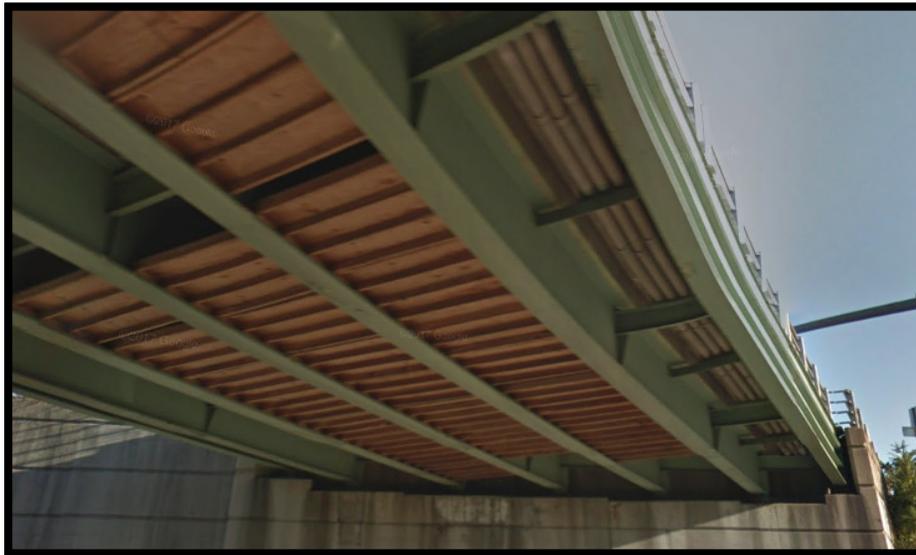
Existing utility A/C conduits owned by VDOT to be removed.

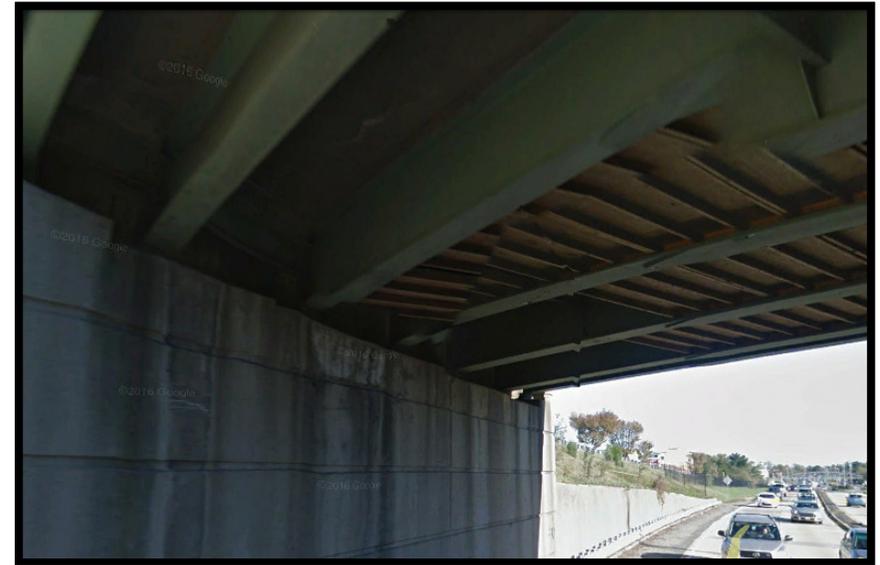
- Condition Rating 4 (Poor Condition)
- Bottom of the deck in poor condition due to numerous cracks, spalls and delaminated areas.
- Concrete overlay in fair condition due to numerous cracks, scaling and delamination.

Timber planks placed by VDOT to protect Rte 50 traffic from falling concrete from the underside of deteriorating deck.

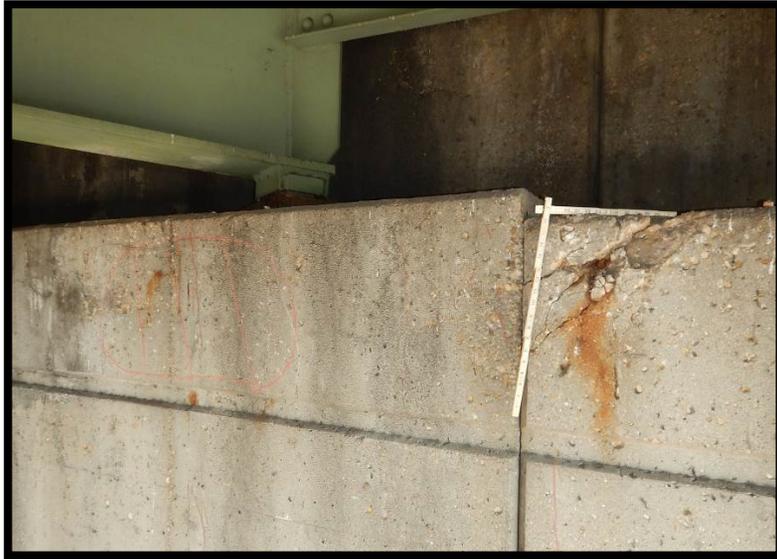
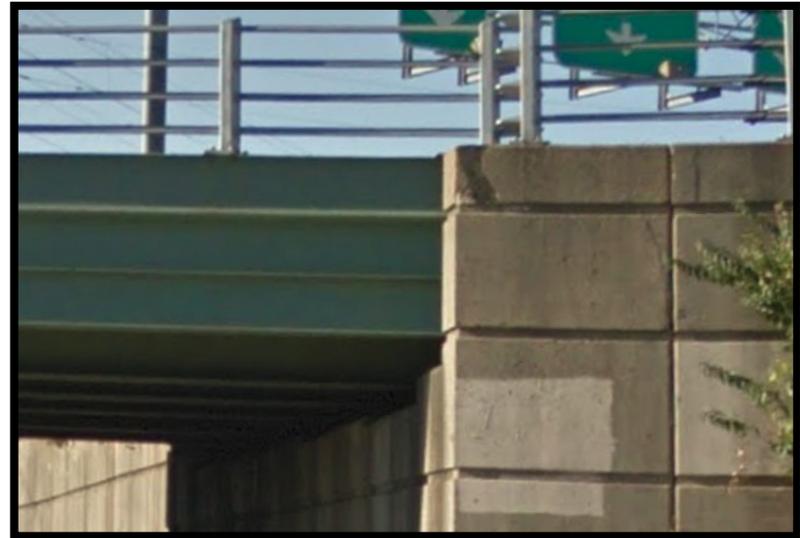
- Condition Rating 6 (Fair Condition)
- The abutment walls are in fair condition with spalls, cracks and delaminated concrete areas.

Spalled and delaminated concrete,  
hairline cracks and exposed rebar  
at Abutment Breastwall.
