**Wilson Boulevard over Arlington Boulevard
Fairfax County
Bridge Rehabilitation**

Project No. 0613-029-380; UPC 111320

**KICK-OFF/PRE-SCOPING MEETING
August 15, 2017, Tuesday**

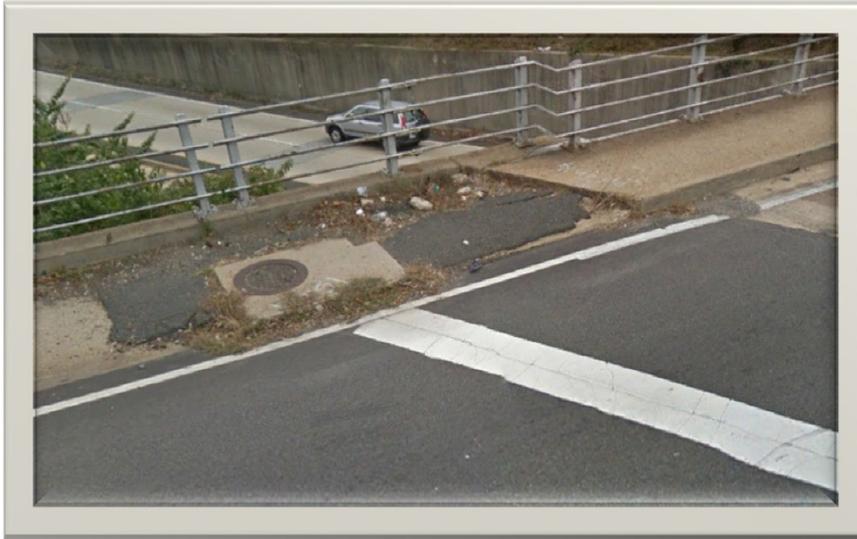
No proper transition from bridge sidewalk to approach roadway sidewalk.

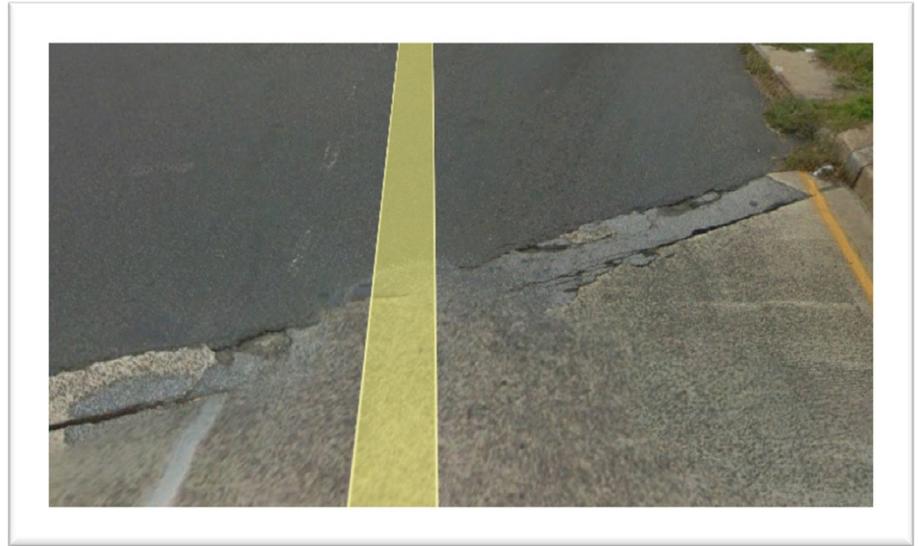
Deck joints are in poor condition.

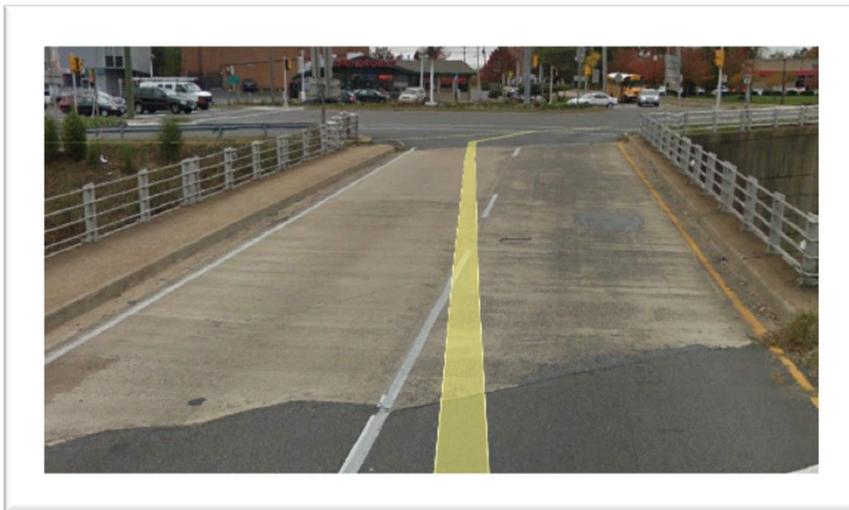
Non-crash tested barriers

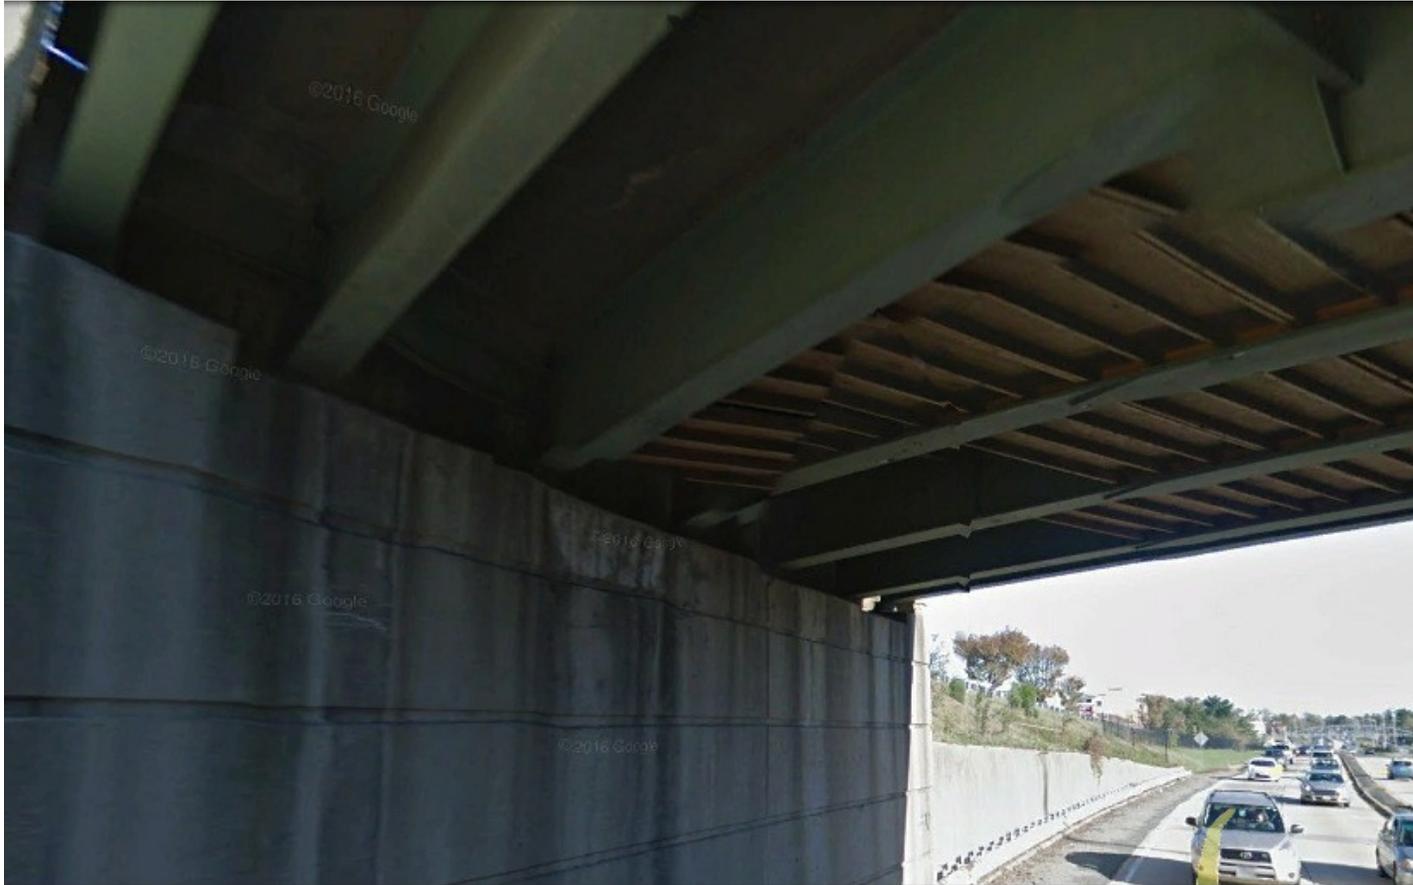
- Condition Rating 7 (Good Condition)
- The steel beams showing light surface rust and areas of peeling paint

Steel rolled beams with cover plates are in good condition.

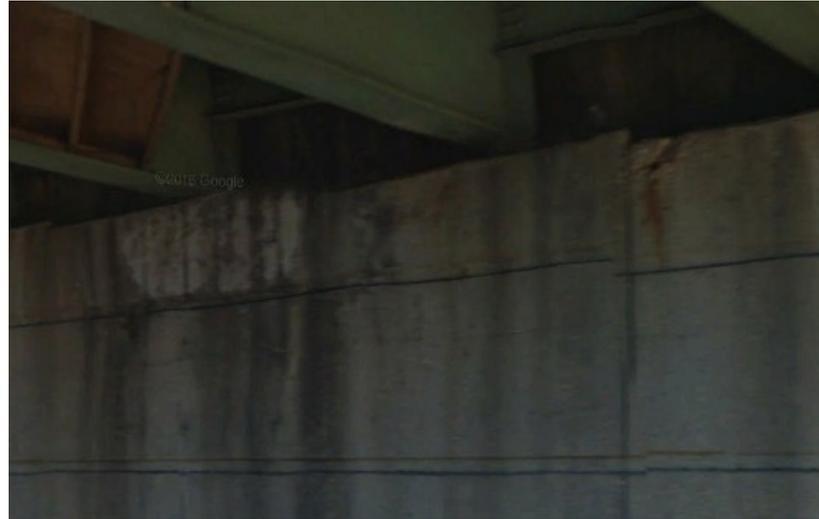
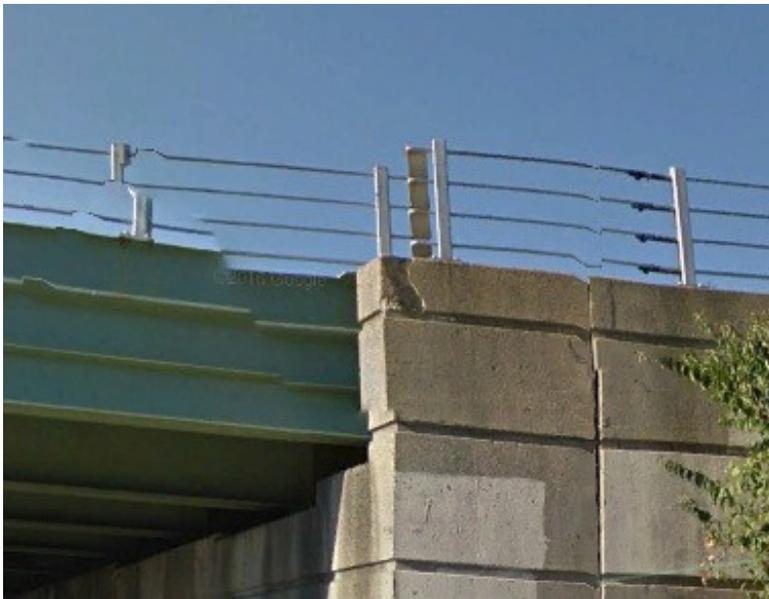
- Condition Rating 6 (Fair Condition)
- The abutment walls are in fair condition with spalls, cracks and delaminated concrete areas.

Spalled concrete,
delaminations, hairline cracks
and exposed rebar at Abutment
Breastwall.
