**Virginia Concrete Conference
March 7, 2008**

VDOT EXPERIENCE WITH GROUTED TENDONS IN
VARINA-ENON PRECAST SEGMENTAL
POST-TENSIONED BRIDGE

Michael Sprinkel, P.E.
Associate Director
VTTC

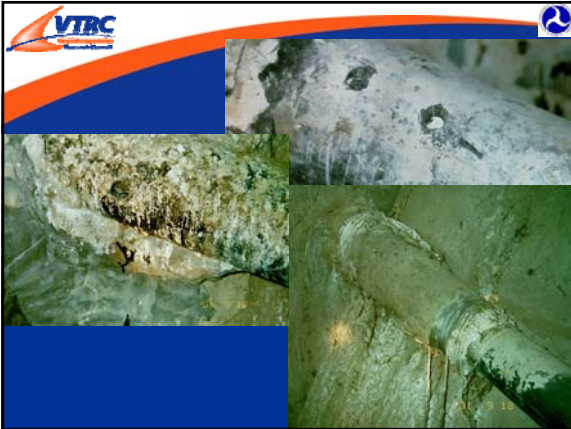
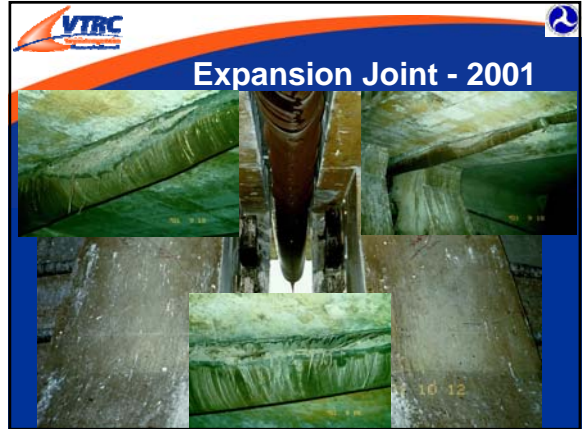
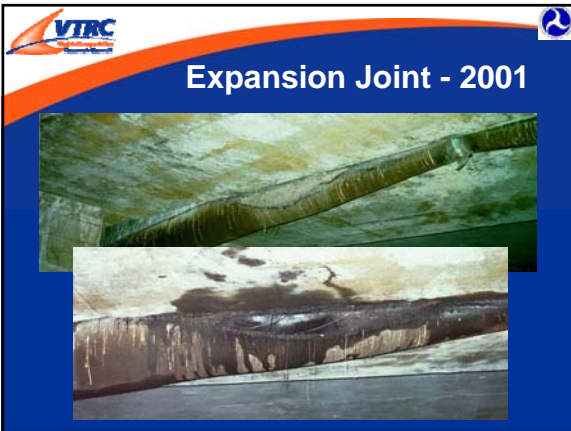
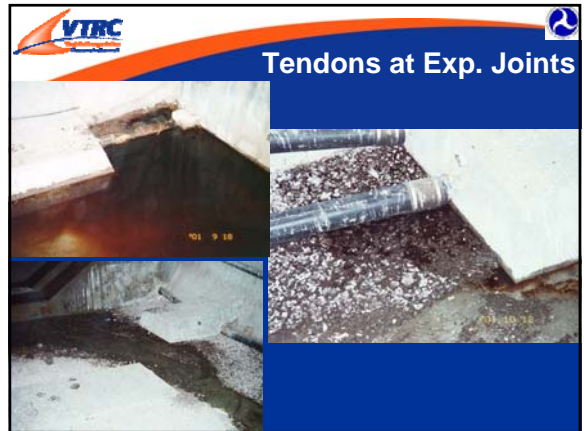
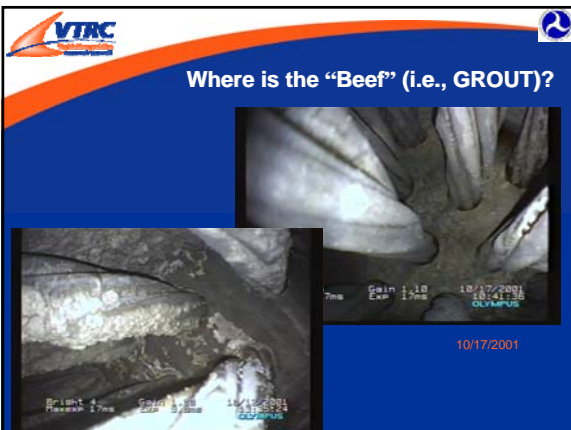
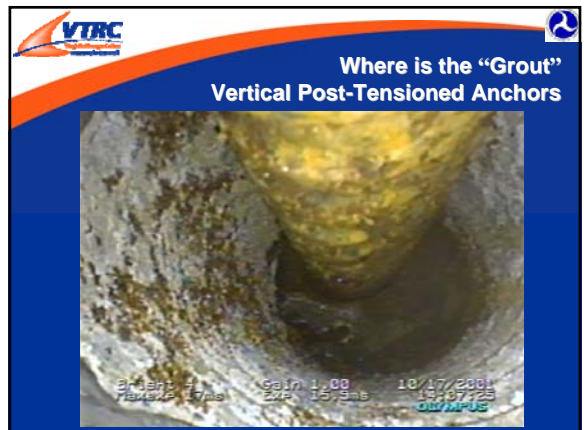
**2001 Varina-Enon Inspection:
hole in duct; rust on strand & void in duct;
rust was confined to vicinity of hole**

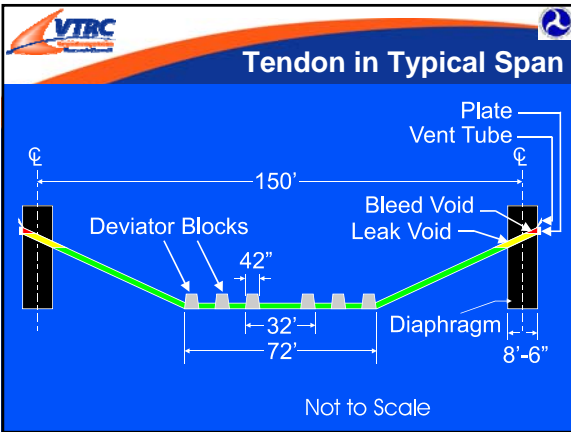
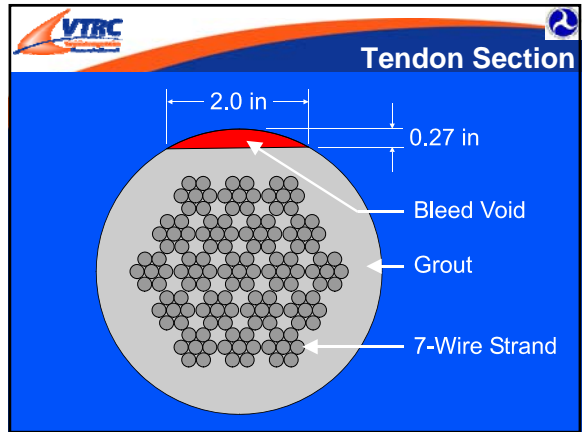
- Voids due to bleeding and segregation (Bleeding in grouts used prior to 2000 was approximately 4 percent. In a 150 ft long tendon, 4 percent bleeding can cause 6 ft of void at the high points in the tendon)
- Voids due to incomplete grouting and leaks

Wick Induced Bleed Test
cement and water, aluminum powder, high performance prepackaged grout

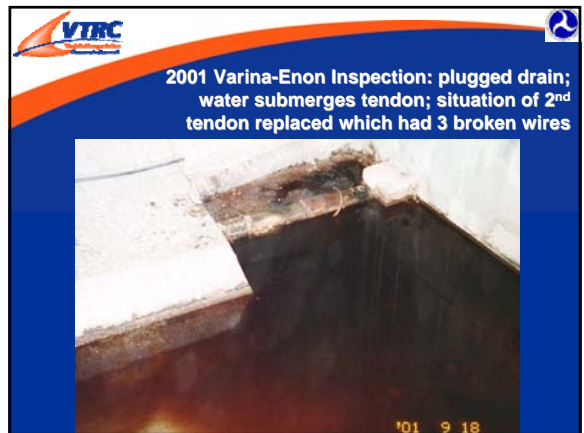
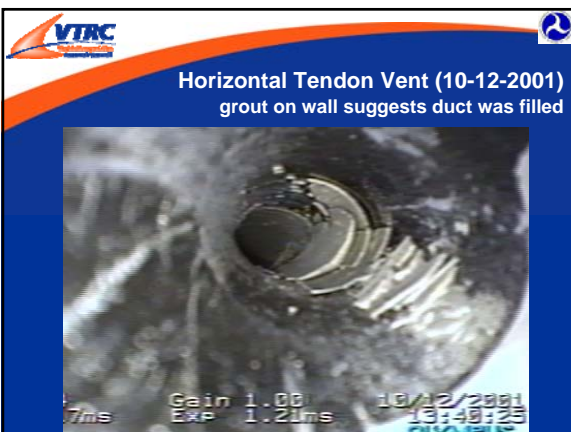
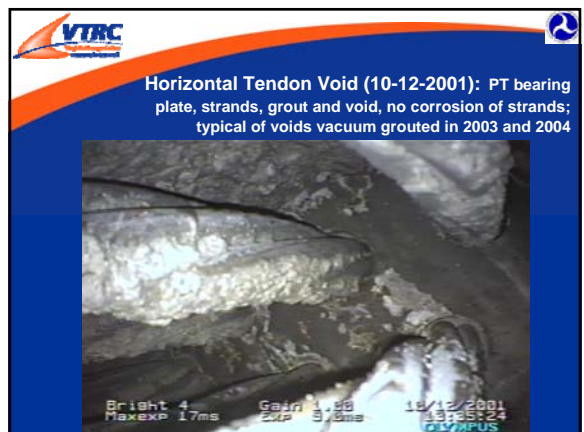
-
- Tendon Inspection and Repair**
- Inspected tendons for voids in grout, flaws in ducts, and corrosion of strands and anchors (visual, wire probes, sounding, and bore scope) (2001 and 2002)
 - Vacuum grouted some voids (2003 and 2004)
 - Sealed some tendons (2003 and 2004)
 - Replaced 2 tendons (1 failed, 1 with 3 broken wires) (2007)
 - Evaluated condition of tendons using Magnetic Flux (approximately 80 % of each duct) (2007)
 - Twenty tendons selected for detailed evaluation by removal of a 2-ft section of duct (18 because of corrosion in bore scope pictures, 1 because of Magnetic Flux measurements by Dr Al Ghorbanpoor and 1 because of his visual inspections) (2007)
 - Plan to monitor tendons representing 6 conditions (2008)
