**Corrosion Evaluation of Post-Tensioned Tendons on Mid-Bay Bridge**

by
Siva Venugopalan
Principal
SCS, Inc.

Mid-Bay Bridge, Destin, Florida

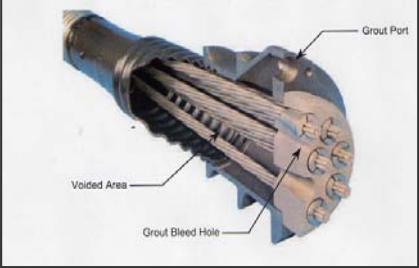
Problems – Voids in the Anchorage

Grout Port
Grout Bleed Hole
Voided Area

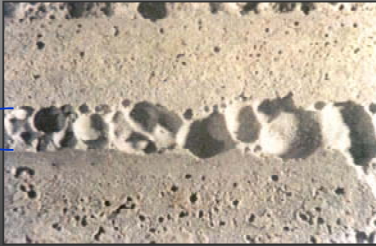
Problems - Air Void Clusters

Bleed Channel

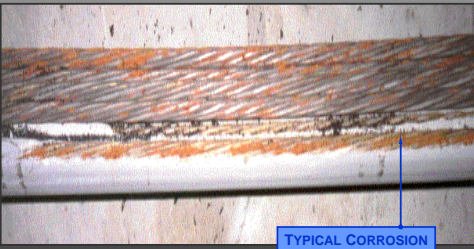
**Problems – Corrosion on Strands**

TYPICAL CORROSION

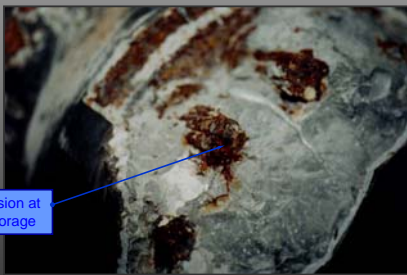
**Problems – Corrosion at the Anchors**

Corrosion at Anchorage

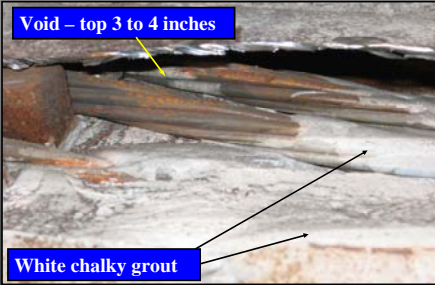
Void in the Coupler

Void – top 3 to 4 inches

White chalky grout

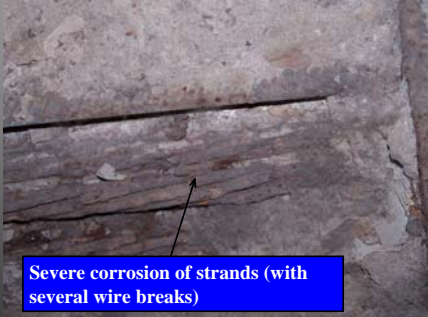
Tendon in Ramp D – Bottom Slab

Severe corrosion of strands (with several wire breaks)
