**Wilson Boulevard over Arlington Boulevard (Route 50)
Fairfax County
Bridge Rehabilitation**

Project No. 0613-029-380; UPC 111320

**INFORMATION MEETING
Friday, March 9, 2018**

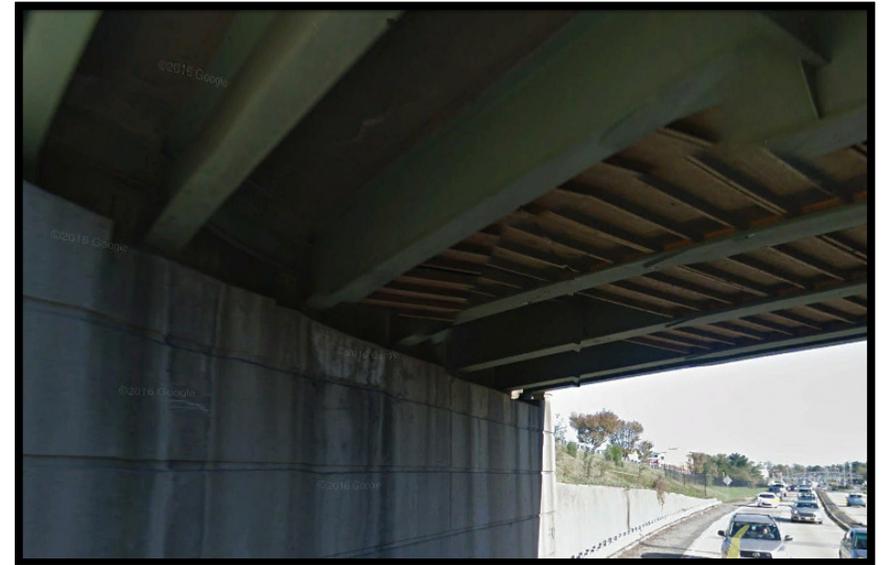
- Condition Rating 4 (Poor Condition)
- Bottom of the deck in poor condition due to numerous cracks, spalls and delaminated areas.
- Concrete overlay in fair condition due to numerous cracks, scaling and delamination.

Timber planks placed by VDOT to protect Rte 50 traffic from falling concrete from the underside of deteriorating deck.
