Ten Year Performance of Overlays on Route 60 Over Lynnhaven Inlet and Overlay Recommendations

Virginia Concrete Conference
Richmond Virginia
March 4 and 5, 2009

Michael Sprinkel, P.E.
Associate Director

Virginia Transportation Research Council

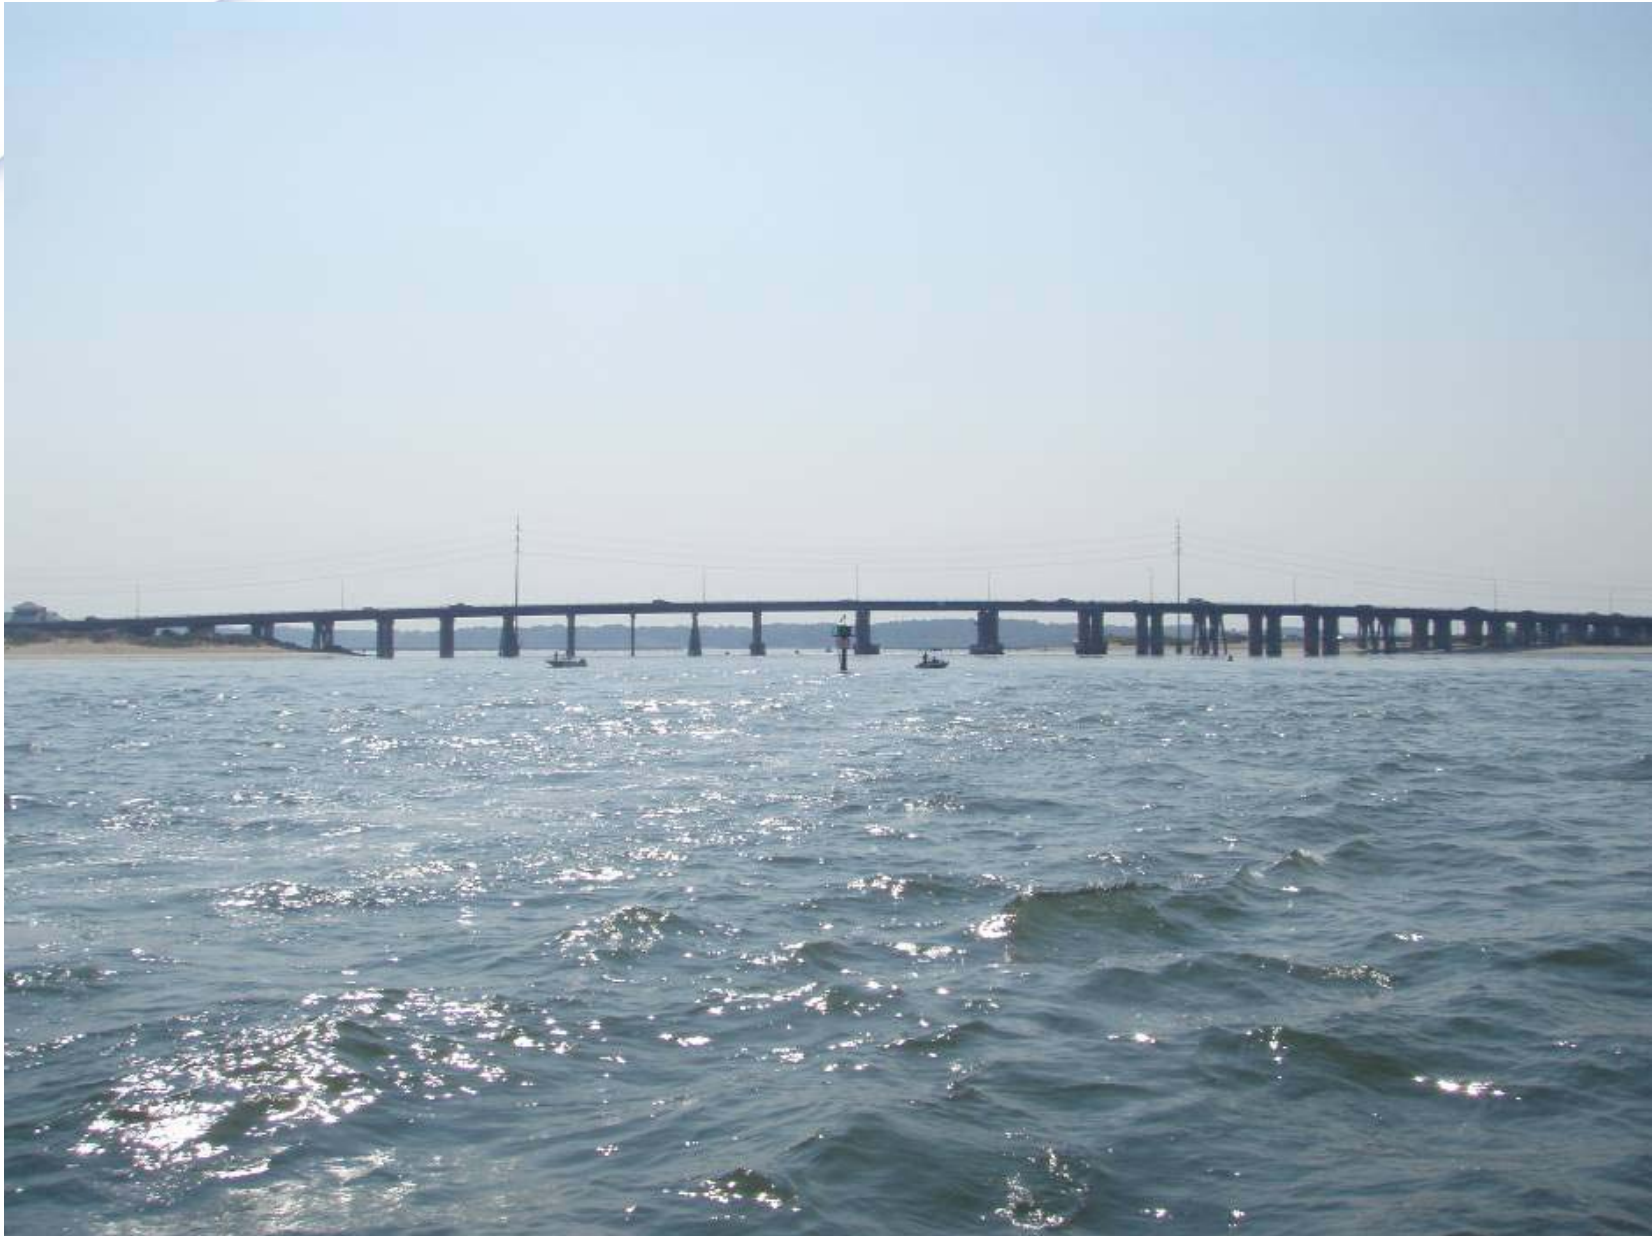
Lynnhaven Bridges (Ref: Clark-Nexsen)

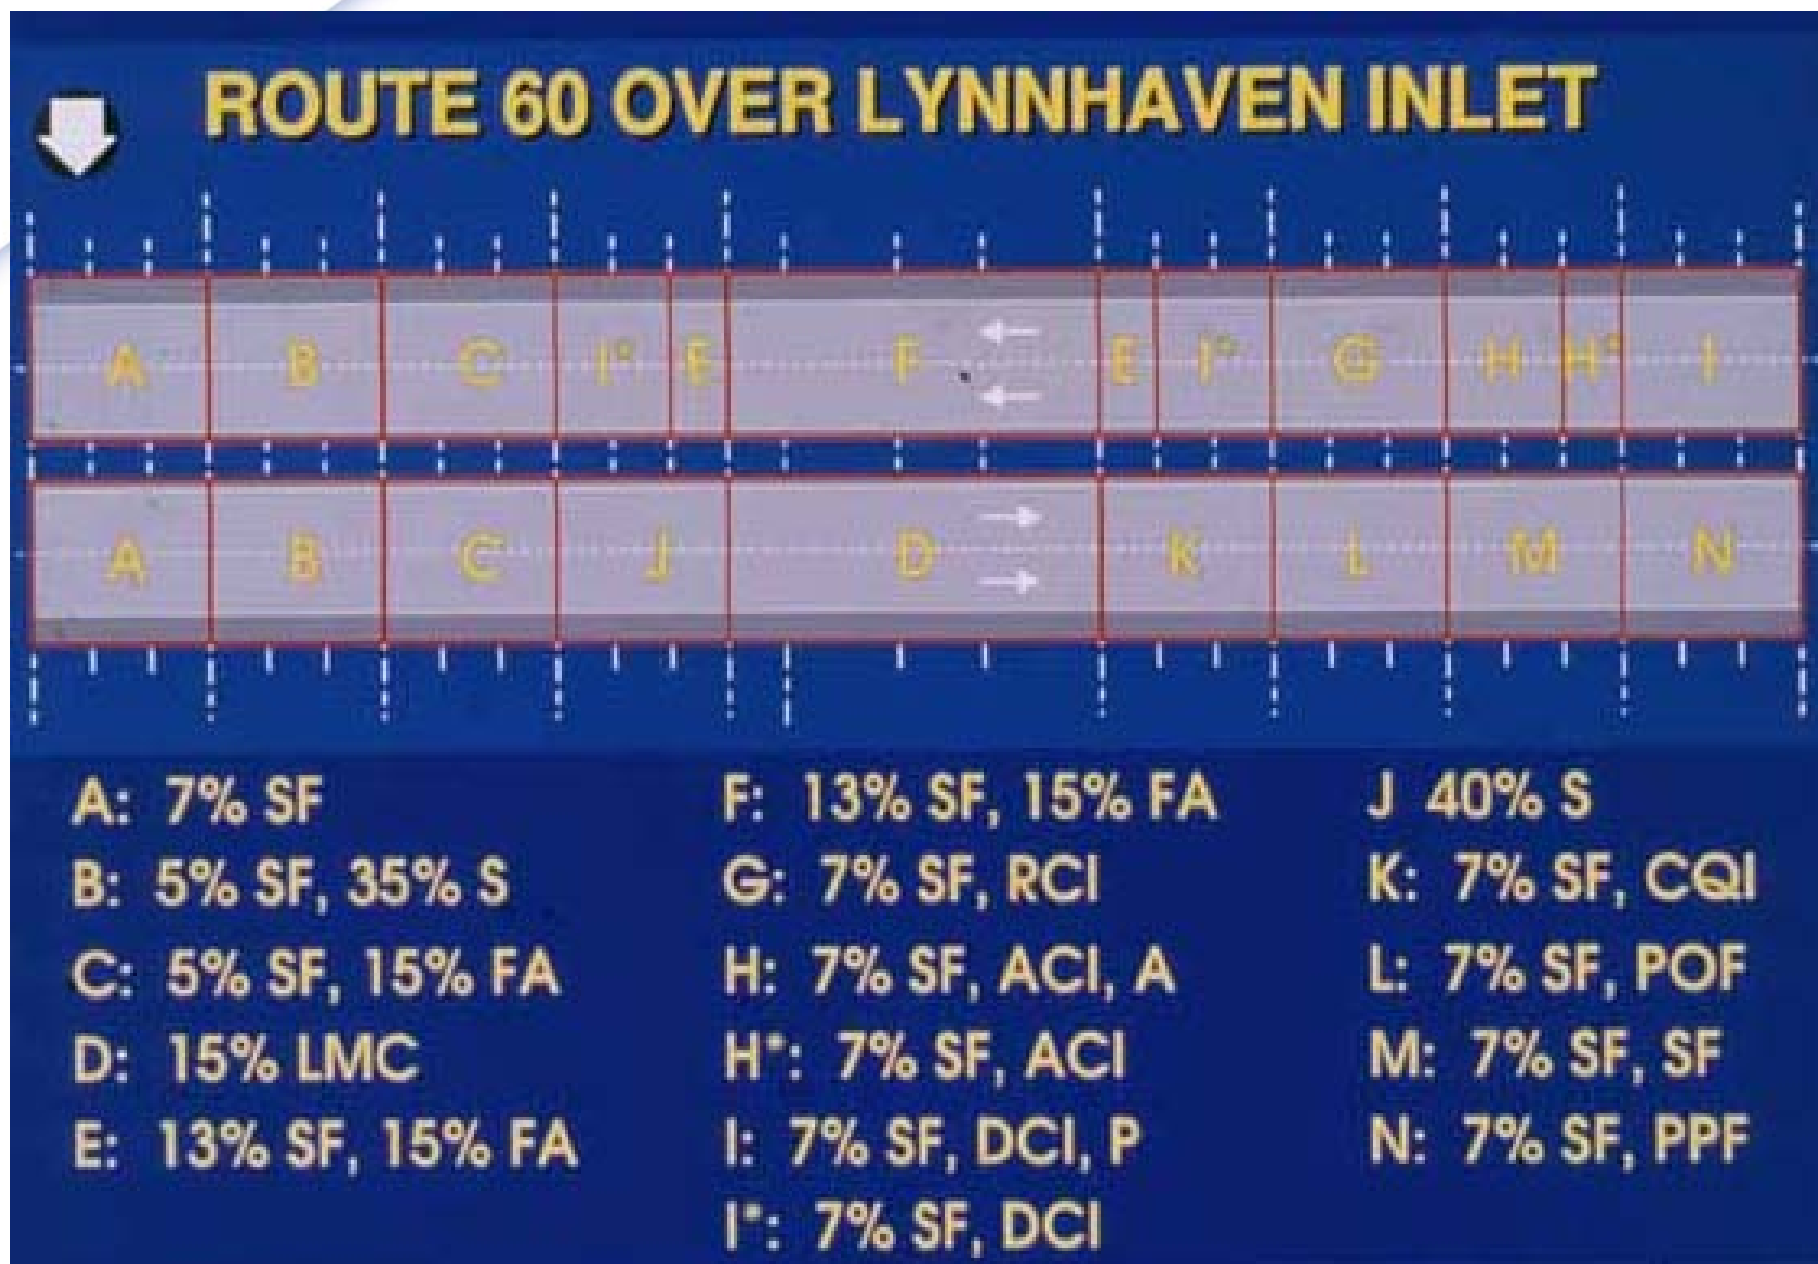
Plan View of Overlays

A minimum of one lane of one span was used to evaluate each overlay system

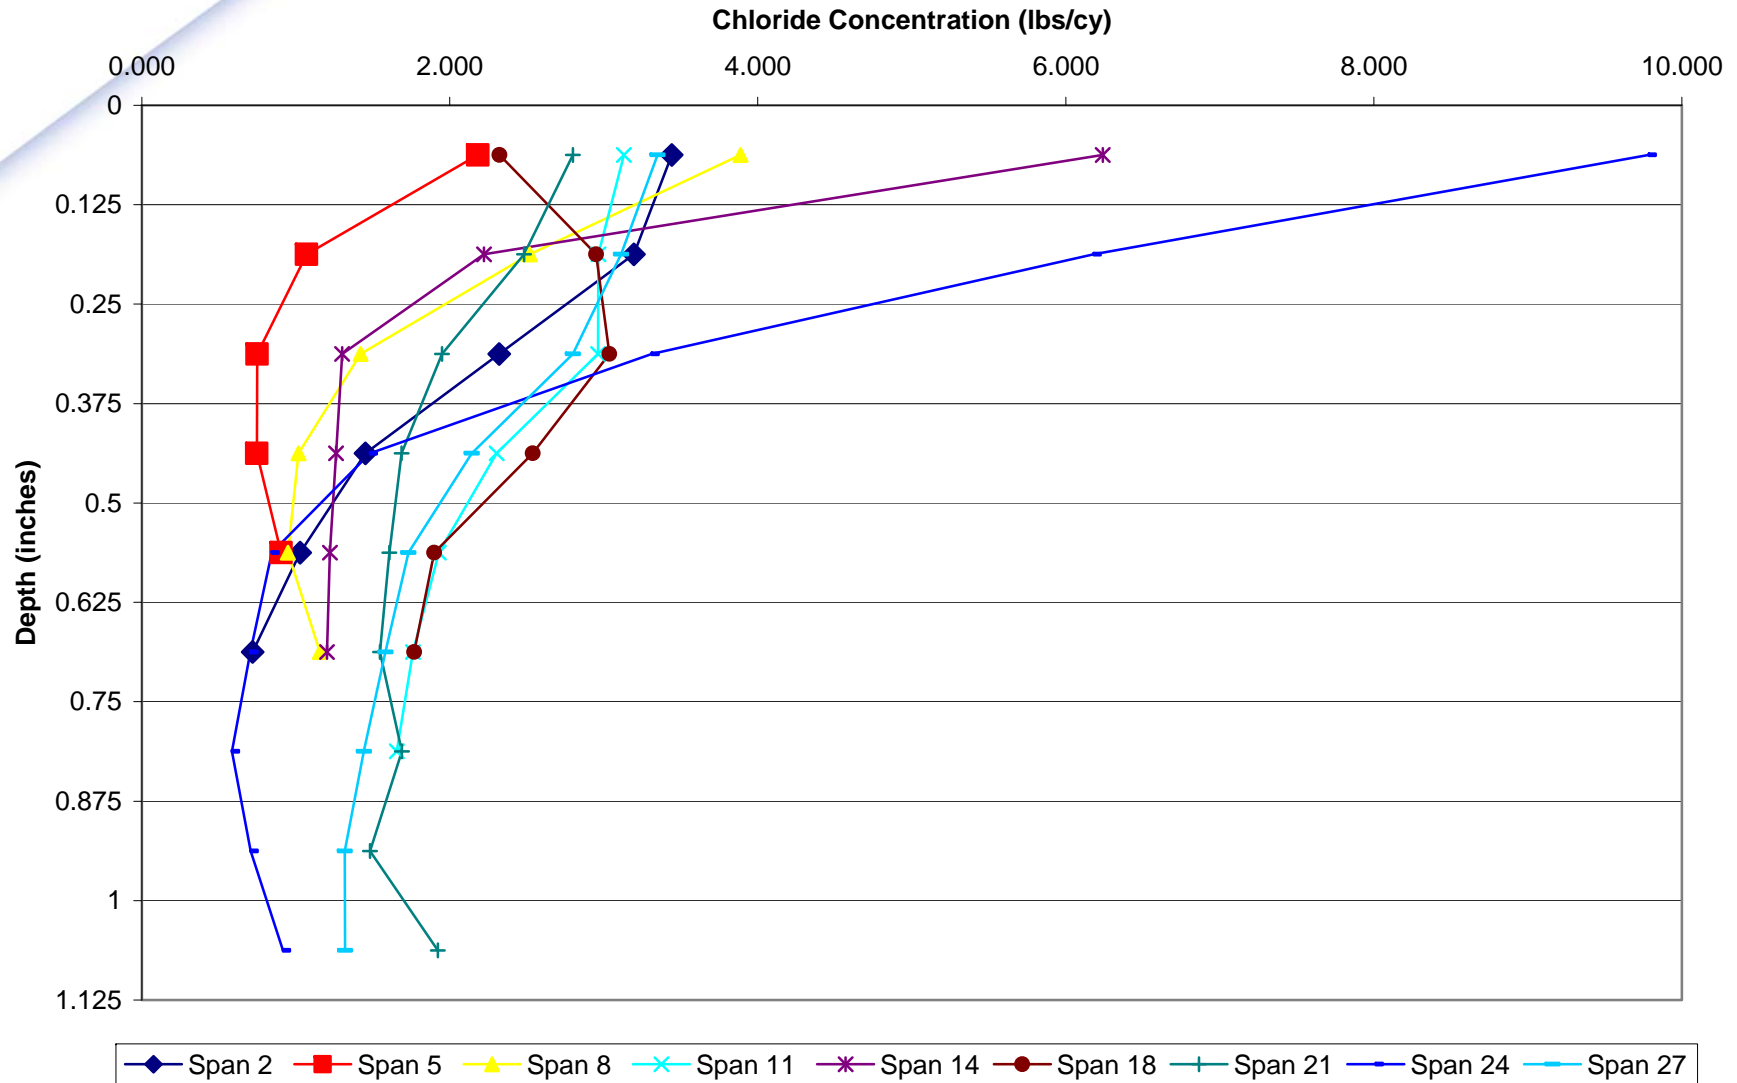
Overlay Chloride Ion Profiles, EBL
