# **Phase II Environmental Site Assessment Roadway Improvement Project**

**Route 1 Widening Project  
1 Performance Auto Care  
17484 Jefferson Davis Highway  
Dumfries, Virginia 22026  
Prince William County**

**Contract ID: 44115  
VDOT Project: 001-212-249  
VDOT UPC: 90339 Act: 689  
VDOT Task Number: E-FR024.09**

**February 2019**

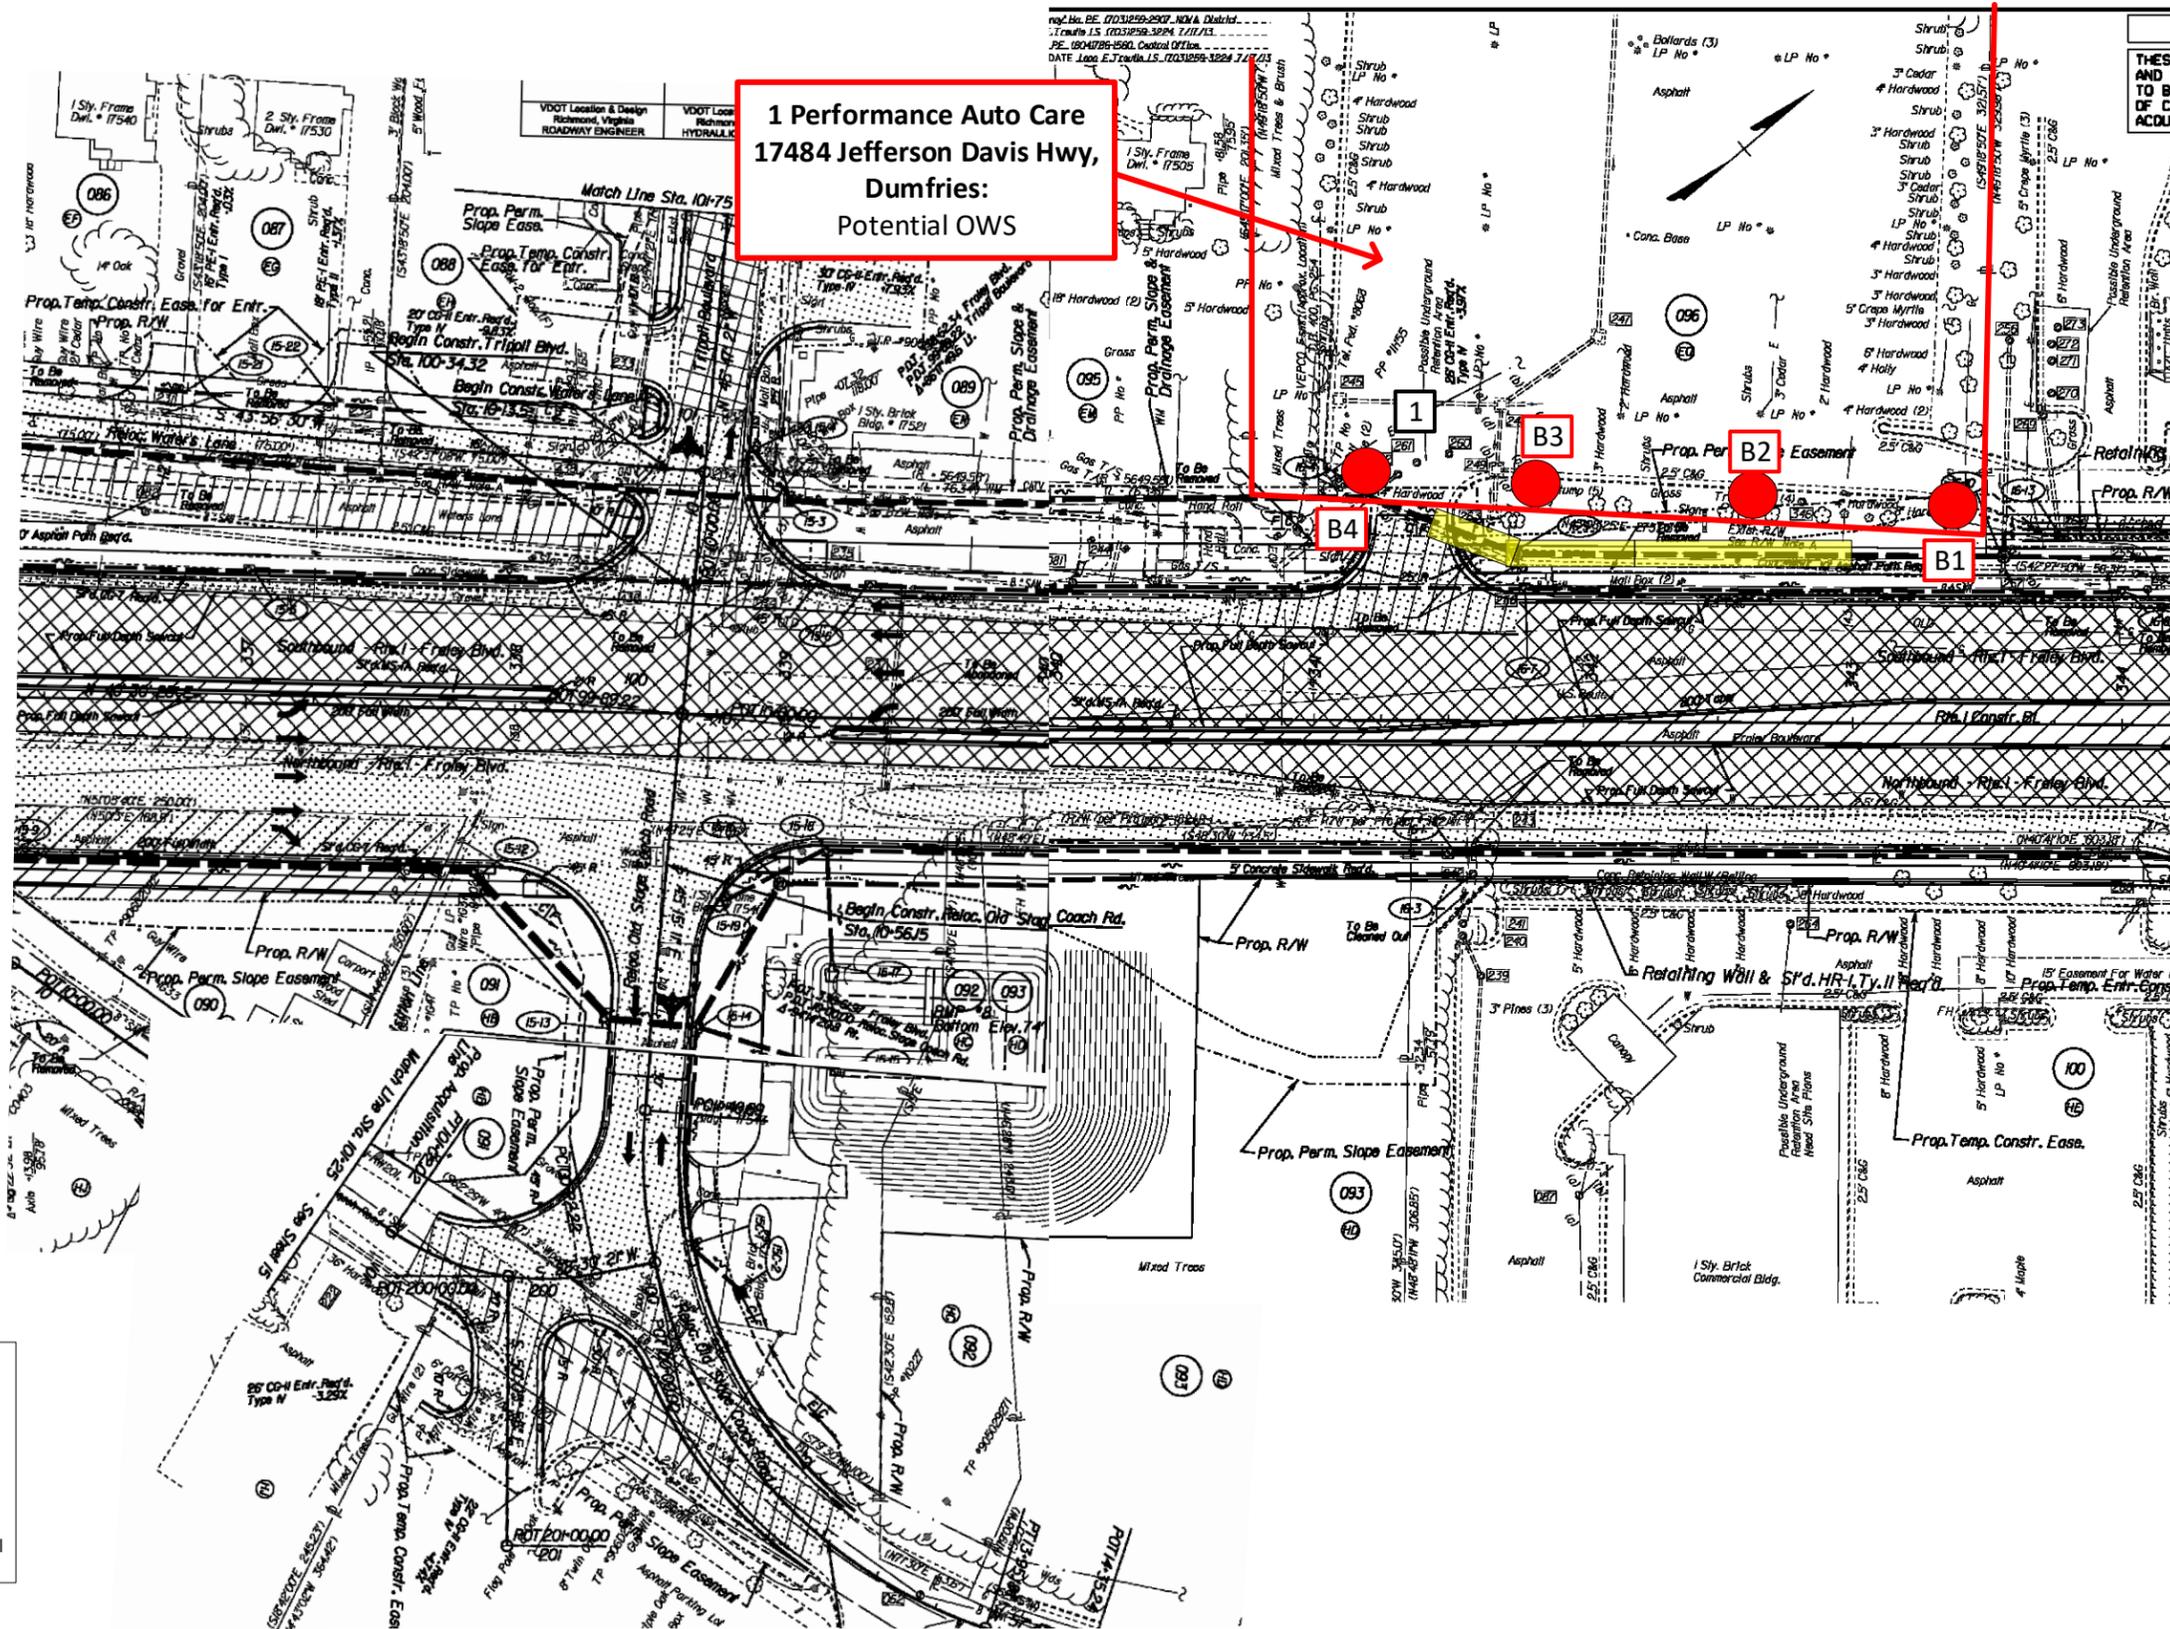
The roadway improvements proposed to date, RECs, and boring locations are depicted on **Figure 4**.

- 1 Suspect OWS Location
- Soil Boring
- Approximate Area of Petroleum Impacted Soil
