Phase II Environmental Site Assessment Roadway Improvement Project

Route 1 Widening Project

Daniel's Auto Care

February 2019

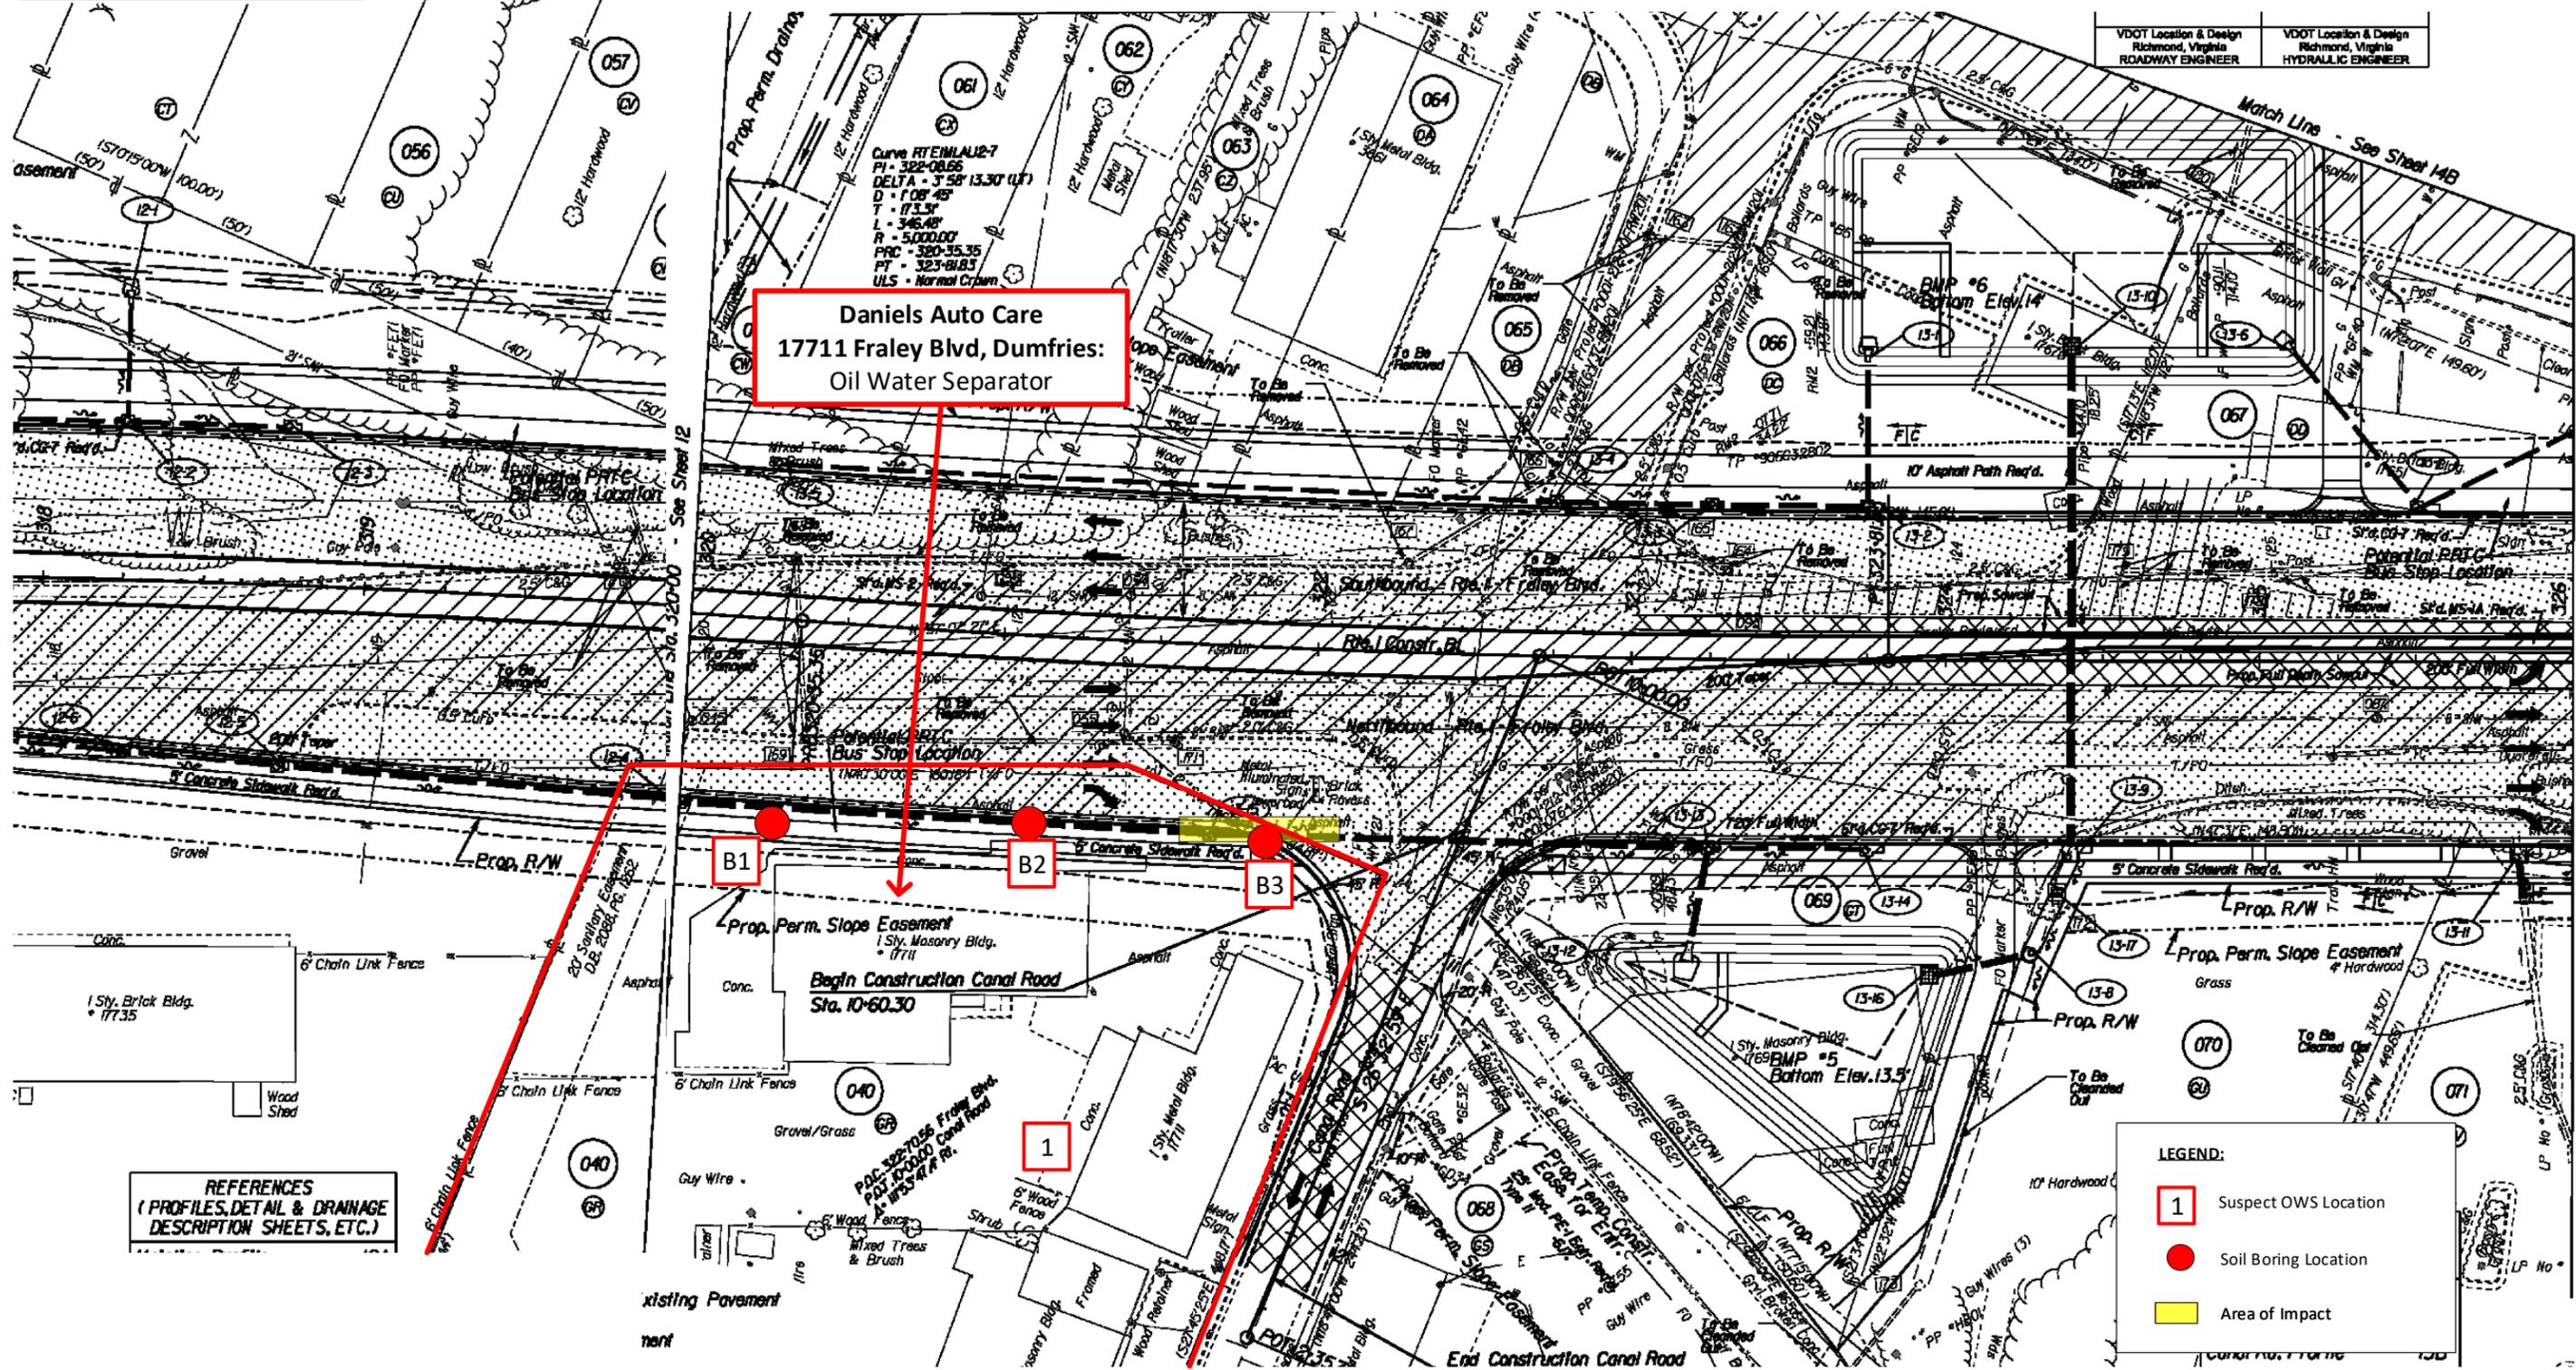
According to Plan Sheet Nos. 12 and 13, the property is a potential full take because of the proposed R/W and permanent slope easement limits that intersect one story masonry building on-site. Improvements proposed to date at Parcel 040 include Drainage Structures 12-4, 13-15 and the associated 24-inch diameter connection pipe, sidewalk, and roadway realignment improvements (see **Figure 4**).

The roadway improvements proposed to date, RECs, and boring locations are depicted on **Figure 4**.

Review of Plan Sheet Nos. 12 and 13 indicates that the following drainage improvements will require excavation in portions of Parcel 040 that are impacted by low residual-phase petroleum concentrations:

- ❖ Drainage Structure No. 13-15 and a portion of the associated 24-inch diameter connection pipe from approximately STA Nos 321+60 to 322+10, 70-ft RT of CL.

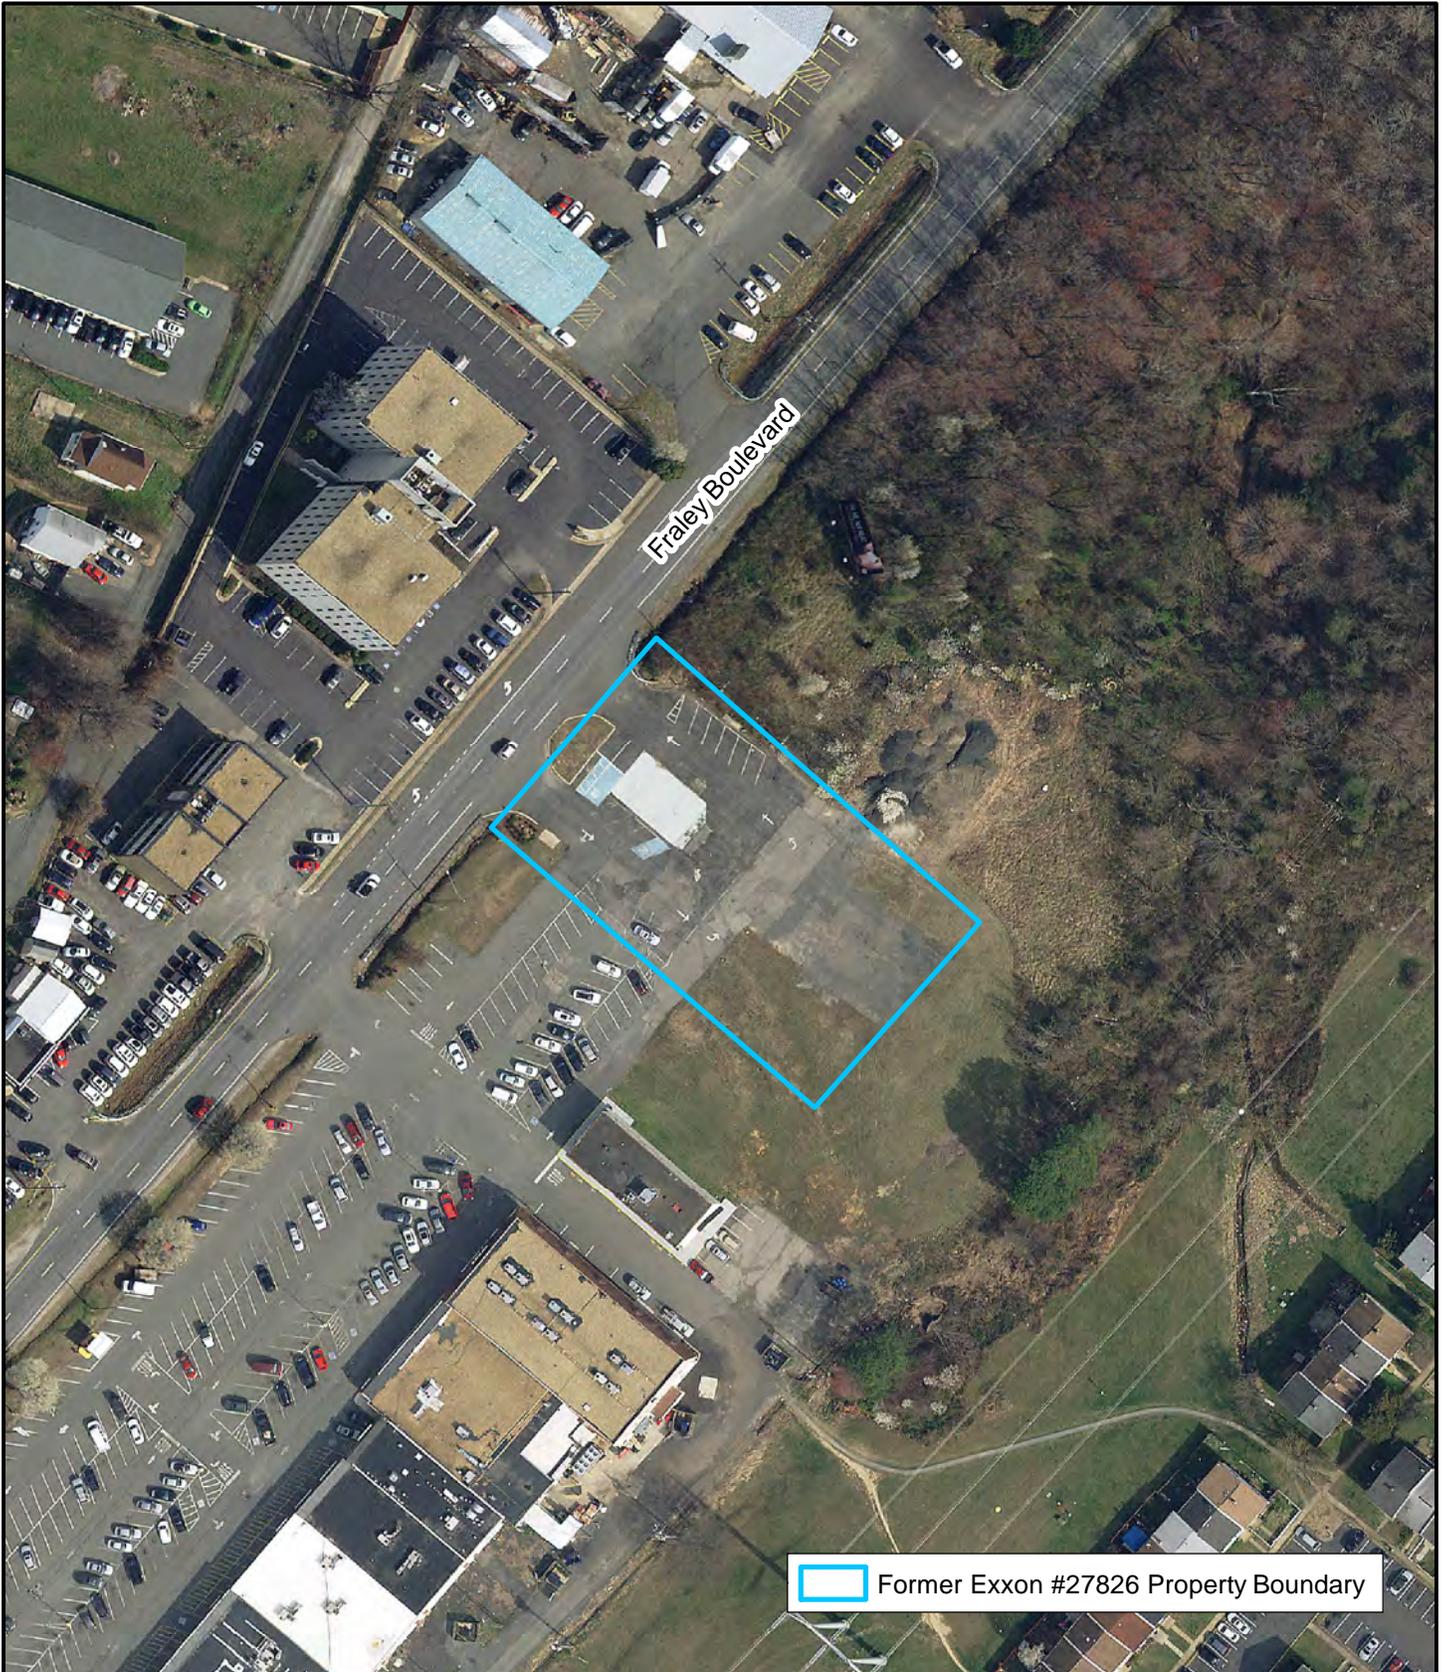
- 1 Former Petroleum UST Locations
- 2 Dispenser Island
- Temporary GW Monitoring Well
- Soil Boring

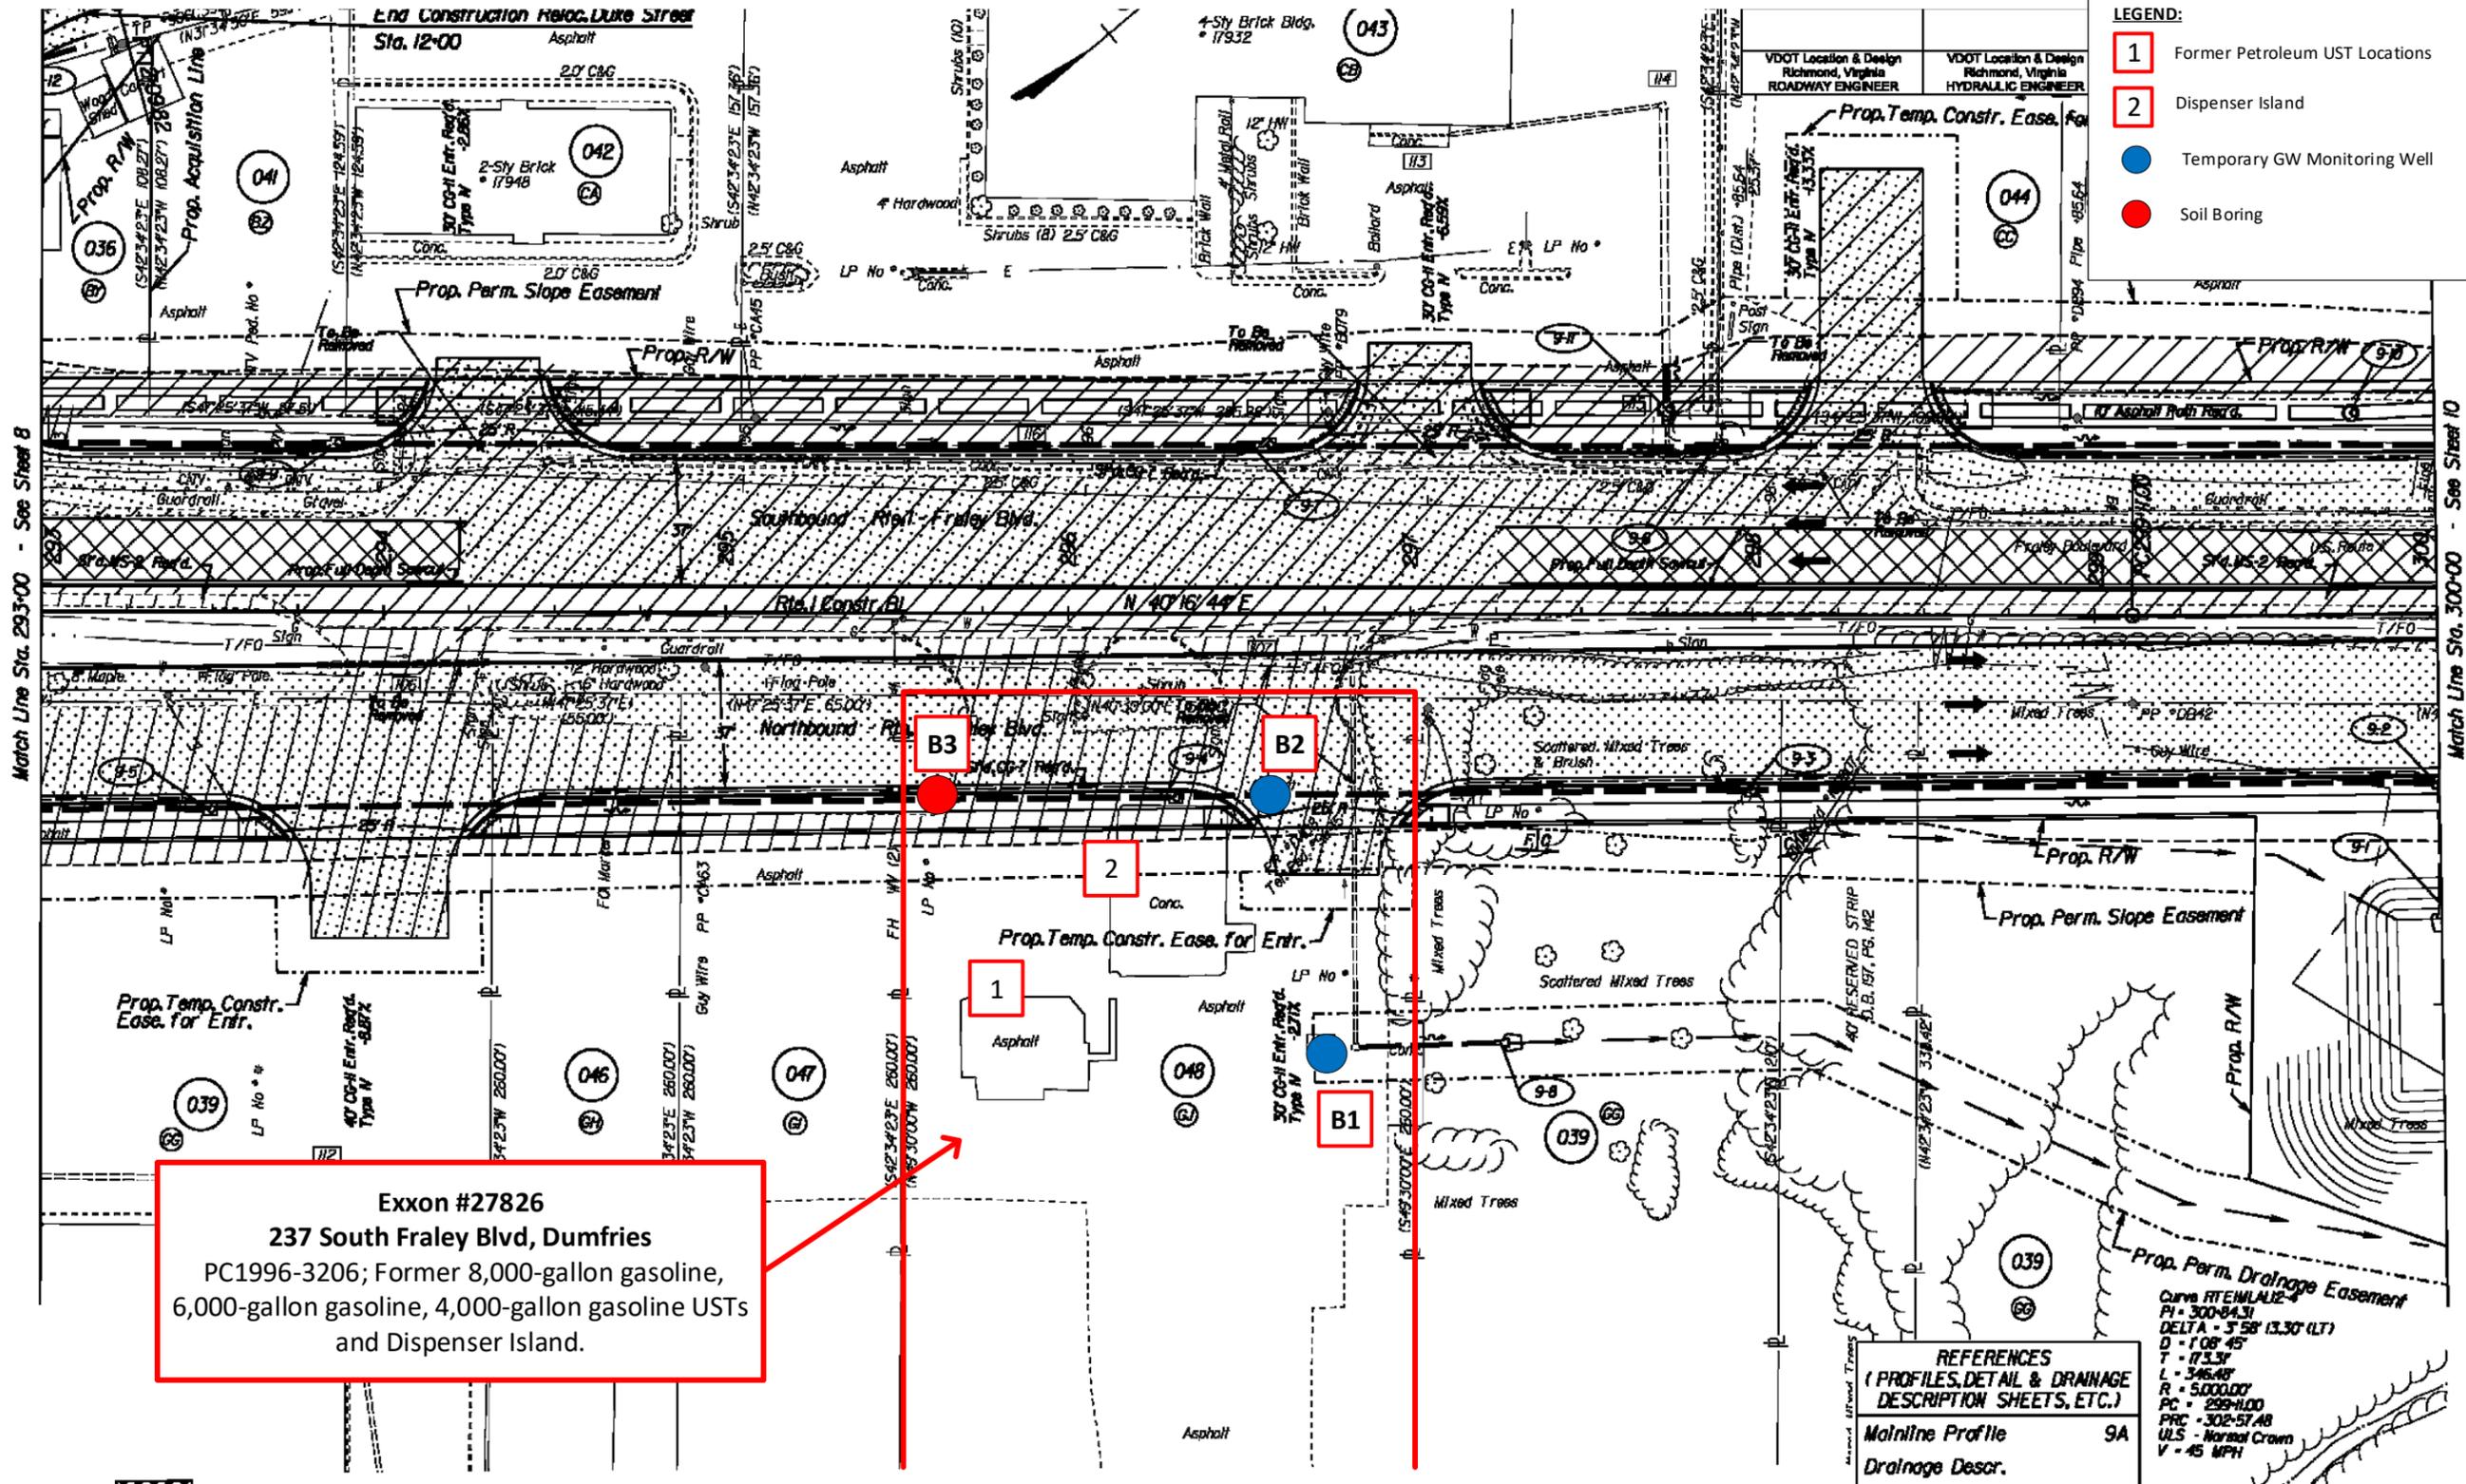
Exxon #27826
237 South Fraley Blvd, Dumfries
 PC1996-3206; Former 8,000-gallon gasoline,
 6,000-gallon gasoline, 4,000-gallon gasoline USTs
 and Dispenser Island.

Denotes Build-up Existing Pavement
 Denotes New Pavement
 Scale
 0' 25' 50'
