# **Phase II Environmental Site Assessment Roadway Improvement Project**

## **Route 1 Widening Project**

### **Mrs. K's Carwash**

**VDOT Project: 001-212-249**

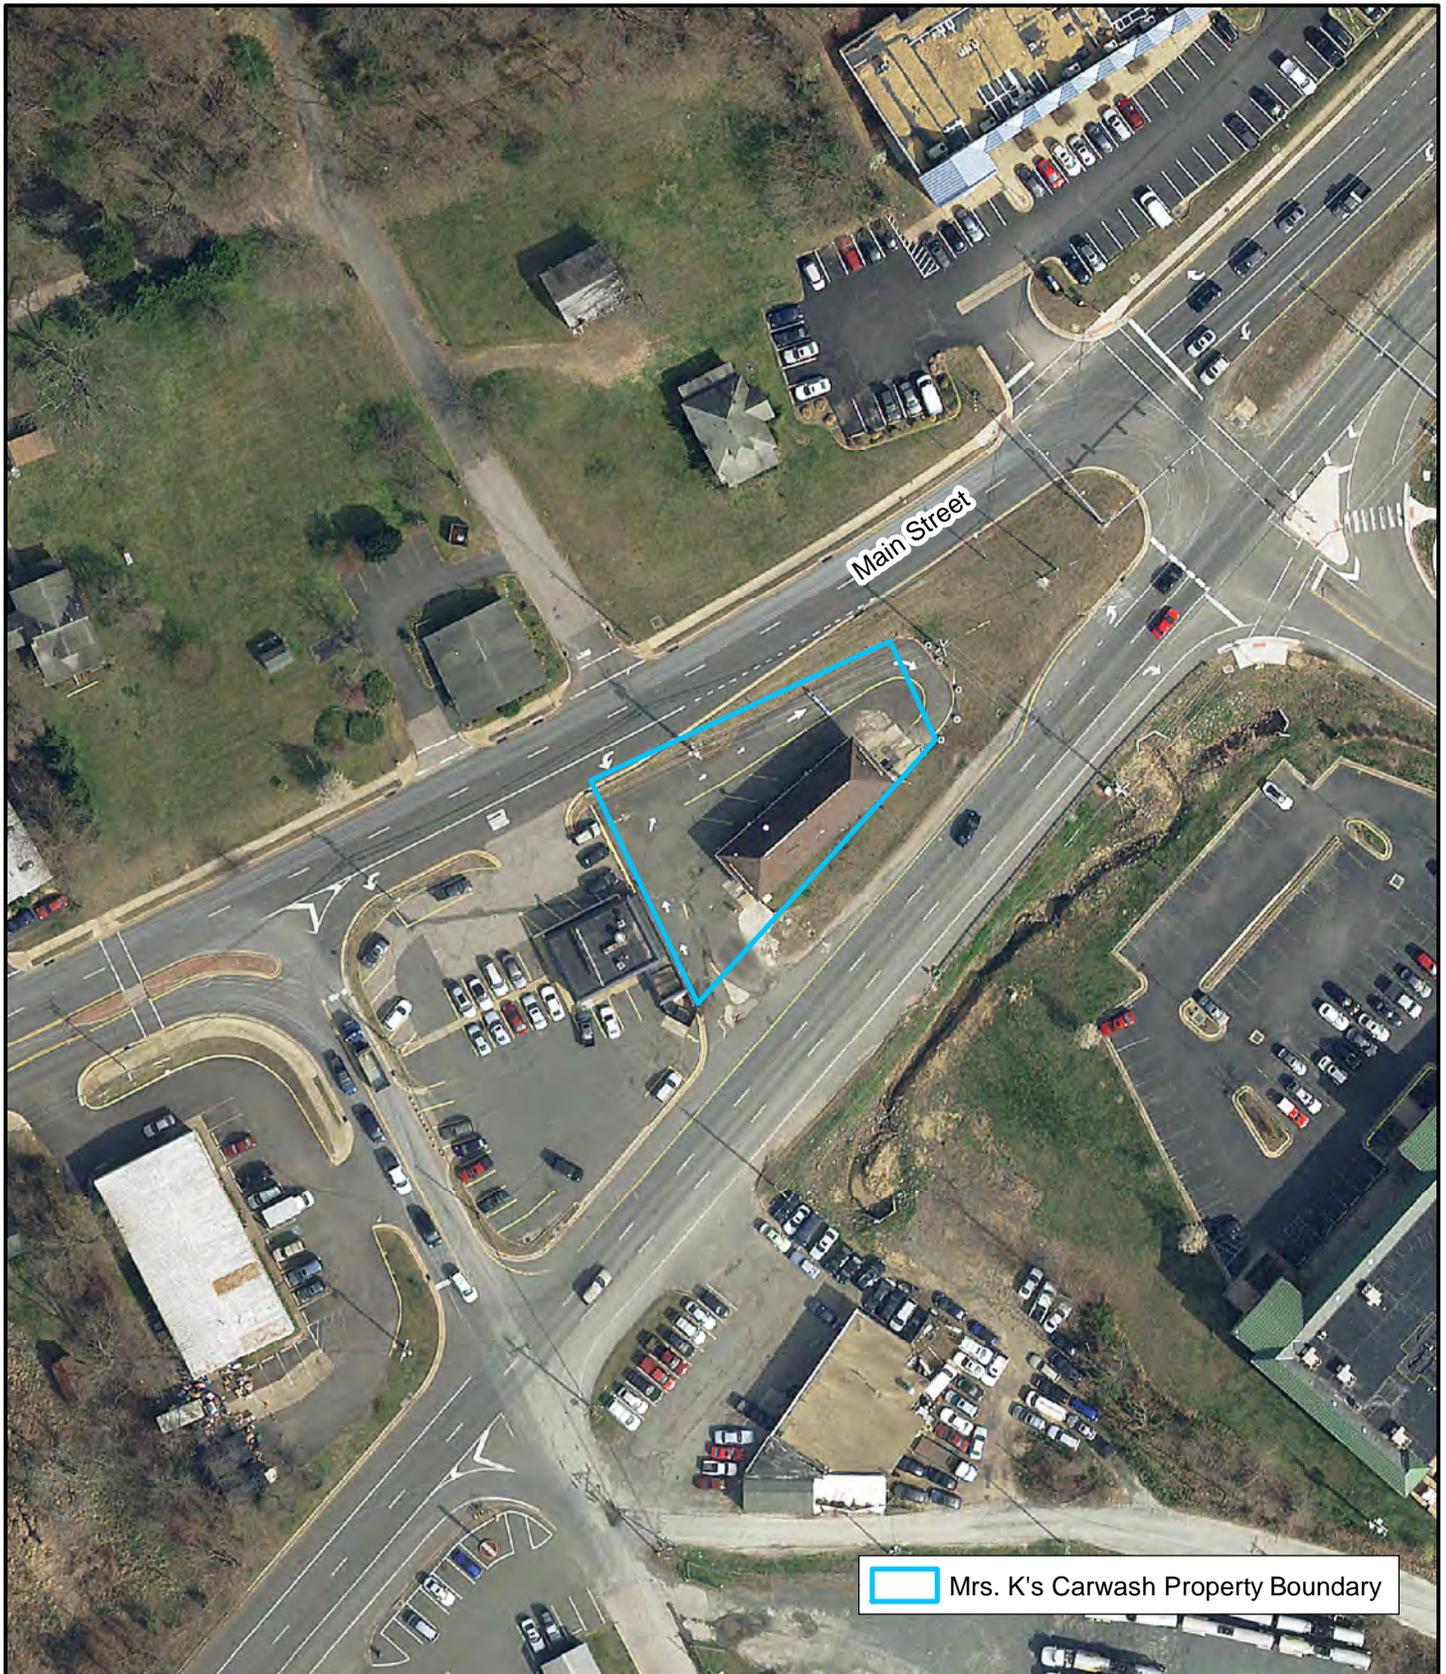
Mrs. K's Carwash Property Boundary

**Mr. K's Carwash**  
 17651 Main Street, Dumfries:  
 Oil Water Separator and 55-gallon  
 drum of Used Oil with surface  
 staining.

<span style="border: 1px solid red; padding: 2px;">1</span>	Suspect OWS & 55-gallon Drum w/Surface Staining
<span style="color: blue;">●</span>	Temporary GW Monitoring Well
<span style="color: red;">●</span>	Soil Boring
<span style="background-color: yellow; border: 1px solid black; width: 15px; height: 10px; display: inline-block;"></span>	Area of Petroleum Impact

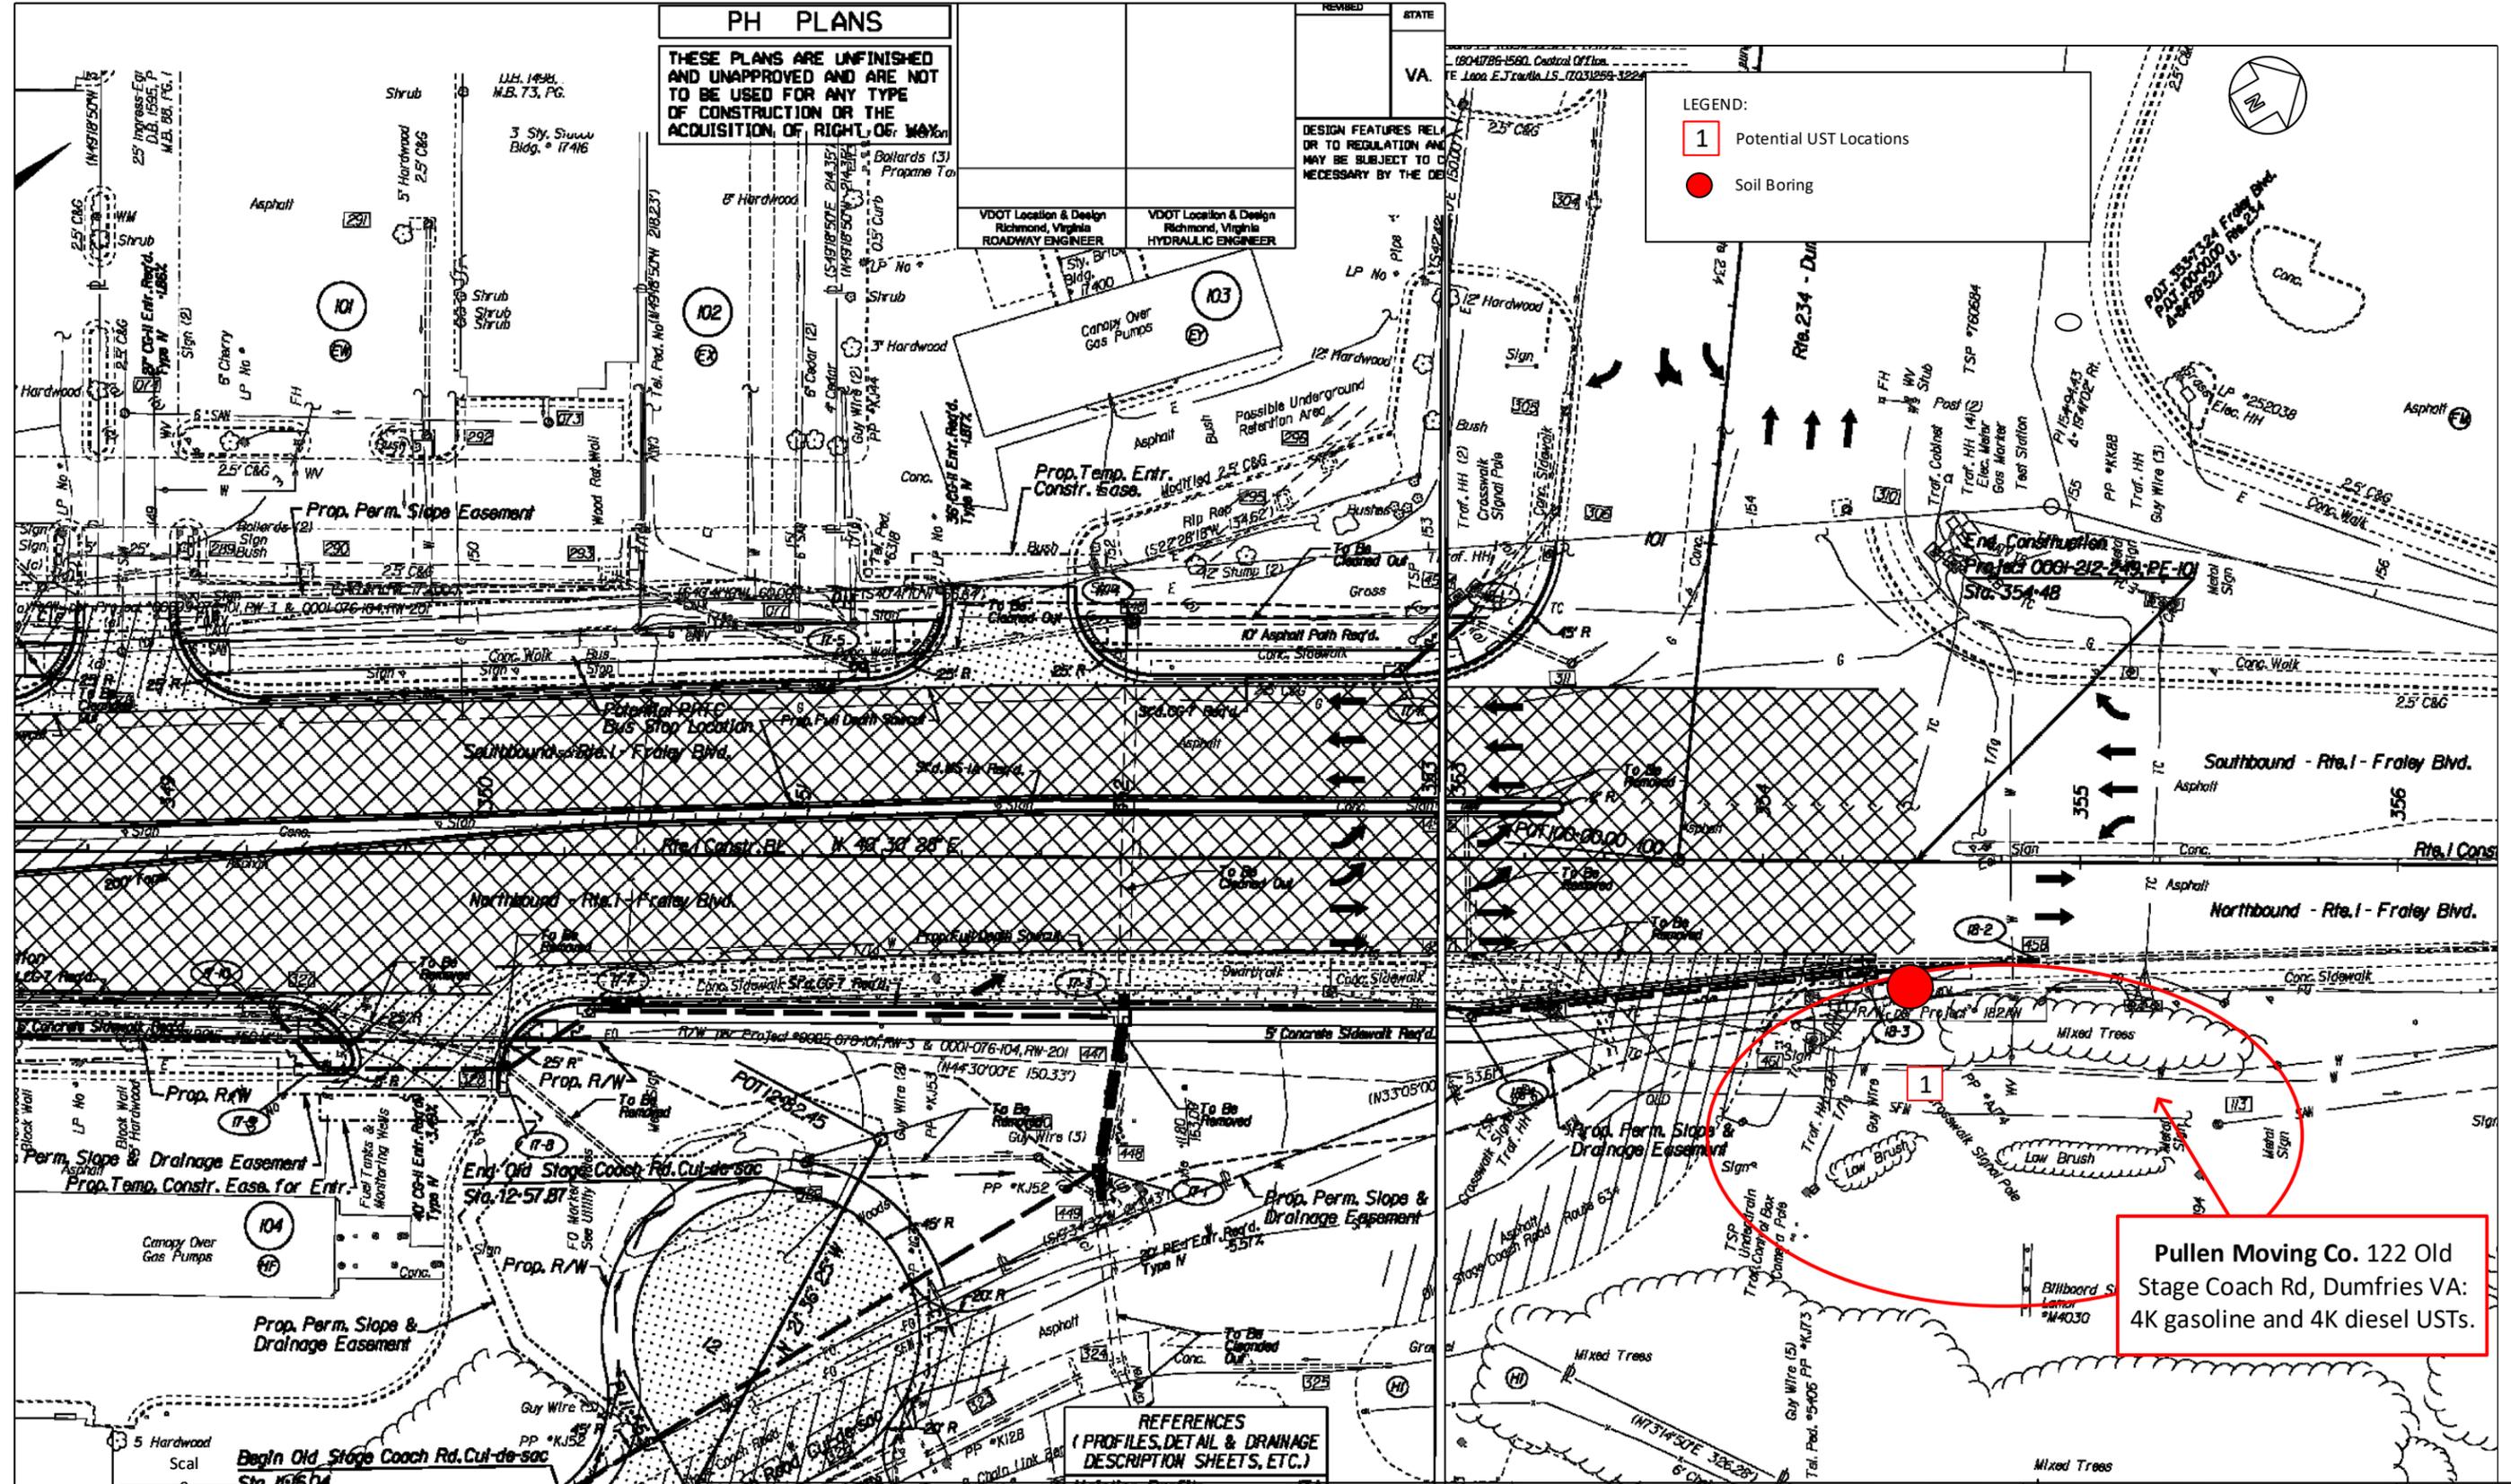
- 1 Potential UST Locations
- Soil Boring

**Pullen Moving Co. 122 Old Stage Coach Rd, Dumfries VA:**  
4K gasoline and 4K diesel USTs.

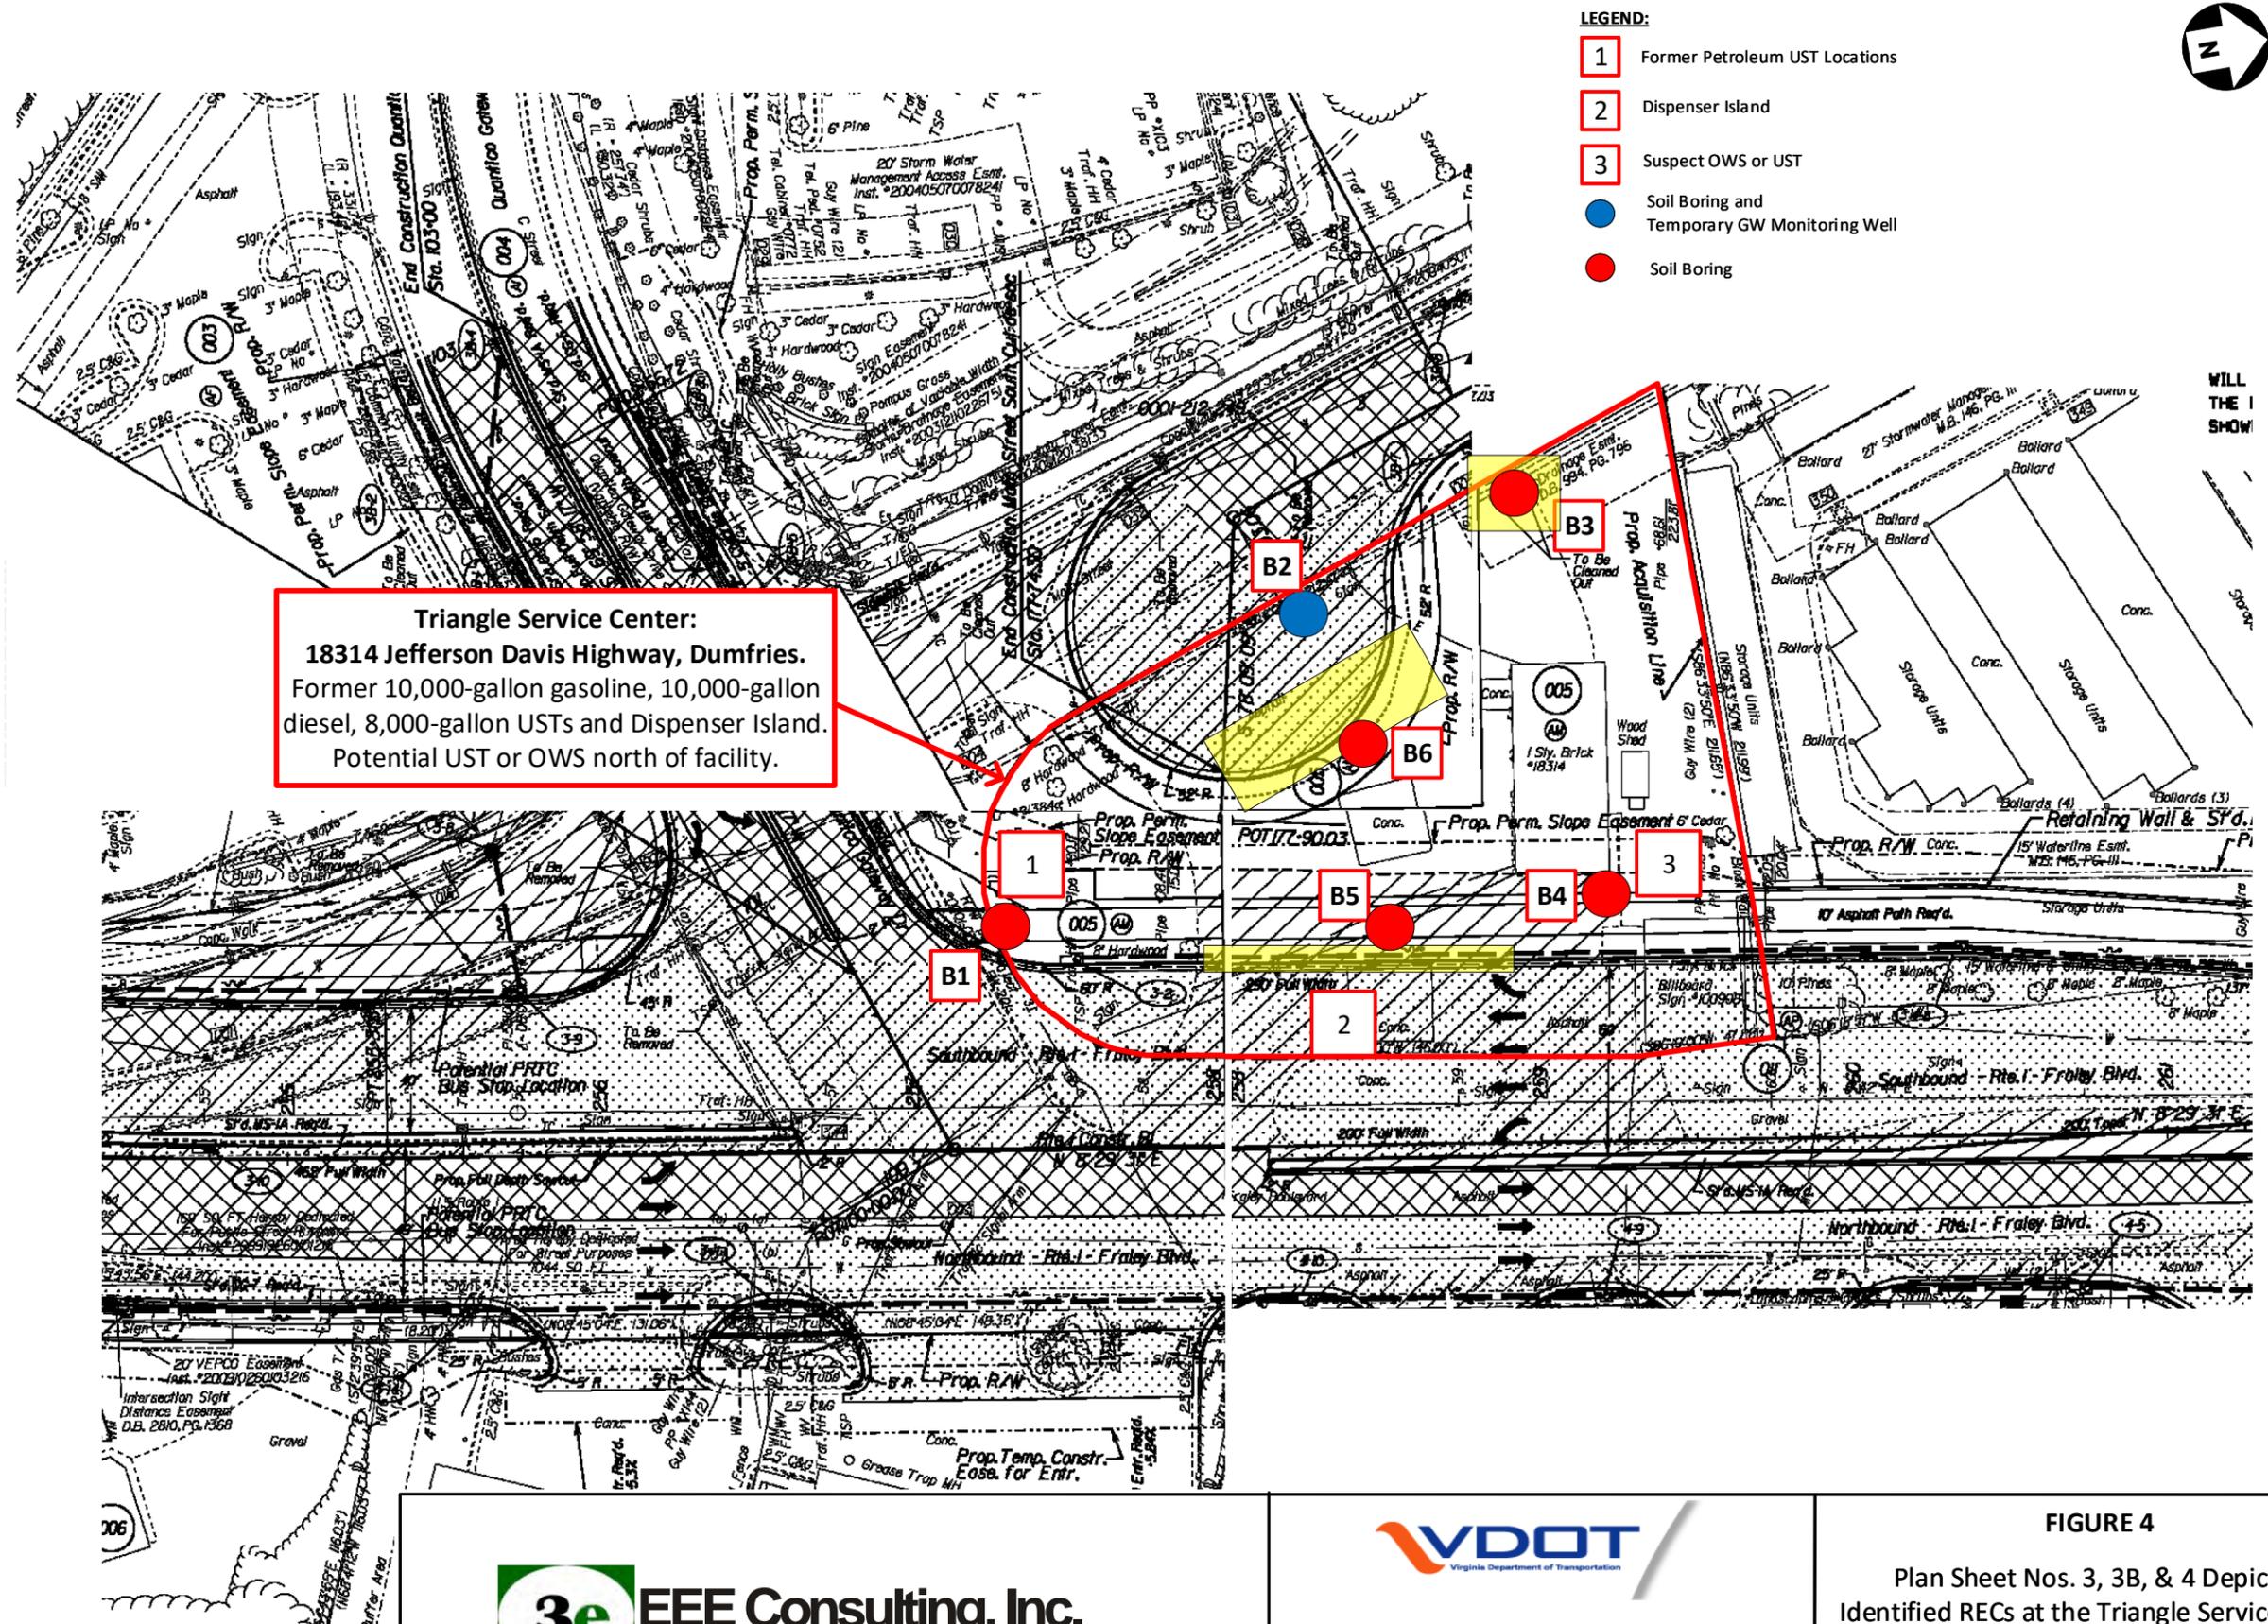
**Triangle Service Center** (Parcel 005) located at 18314 Jefferson Davis Highway, Triangle, VA 22172 (VDOT Plan Sheet Nos 3, 3A, 3B, 3C, 4 and 4A), which is an active vehicle repair shop with a suspect oil/water separator in the northern portion of the property. The historical use of the property includes a former refueling station that operated three petroleum USTs that were closed/removed from the ground in 1991.

Parcel 005 will likely be acquired as R/W to facilitate the installation of the roadway and drainage improvements proposed as of the date of this report. **Prior to R/W acquisition, it is recommended that the current property owner report a documented petroleum release to the environment to the DEQ-NRO.** This recommendation is based on the detection of TPH and BTEX constituent concentrations in select soil samples collected from B5 and B6 that exceed the DEQ reporting limits for a petroleum release to the environment.

The cut associated with the cul-de-sac from STA 257+90 to 258+75 LT of CL is currently proposed to encounter petroleum-impacted soil below the VSWMR fill limit of 50-mg/kg at depths of 0-5-ft BGS. If excavation in this portion of Parcel 005 (i.e. proximate to B6) will trend to depths greater than five (5)-ft BGS, then additional Special Management Provisions will likely apply to manage this soil as a non-hazardous, petroleum-impacted solid waste stream (see **Section 7.2** below).

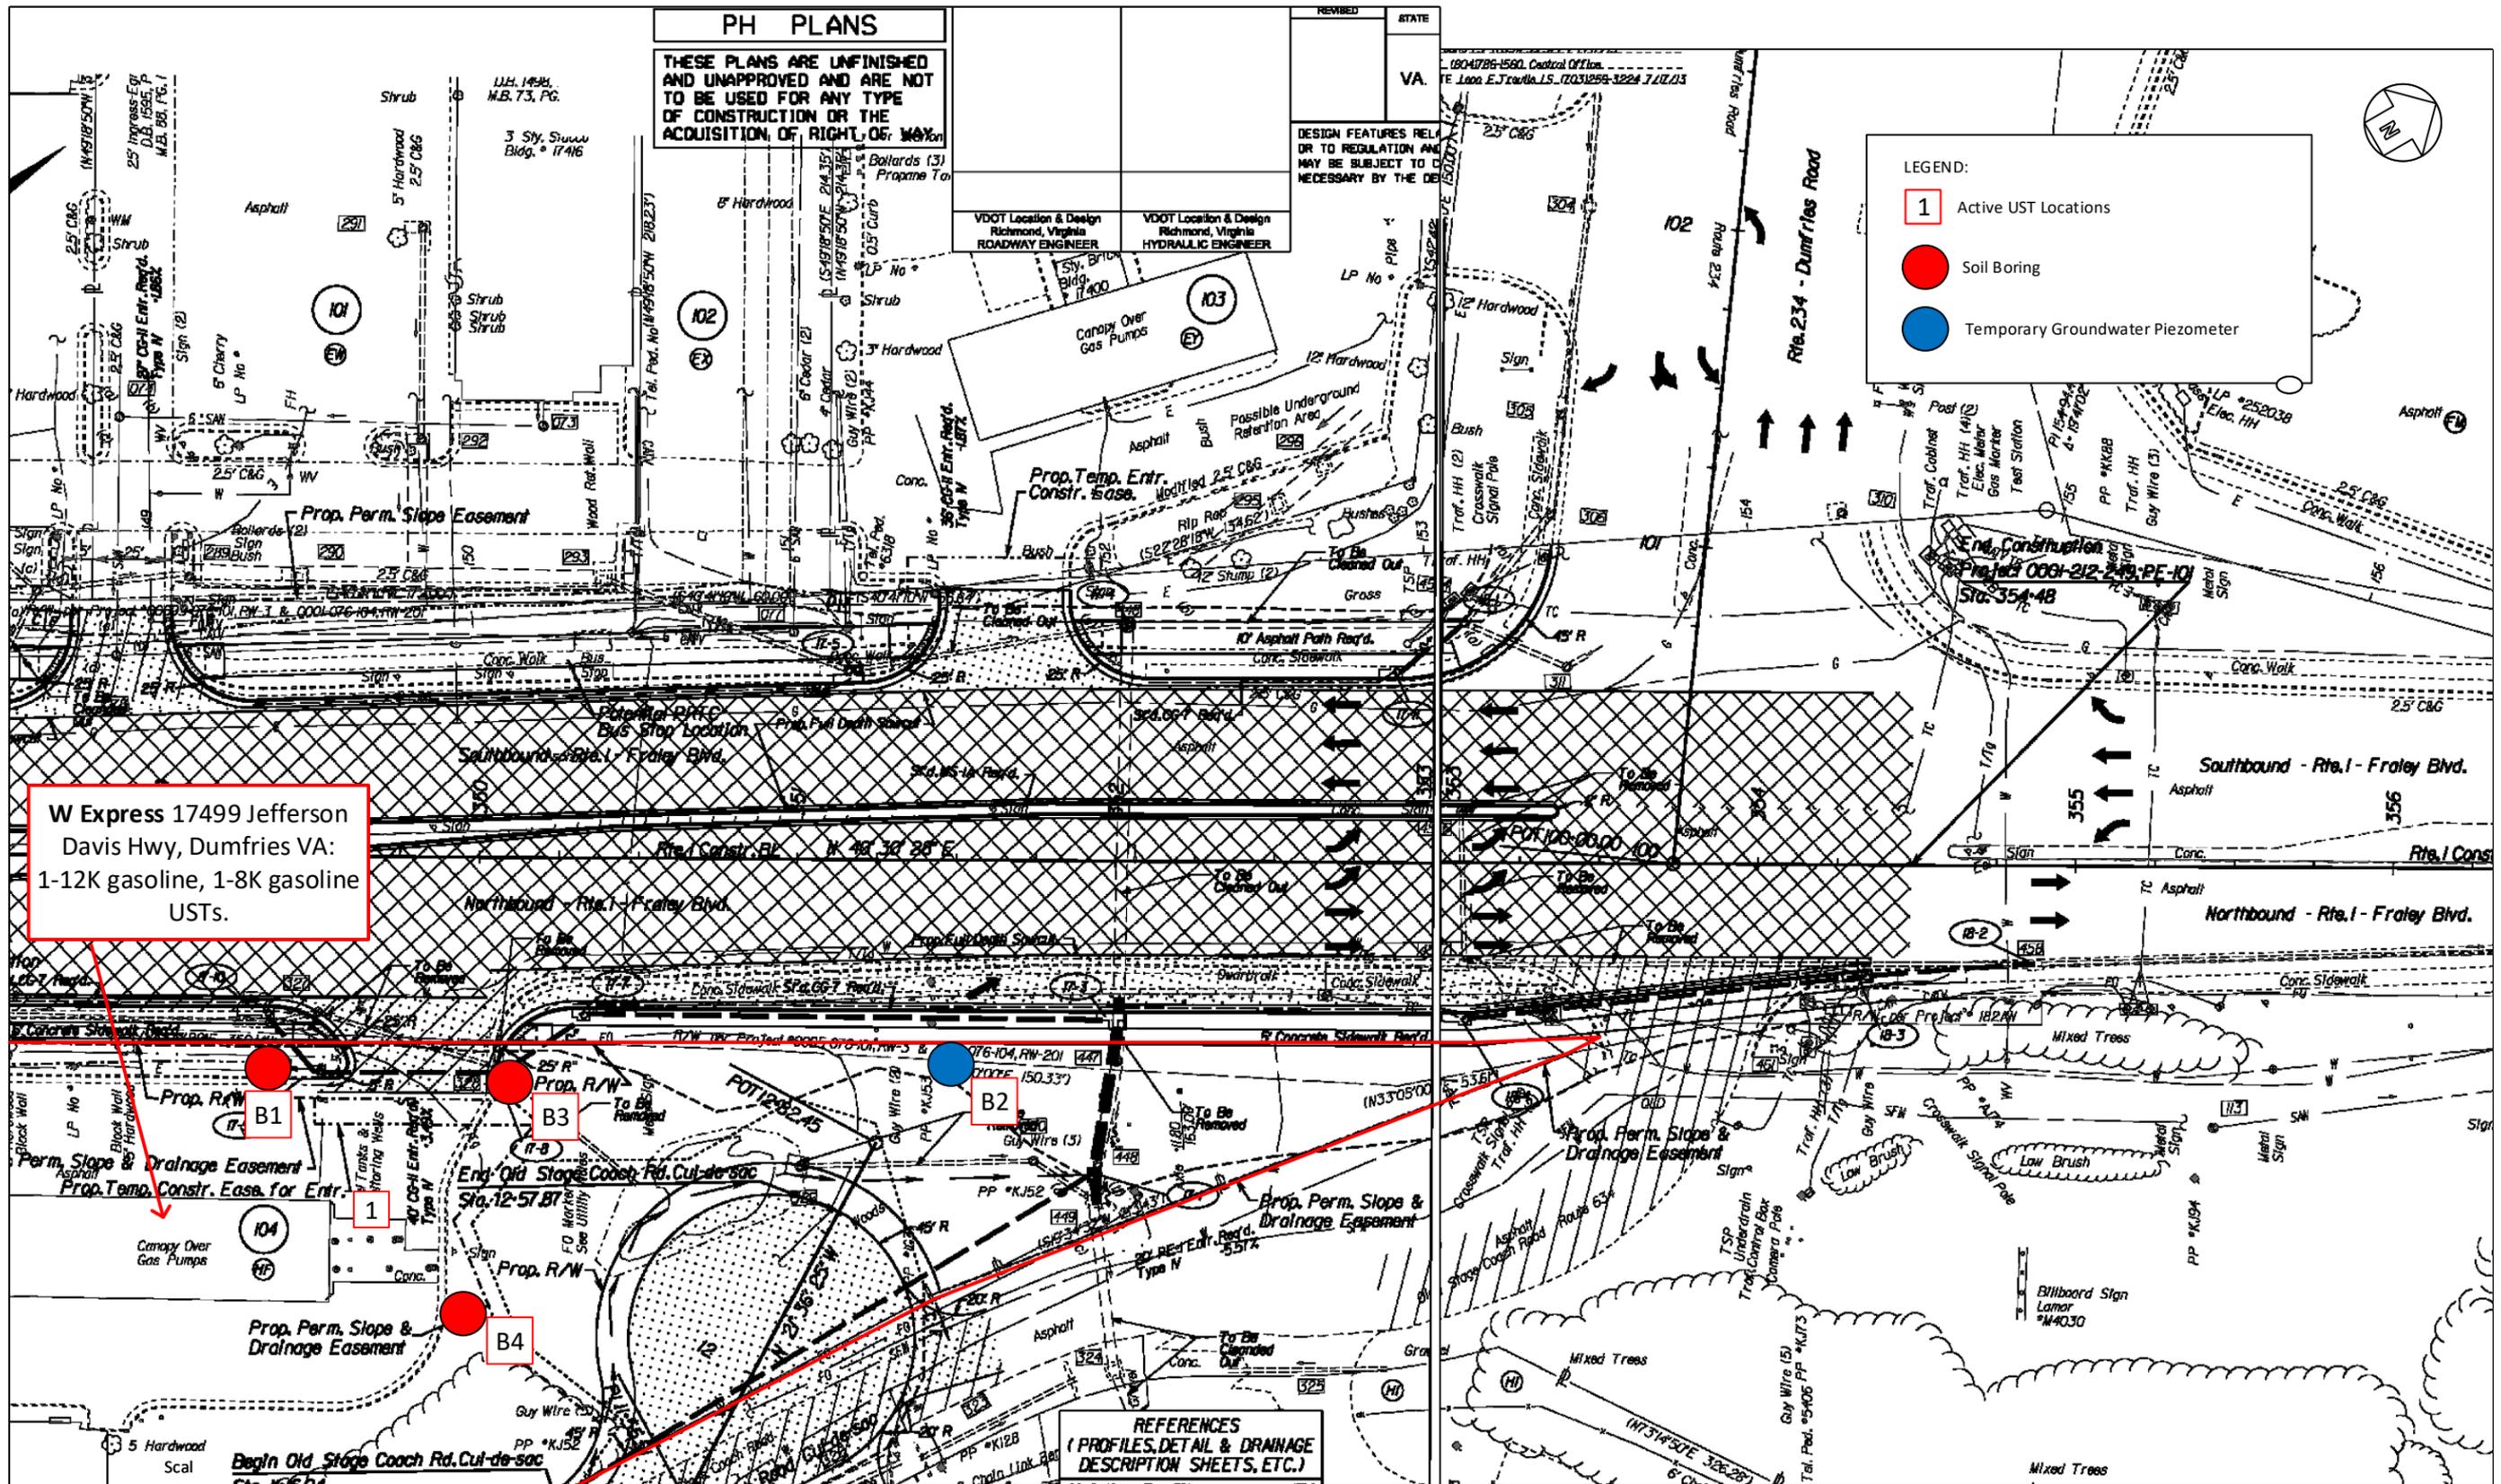
- 1 Active UST Locations
- Soil Boring
- Temporary Groundwater Piezometer

**W Express 17499 Jefferson Davis Hwy, Dumfries VA:**  
1-12K gasoline, 1-8K gasoline USTs.
