# Bagging Plant Road and Route 100

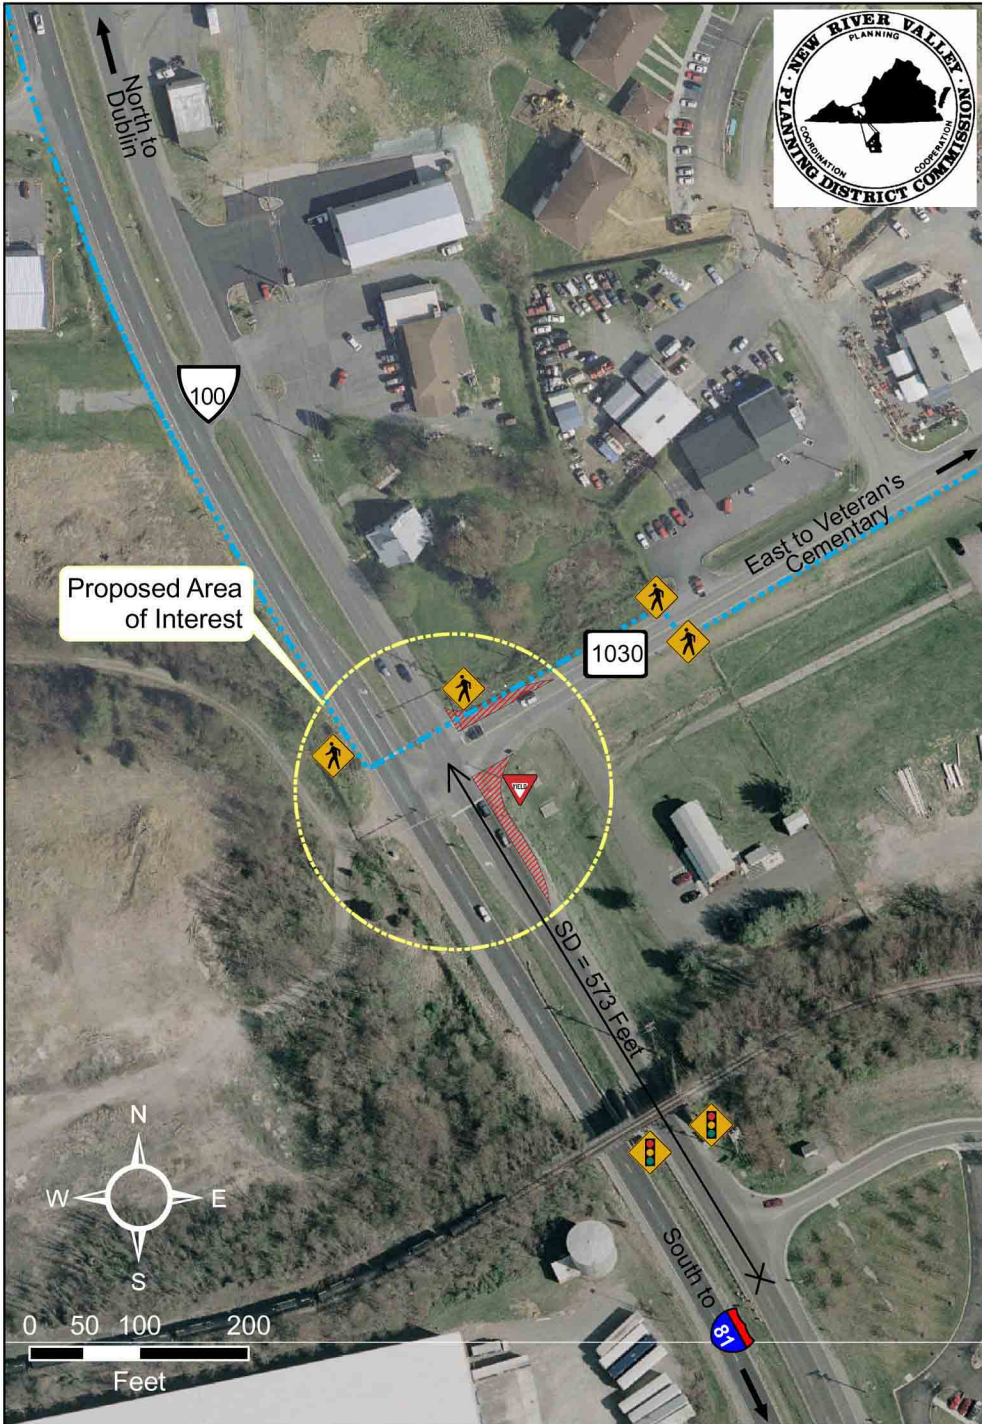
This signalized intersection has poor sight distance and limited clearance for north bound Route 100 traffic due to a east-west crossing railroad bridge. Currently there are warning signs in the field to the south of the bridge, but with anticipated increase of traffic for both routes, the intersection should be evaluated for potential safety improvements such as flashing warning devices. Also, the addition of turning lanes could avoid future congestion issues.

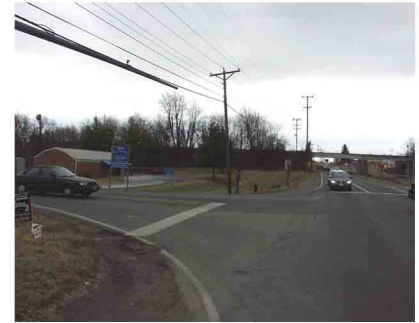
Field photo of existing intersection of Bagging Plant Road and Route 100. View of photo is to the south-east from roadside edge of pavement.

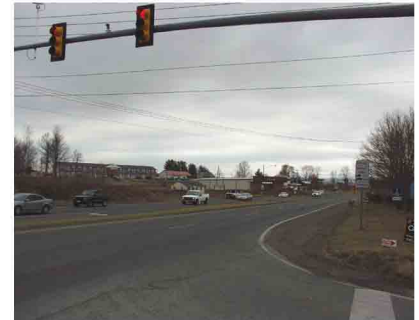
Field photo from Bagging Plant Road center line looking north along Route 100.

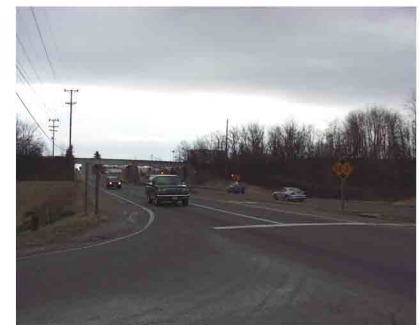
Field photo from Bagging Plant Road center line looking south along Route 100.
