Site Specific Details:

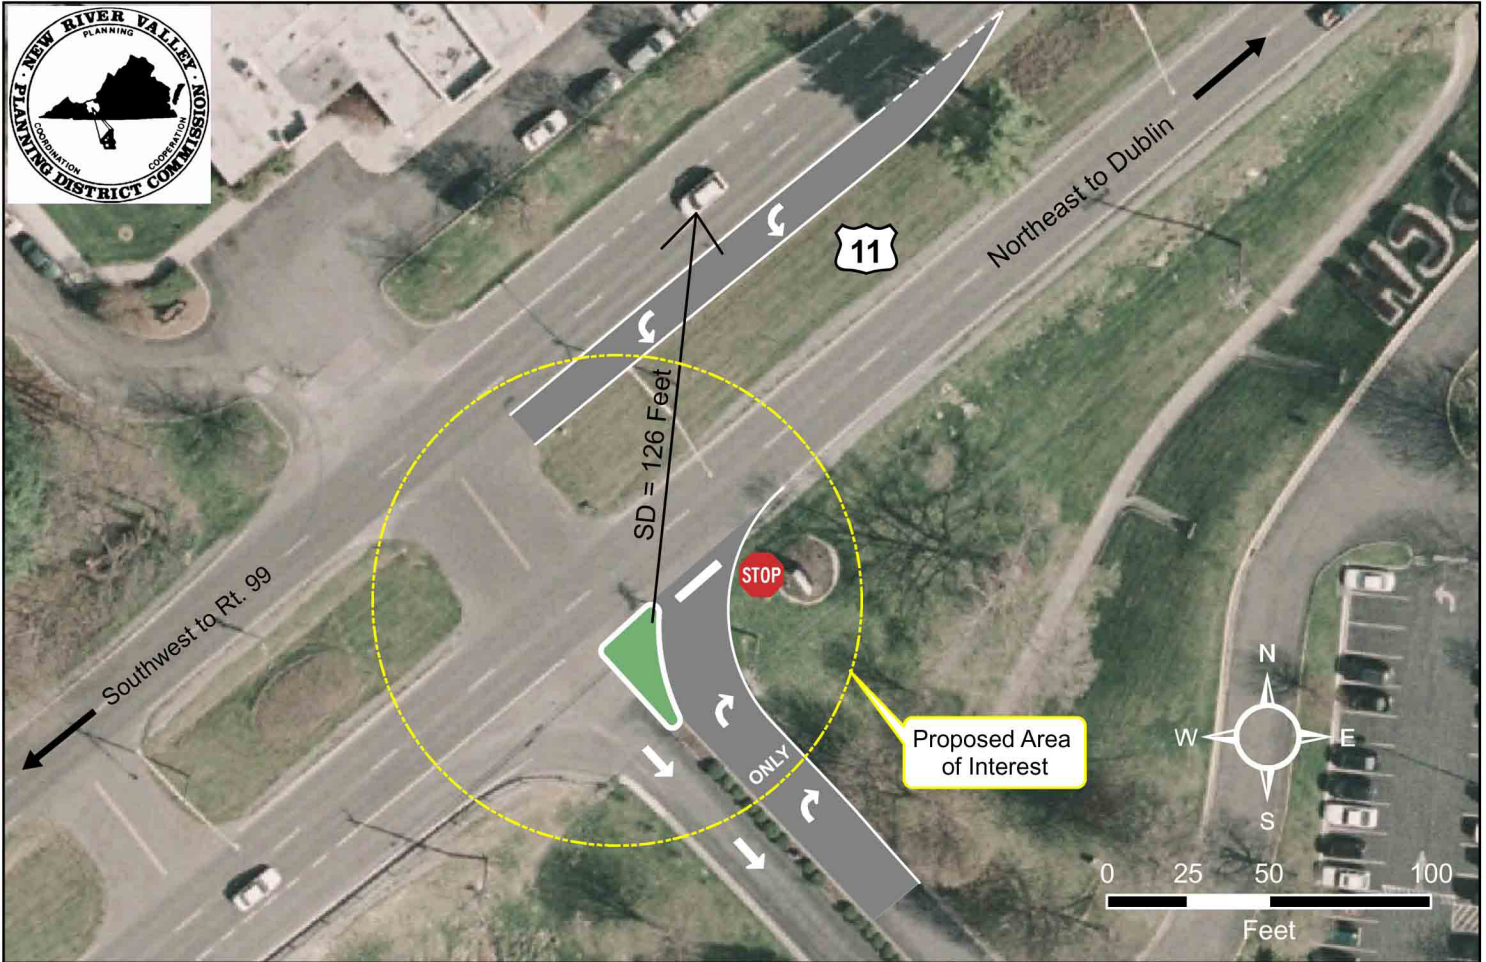
This intersection has poor sight distance greatly attributed to alternating vertical grade differences between the east and west bound Route 11 roadway corridors. The intersection currently has under 150 ft. of site distance for west bound entry due to the lane being lower than the existing grade of the intersection. Currently signage directs traffic exiting the hospital to enter Route 11 east (as shown below). It is proposed to construct a raised grass median forcing traffic to take this route. In addition the intersection should be evaluated to add a west bound turning lane for general traffic and emergency vehicles.

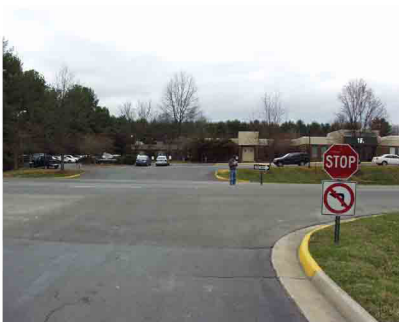
Field photo of existing intersection of the Hospital Entrance and Route 11. View of photo is from exit lane of the Hospital across Route 11.

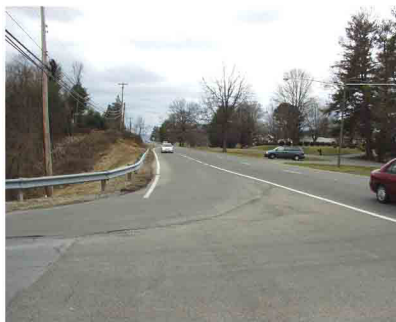
Field photo of existing intersection of the Hospital Entrance and Route 11. View of photo is to the west from the exiting lane of the Hospital Entrance.

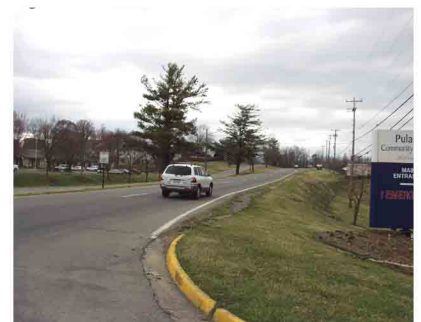
Field photo of existing intersection of the Hospital Entrance and Route 11. View of photo is to the West from the exiting lane of the Hospital Entrance.
