Site Specific Details:

This intersection has poor sight distance greatly attributed to alternating vertical grade differences between the east and west bound Route 11 roadway corridors. The intersection currently has under 200 ft. of site distance for west bound entry due to the west bound lane being lower than the existing grade of the intersection. Mature vegetation also exists in the landscaped median that prohibits appropriate site distance. It is proposed that this intersection be formally evaluated and a LOS be determined to propose potential improvements to this area.

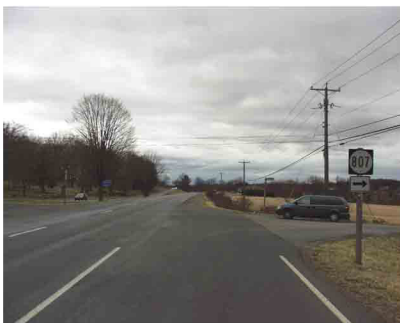
Field photo of existing intersection of Hatcher Road and Route 11. View of photo is to the east from roadside edge of pavement.

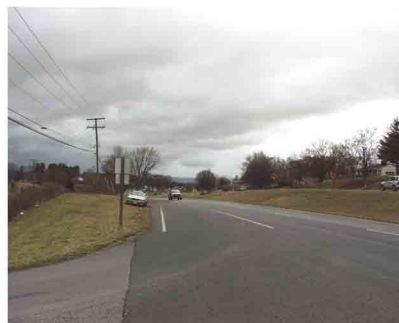
Field photo of existing intersection of Hatcher Road and Route 11. View of photo is to the west from the center of Hatcher Road exit lane.

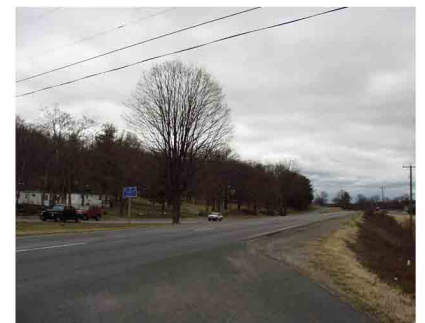
Field photo of existing intersection of Hatcher Road and Route 11. View of photo is to the east from the center of Hatcher Road exit lane.
