Site Specific Details:

This intersection has poor sight distance greatly attributed to a poor angle of entry as well as the rolling vertical grade along Route 11. The intersection currently has under 200 ft. of site distance for west bound entry due to the existing Route 11 verticle alignment. Mature vegetation also exists in the landscaped median that inhibits existing site distance. The roadway is currently utilized a signal bypass for local traffic. It is proposed that this intersection be formally evaluated and a LOS be determined to propose potential improvements to this area.

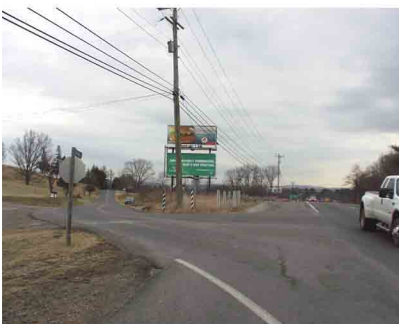
Field photo of existing intersection of Roundhouse Road and Route 11. View of photo is to the east from roadside edge of pavement.

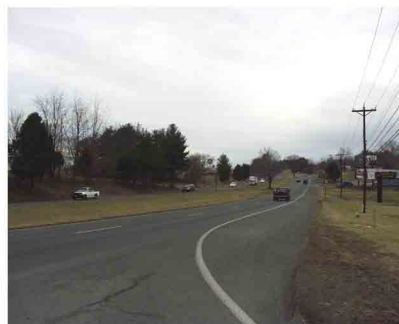
Field photo of existing intersection of Roundhouse Road and Route 11. View of photo is to the west from the center of Roundhouse Road exit lane.

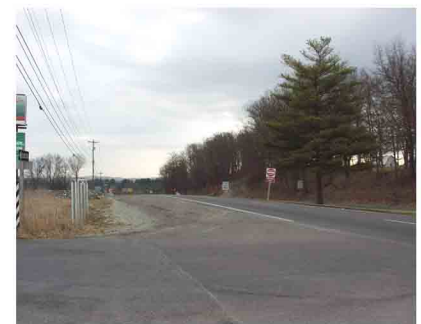
Field photo of existing intersection of Roundhouse Road and Route 11. View of photo is to the east from the center of Roundhouse Road exit lane.
