CONTRACT REPORT

**STRATEGIES FOR IMPEDIMENT REHABILITATION TO CREATE FISH PASSAGE
OPPORTUNITIES IN THE RAPPAHANNOCK RIVER BASIN**

June 2004
VTRC 04-CR2

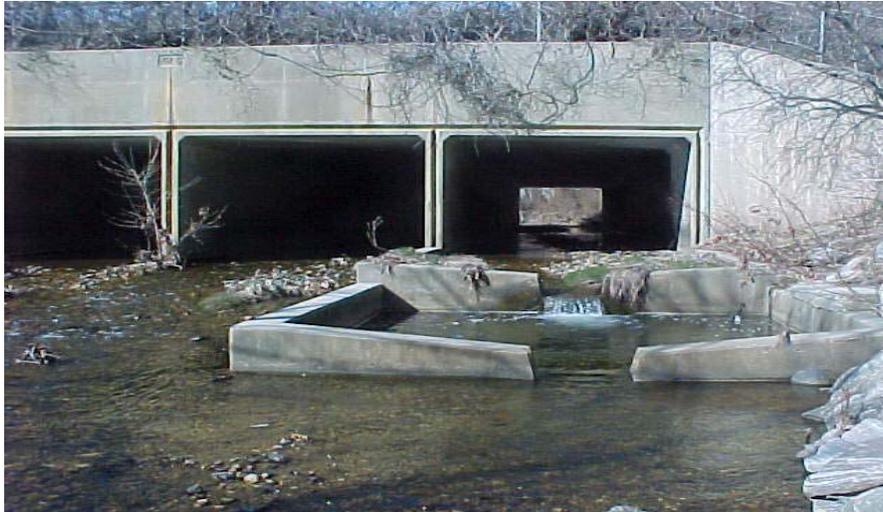
The fish passage at the Paint Branch site is a simple pool-weir design (Figure 4). Upstream of the large box culvert is a small diversion wall that is designed to force most of the streams flow into a single culvert. Downstream of the culvert two concrete boxes were formed (the pools) with notches cut allowing appropriate flow and depth for anadromous fishes. As one can see from the Figure 4, presently this design represents a failed system in that the intended channel has filled with sediment and gravel effectively raising the elevation above that of the remainder of the stream and hence reducing real and potential flow in the intended area. At present there is a need for heavy machinery to clean out the deposited sediments (too much for manual labor). It is unlikely that fishes will utilize this passage facility. Table 1 lists the species that were captured at the Paint Branch site in 2001 and 2004, as well as those that were marked. No marked fishes were captured above the culvert at any of the collections. No anadromous fishes were found above the culvert. Water quality parameters measured (temperature, dissolved oxygen, pH, conductivity, and salinity) were within acceptable range for anadromous fishes.

Figure 4. Paint Branch site at I-495, Prince Georges County, MD.

The pool-weir at Paint Branch site is obviously a failed system (Figure 4) due to a lack of required regular maintenance at this site. A different placement of the structure or, perhaps a different hydrological assessment of the site may have suggested an alteration of the passage placement. However, shifting substrates that exist in these settings and the ability of those sediments to fill constructed pool-weir systems suggests high maintenance and must be considered prior to construction. To a lesser extent the Budd's Creek Alaskan steep pass (Figure 7) requires periodic maintenance (here performed by a landowner) to clear woody debris from the structure. If not adequately removed, build up of woody debris and leaf litter may effectively clog the system rendering its passage abilities non-existent. The substrates upstream of the Sawmill Creek site are finer and thus, with ample flow in the system, are not likely to clog the pool-weir design placed therein (Figure 5).

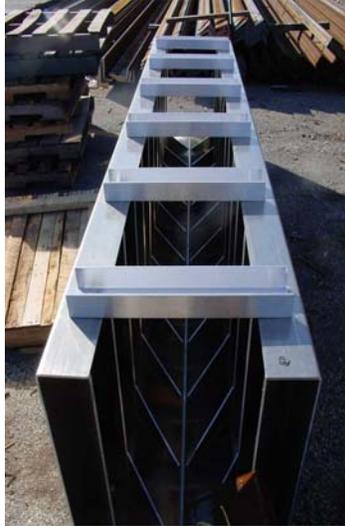
Although Claiborne Run was our first and initially best choice for fish passage in the Rappahannock River system, we have formally abandoned the site for the passage project. Following our initial site visit, we met on-site with personnel from VA Dept. of Transportation (Brian Hawley, primary contact; Brain.Hawley@VirginiaDOT.org), VA Transportation Research Council (G. Michael Fitch; gmf8X@virginia.edu), VA Department of Game and Inland Fisheries (Alan Weaver; aweaver@dgif.state.va.us), US Fish and Wildlife Services (Dick Quinn; Dick.Quinn@fws.gov and David Sutherland; David.Sutherland@fws.gov) and consultants and engineers [Scott Cahill (watershedservices@yahoo.com) and Tim Davey and Mike Claude, Timmons Engineering (Mike.Claud@timmons.com, tim.davey@timmons.com)]. Dick Quinn (USFWS) fish passage expert provided engineering recommendations for effective installation of a proposed Alaskan steep pass structure. Additional meetings with VDOT and VDGIF personnel discussed necessary permits and potential for time of year restrictions on construction. We obtained cost and time estimates for the production of steep pass structures from local and out-of-state-manufacturers. After review of estimates, we settled on a local metal shop, Richmond Steel Inc. in Richmond to build the first two sections of steep pass for the Claiborne Run site (Figure 8).

Figure 8. Alaskan steep pass section built for Claiborne Run site.

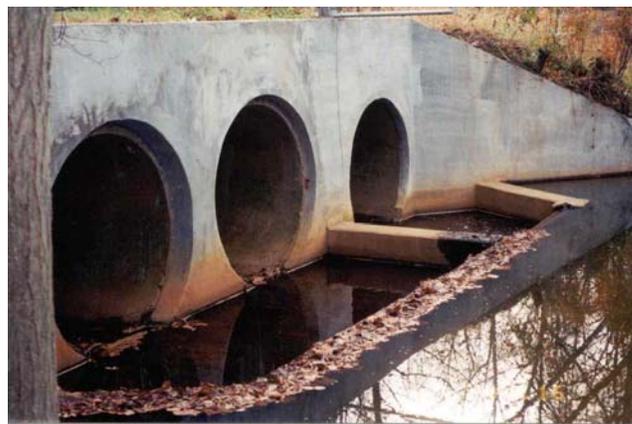
White Oak Run (Figure 2) is presently being fitted with a pool-weir fish passage system. Water will be diverted into a single pipe culvert and the pool-weir steps will be placed in the road rubble and substrate downstream of the road culverts. Landowner permission to perform this work was obtained from Mr. Manley Turner as the written permission is archived at Virginia Commonwealth University. The upstream diversion wall will be similar to that of Figure 10.

Figure 10. Upstream diversion wall for fish passage system. Wall to right of picture has removable gates that are presently keeping water level even through the three pipes. Removable gates make maintenance and flood control easier when passage is not required.
