Visibility of Steel Plates Used in Connection with Highway Repairs

Report No. VTRC 07-R16	Report Date November 2006	No. Pages 23	Type Report: Final Period Covered:	Project No.: 73196
				Contract No.
Title: Visibility of Steel Plates Used in Connection with Highway Repairs				Key Words: Steel plates, work zone, motorcyclists, visibility
Authors: B. H. Cottrell, Jr.				
Performing Organization Name and Address: Virginia Transportation Research Council 530 Edgemont Road Charlottesville, VA 22903				
Sponsoring Agencies' Name and Address Virginia Department of Transportation 1401 E. Broad Street Richmond, VA 23219				
Supplementary Notes				
<p>Abstract</p> <p>Steel plates are used primarily in urban areas where an excavation is made in the roadway for utility work, such as installing or replacing utility lines, pipes, and conduits. The steel plate is positioned on the roadway to cover the excavation and allow traffic to proceed when utility work is not underway. Motorcyclists are challenged when they traverse a plate unexpectedly. Although the Virginia Department of Transportation has policies and procedures in place that all but eliminate the use of steel plates on the roads it mai

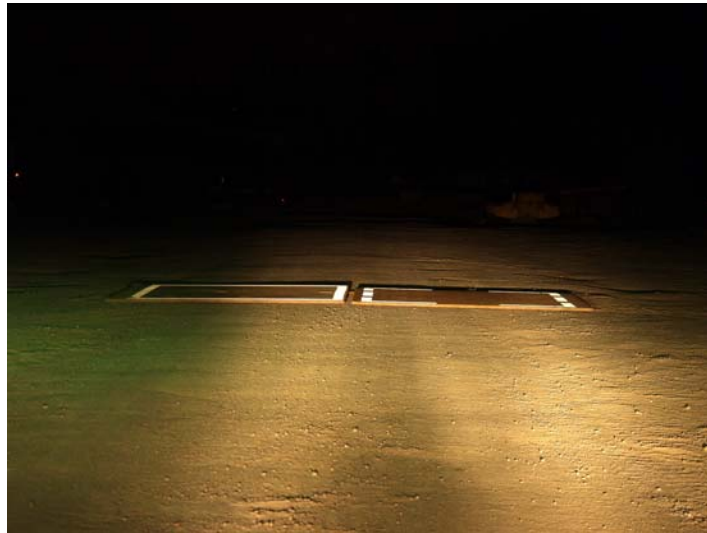
**Figure 2. Outlined Plate and Corners and Skip Lines Plate Under Low-Beam Headlights
Zoomed in from 80 Feet**

The participants commented that the broken lines of the corners and skip lines plate conveyed a message that they preferred in part because the broken lines added contrast against the steel plates. Figure 2 shows this pattern on the right under low-beam light and zoomed in from 80 foot. This marking was different from others seen. There was some concern about the skip lines being confused with the lane lines that are present when there are two or more lanes in the same direction. This possible confusion was evident at a July 21, 2004, field visit in Richmond by the stakeholder task group. For some, the outlined plate reminded them of a crosswalk marking with the continuous horizontal or transverse lines.

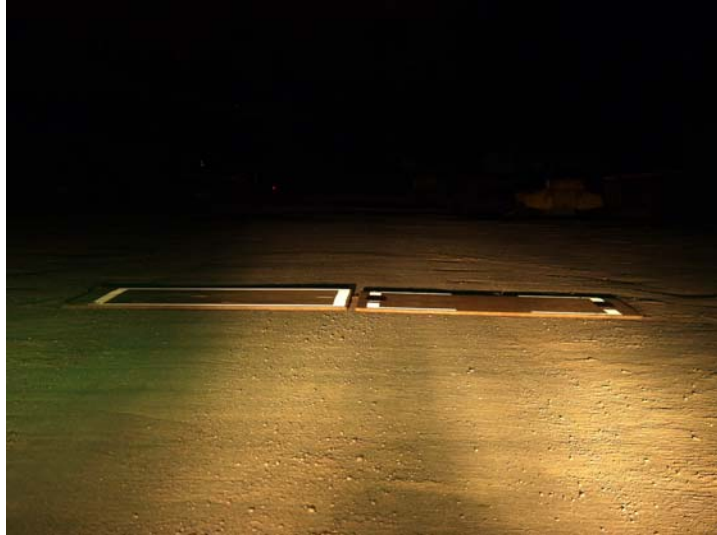
**Figure 4. Outlined Plate and Corners Only Plate Under Low-Beam Headlights
Zoomed in From 80 Feet**

pattern on the right under low-beam light and zoomed in from 80 feet. Six of the seven participants chose the corners only marking as their preferred choice overall. The participant who preferred the outline overall stated that there was not a lot of difference. To him, the outline was preferred at longer distances. At closer distances, the corners only alternative looked better or at least different. A negative comment regarding the corners only alternative was that although it “speaks to the motorists well, less marking material will be visible as it goes bad.” Although this is true, it also points out the need to maintain the pavement marking on the steel plates.
