## Condition of Concrete Overlays on Route 60 Over Lynnhaven Inlet After 10 Years

1. Report No.: FHWA/VTRC 09-R13		2. Government Accession No.:		3. Recipient's Catalog No.:	
4. Title and Subtitle: Condition of Concrete Overlays on Route 60 Over Lynnhaven Inlet After 10 Years				5. Report Date: February 2009

**FINAL REPORT**  
**CONDITION OF CONCRETE OVERLAYS ON ROUTE 60 OVER LYNNHAVEN  
INLET AFTER 10 YEARS**

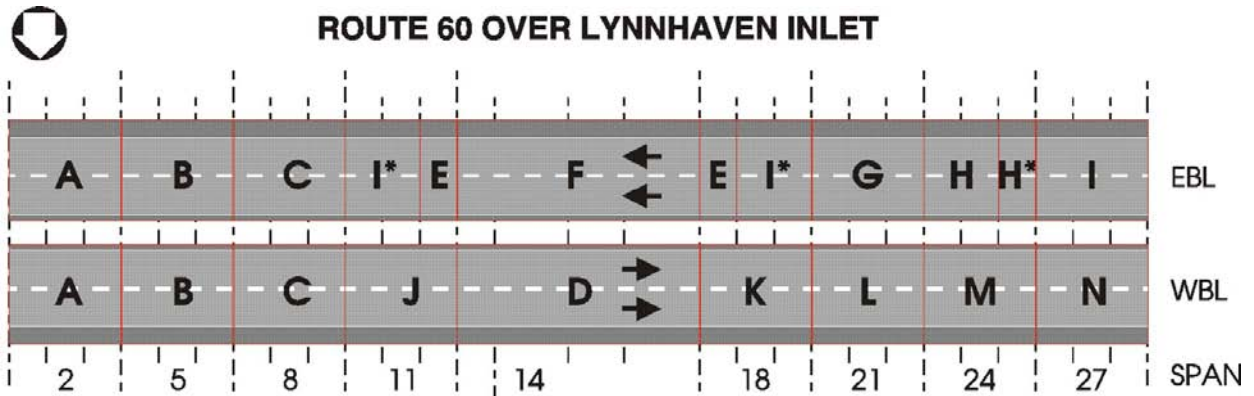
The installation included 13 concrete mixtures, an overlay with a thickness of only 0.75 in (19 mm), and spans with and without topical treatments of two corrosion inhibitors for a total of 16 overlays. The overlay systems are identified in Figure 1 as follows:

- Overlay System A: 7% SF
- Overlay System B: 5% SF and 35% S
- Overlay System C: 5% SF and 15% Class F FA
- Overlay System D: 15% LMC
- Overlay System E: 13% SF and 15% FA
- Overlay System F: 13% SF and 15% FA placed 0.75 in (19 mm) thick
- Overlay System G: 7% SF and Rheocrete corrosion-inhibiting admixture (CIA) (RCI)
- Overlay System H: 7% SF, Arimatec CIA (ACI), ACI topical treatment (A)
- Overlay System H\*: 7% SF and ACI
- Overlay System I: 7% SF, Darex CIA (DCI), and Postrite (P) topical treatment
- Overlay System I\*: 7% SF and DCI
- Overlay System J: 40% S
- Overlay System K: 7% SF and shrinkage-reducing admixture (CQI)
- Overlay System L: 7% SF and polyolefin fibers (POF)
- Overlay System M: 7% SF and steel fibers (STF)
- Overlay System N: 7% SF and polypropylene fibers (PPF).

**Figure 1. Plan View for Overlays on Two 28-Span Bridges on Route 60 Over Lynnhaven Inlet.** EBL = eastbound lane; WBL = westbound lane; SF = silica fume; S = slag; FA = fly ash; LMC = latex-modified concrete; RCI = Rheocrete corrosion-inhibiting admixture (CIA); ACI = Armatec CIA; A = ACI topical treatment, DCI = Darex CIA, P = Postrite; CQI = shrinkage-reducing admixture, POF = polyolefin fibers, STF = steel fibers, PPF = polypropylene fibers.

As shown in Figure 1, the bridges were overlaid with 21 test sections. The outside lane of one span with each of the overlay mixtures on both decks was evaluated as follows:

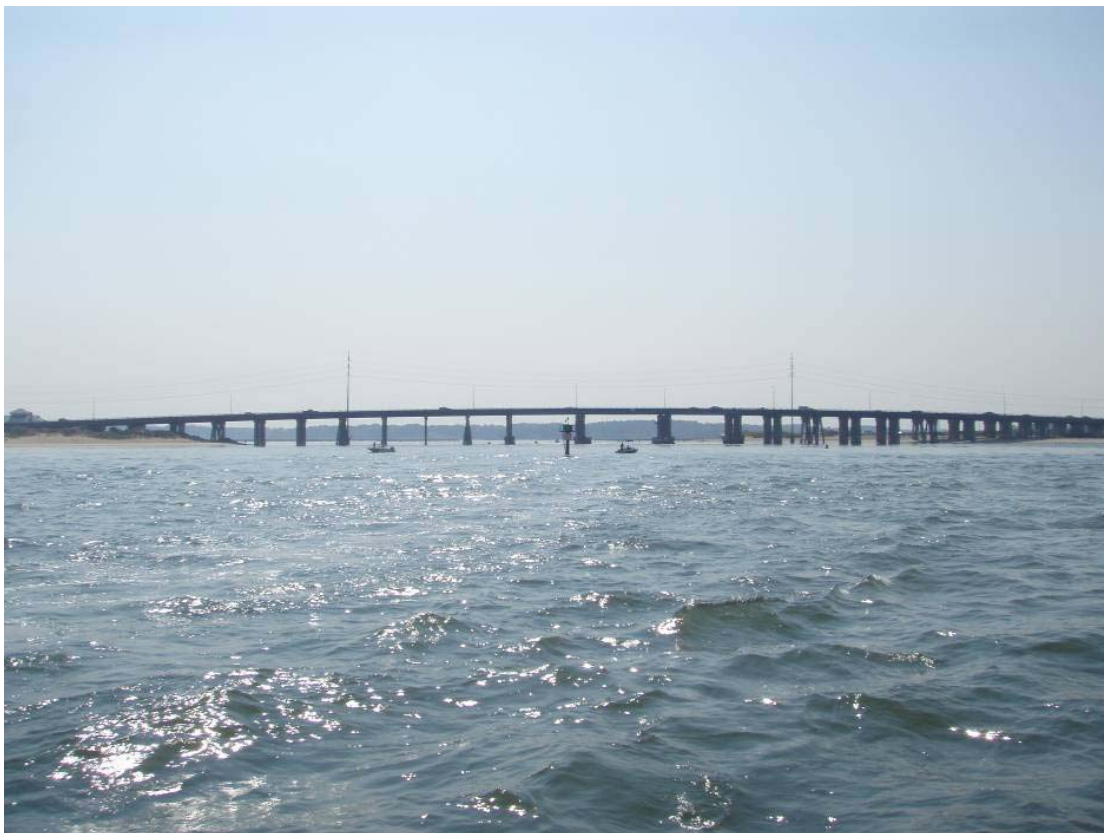
**Figure 2. North Elevation of Lynnhaven Bridge<sup>5</sup>**

A site location map for the two bridges is shown in Figure 1, and a photograph of the bridges is provided in Figure 2.<sup>5</sup> Initially, the westbound bridge (westbound lane [WBL]) was overlaid while traffic used the eastbound bridge (eastbound lane [EBL]). Then, traffic was detoured to the WBL while the EBL was overlaid.

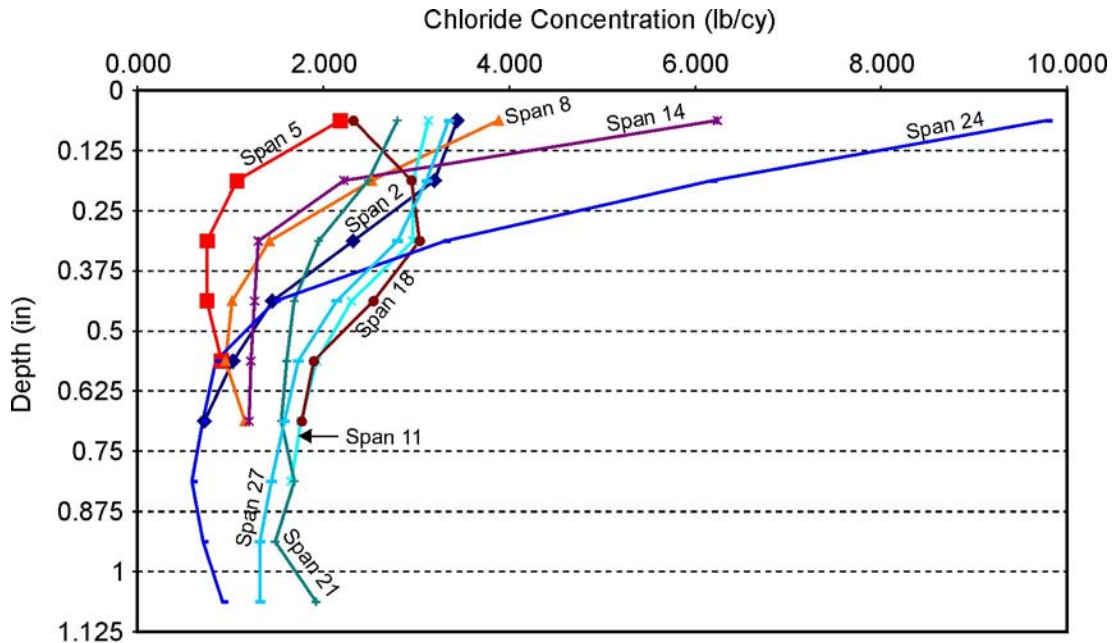
**Figure 3. Chloride Profiles for Overlays in Eastbound Lane**

At the time the overlays were placed, there was not sufficient chloride (1.3 lb/yd<sup>3</sup>) at the level of the top mat of reinforcement to cause corrosion in the deck under any of the overlays.<sup>3</sup> The chloride data and the half-cell potential data recorded 10 years later indicate that the overlays have prevented additional chloride from reaching the reinforcement and the decks have been protected from corrosion-induced spalling. After 10 years, half-cells are less negative and chlorides in the deck are likely lower because of upward migration into the overlay. The overlays should retard the further ingress of chlorides and extend the life of the structures, some more than others.

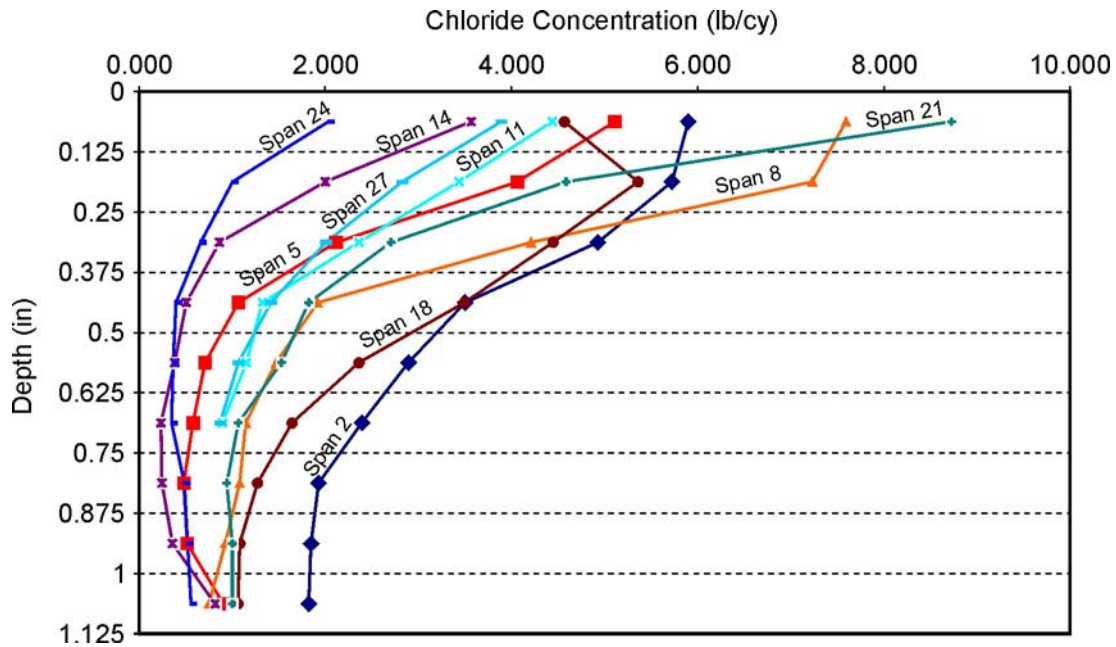
Figure 4. Chloride Profiles for Overlays in Westbound Lane

second lowest permeability and second lowest chloride ion content. Span 24 WBL with the lowest chloride content could not be tested for permeability because of the steel fibers.
