## Introduction of Nano & HP Fiber-Reinforced Link Slab Technologies

Celik Ozyildirim, Ph.D., P.E.

*A partnership of the **Virginia Department of Transportation**  
and the **University of Virginia** since 1948*

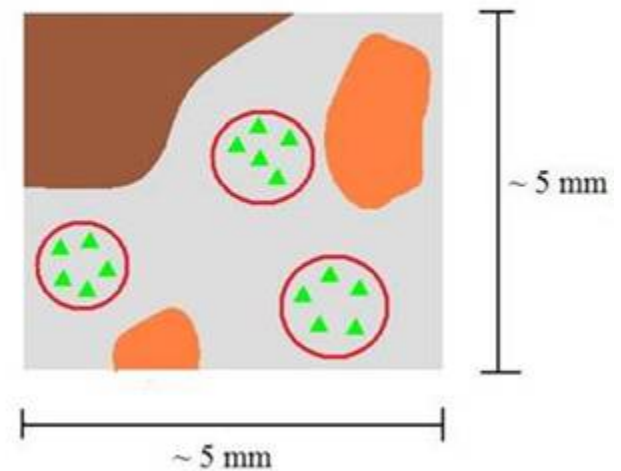
# Nanoindentation Details

- Indented using a Berkovich tip (3 sided pyramid)
- Indented 5  $\mu\text{m}$  into the surface

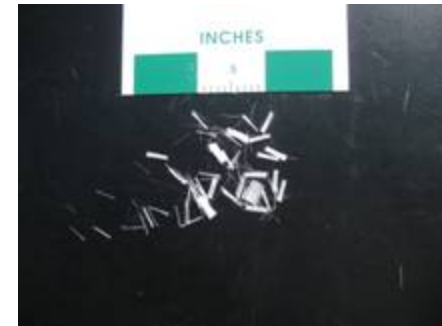
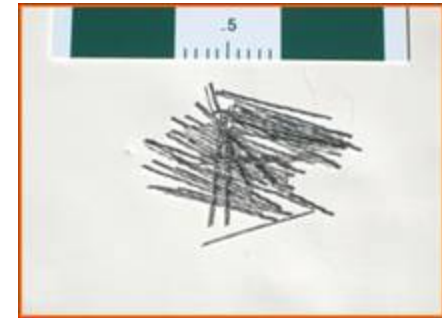
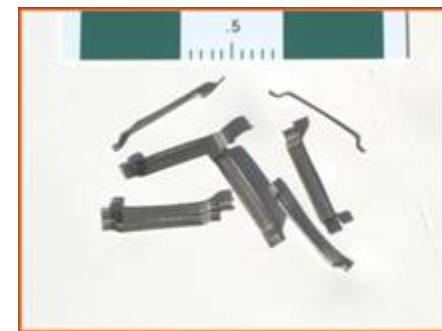
# Fibers

- PVA – Polyvinyl Alcohol
- Steel (SH) – Triangular cross-section and twisted along its length.
- Steel (SB) – Round in cross-section with hooked ends.

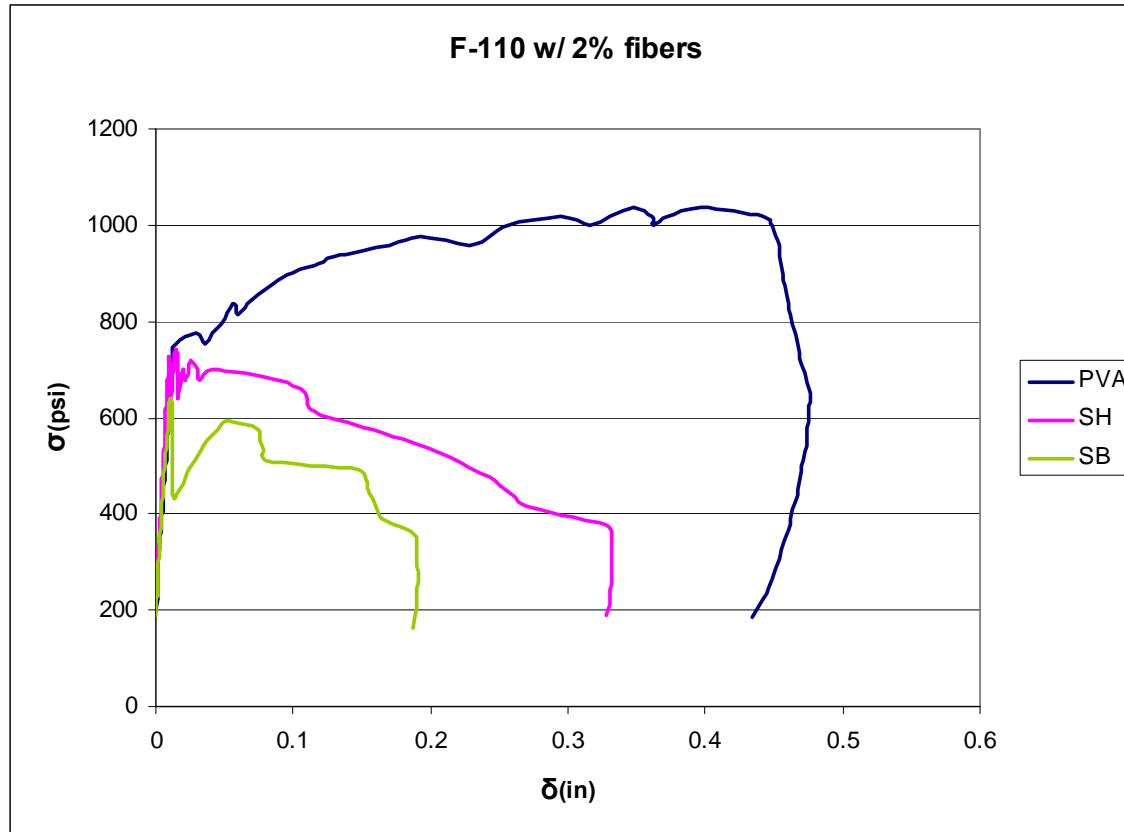
# Flexural Stress vs Midspan Deflection

1-in beams with PVA, SH and SB fibers mixed with F-110 sand at 28 days.

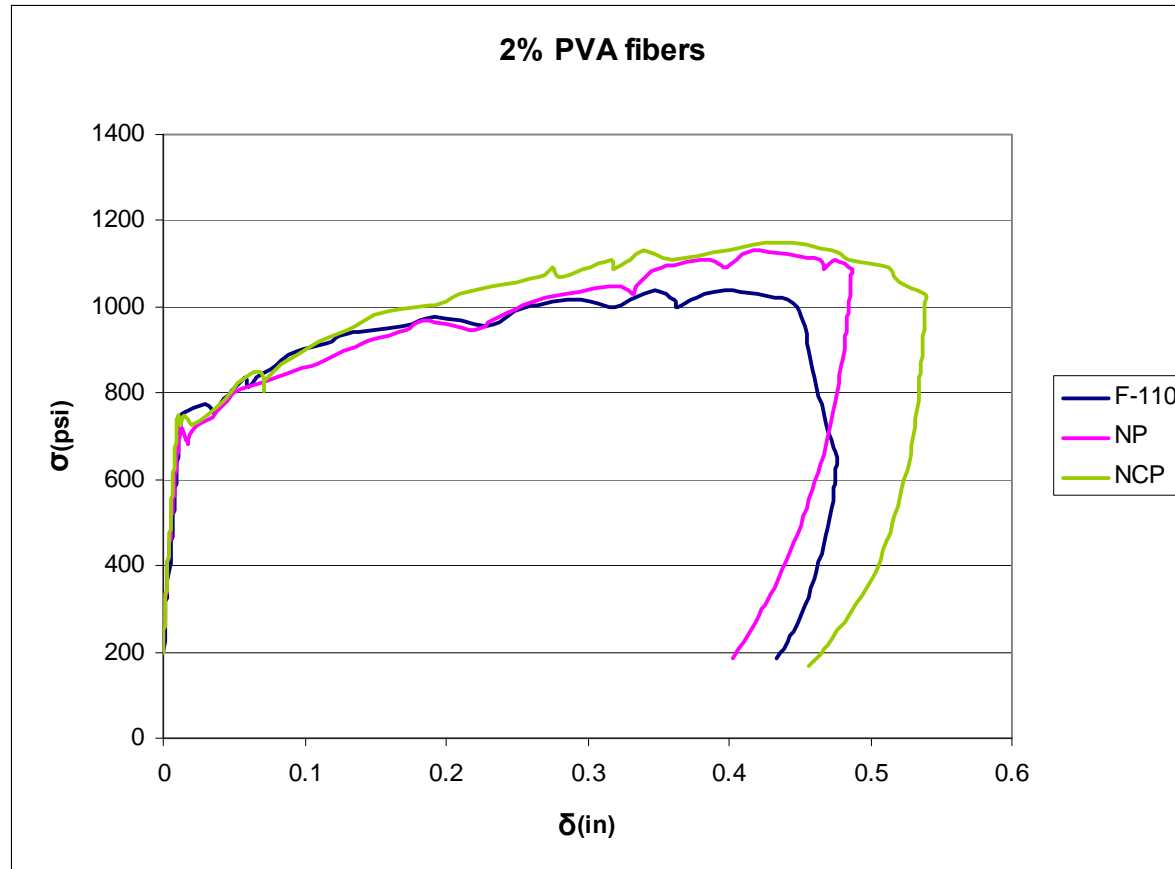
# Flexural Stress vs Midspan Deflection

1-in beams with F-110, mortar (NP) and concrete (NCP) sand and PVA fibers at 28 days.

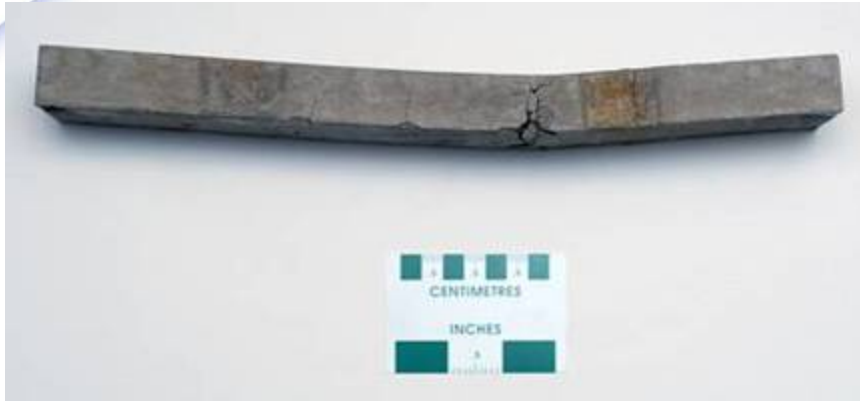
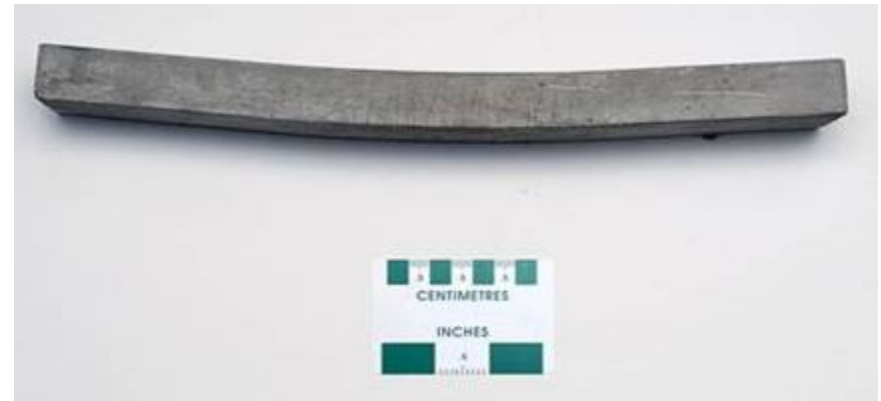
## Deflection at Failure

Large deflections in beams with steel (SH) fibers (left) and PVA (right)

- HPFRCC with PVA provided strain hardening and multiple micro-cracking using locally available sand.
- HPFRCC with PVA fibers can provide high residual strength up to 0.5-in deflection in 1-in thick beams. In 4-in beams the deflection was less, but still reached a large average value of 0.13-in.

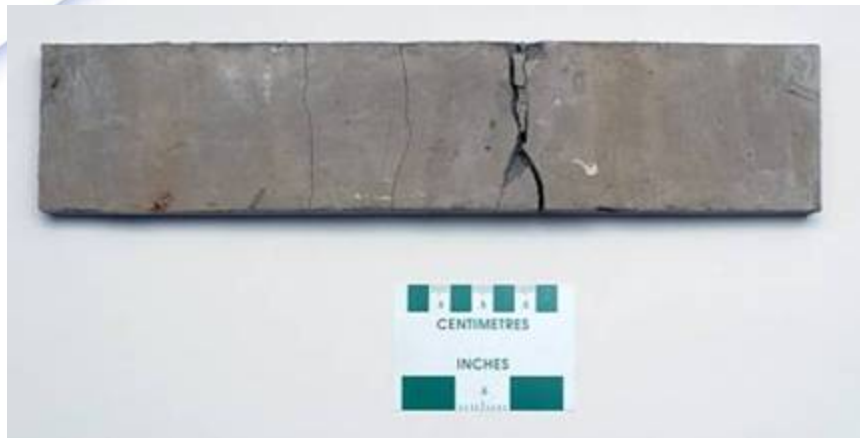
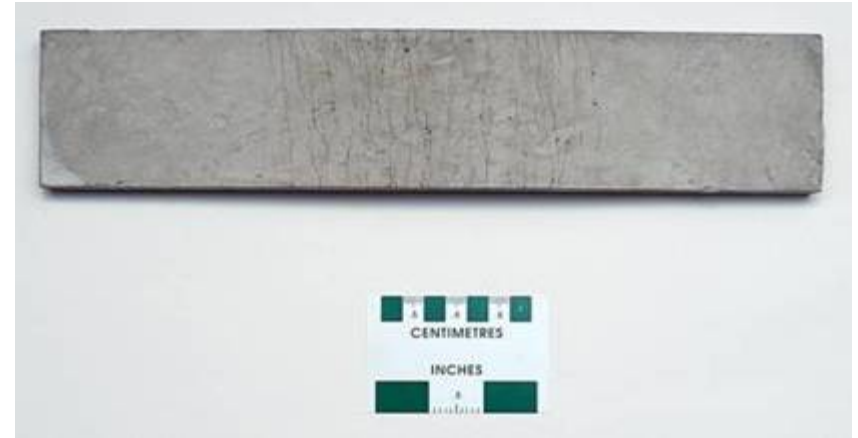
## Cracking Pattern at Failure

Cracks in beam with steel (SH) fibers (left) and PVA (right)
