Concrete Pavement Maintenance

Making The Most of Your
Concrete Assets

PCCP Preservation Techniques

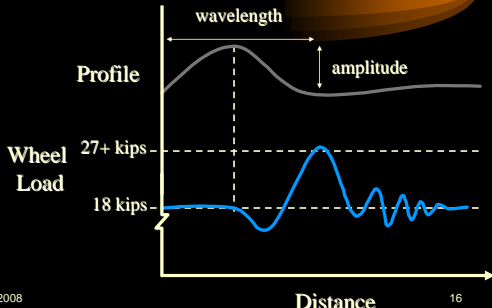
Rough Pavement

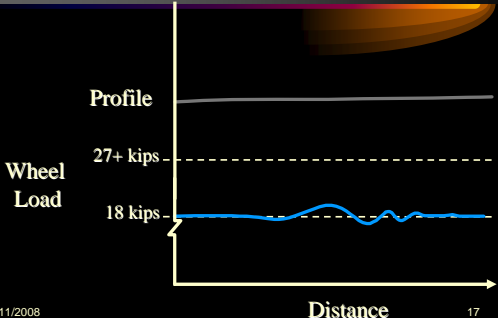
Smooth Profile

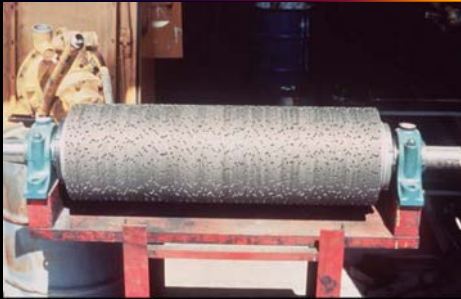
Diamond Grinding Cutting Head

- Removal of thin surface layer of hardened PCC using closely spaced diamond saw blades;
- Results in smooth, level pavement surface;
- Longitudinal texture with desirable friction and low noise characteristics;
- Frequently performed in conjunction with other CPR techniques, such as full-depth repair, dowel bar retrofit, and joint resealing.
- **Comprehensive part of any PCC Pavement Preservation program;**

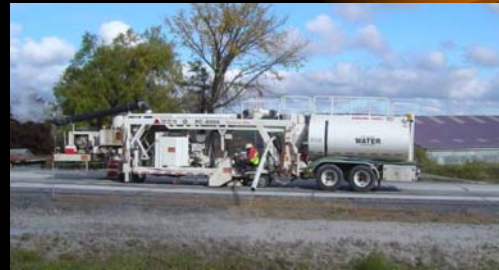
Diamond Grinding Grinding Machine

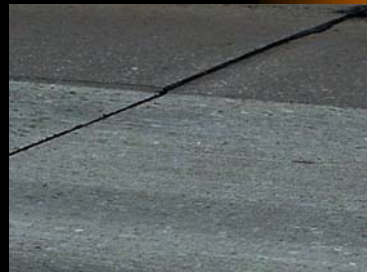
Diamond Grinding Finished Product

- Cost competitive;
- Enhances surface friction and safety;
- Can be accomplished during off-peak hours with short lane closures and without encroaching into adjacent lanes;
- Grinding of one lane does not require grinding of the adjacent lane;
- Does not affect overhead clearances underneath bridges;
- Blends patching and other surface irregularities into a consistent, identical surface;
- **Provides a low noise surface texture!**

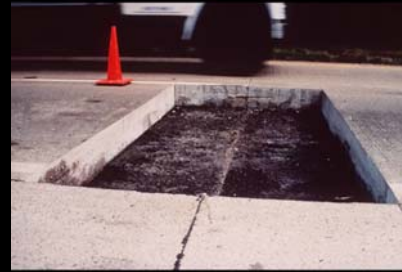
Full-Depth Patching Operations

- Purpose
 - Restore structure
 - Restore ride
- Used for:
 - Joint deterioration
 - Transverse cracking
 - Longitudinal cracking
 - Broken slabs & corner breaks

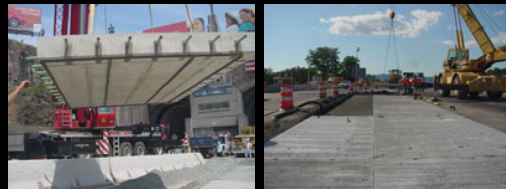
Pre-cast Pavement Panels

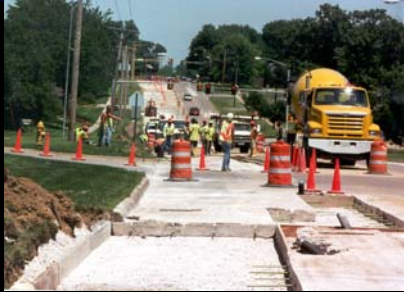
In situ Full Depth Repair

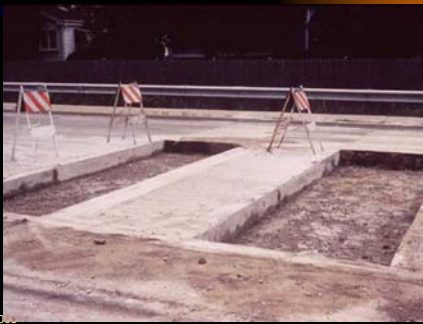
Combine Patches!!

- Go beyond deterioration
- Remember to check for below-surface spalling
- Minimum length 6 feet
- Adjust as necessary
- Combine closely spaced patches

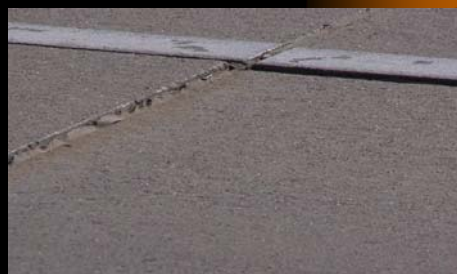
Faulted Panel

- **Cracked / broken concrete slabs**
- **Exposed aggregate surface**
- **Wheel Rutting (wear)**
 - 25% of the existing pavement had average rutting of 5/16" to 3/8"
- **Settlement in drive lane at the edge of traveled way**
 - Settlement of up to one inch below the adjacent shoulder slab
 - Surface runoff pooling at the edge of the traveled way
- **Minor faulting**
