Ten Year Performance of Overlays on Route 60 Over Lynnhaven Inlet and Overlay Recommendations

Virginia Concrete Conference
Richmond Virginia
March 4 and 5, 2009

Michael Sprinkel, P.E.
Associate Director

Virginia Transportation Research Council

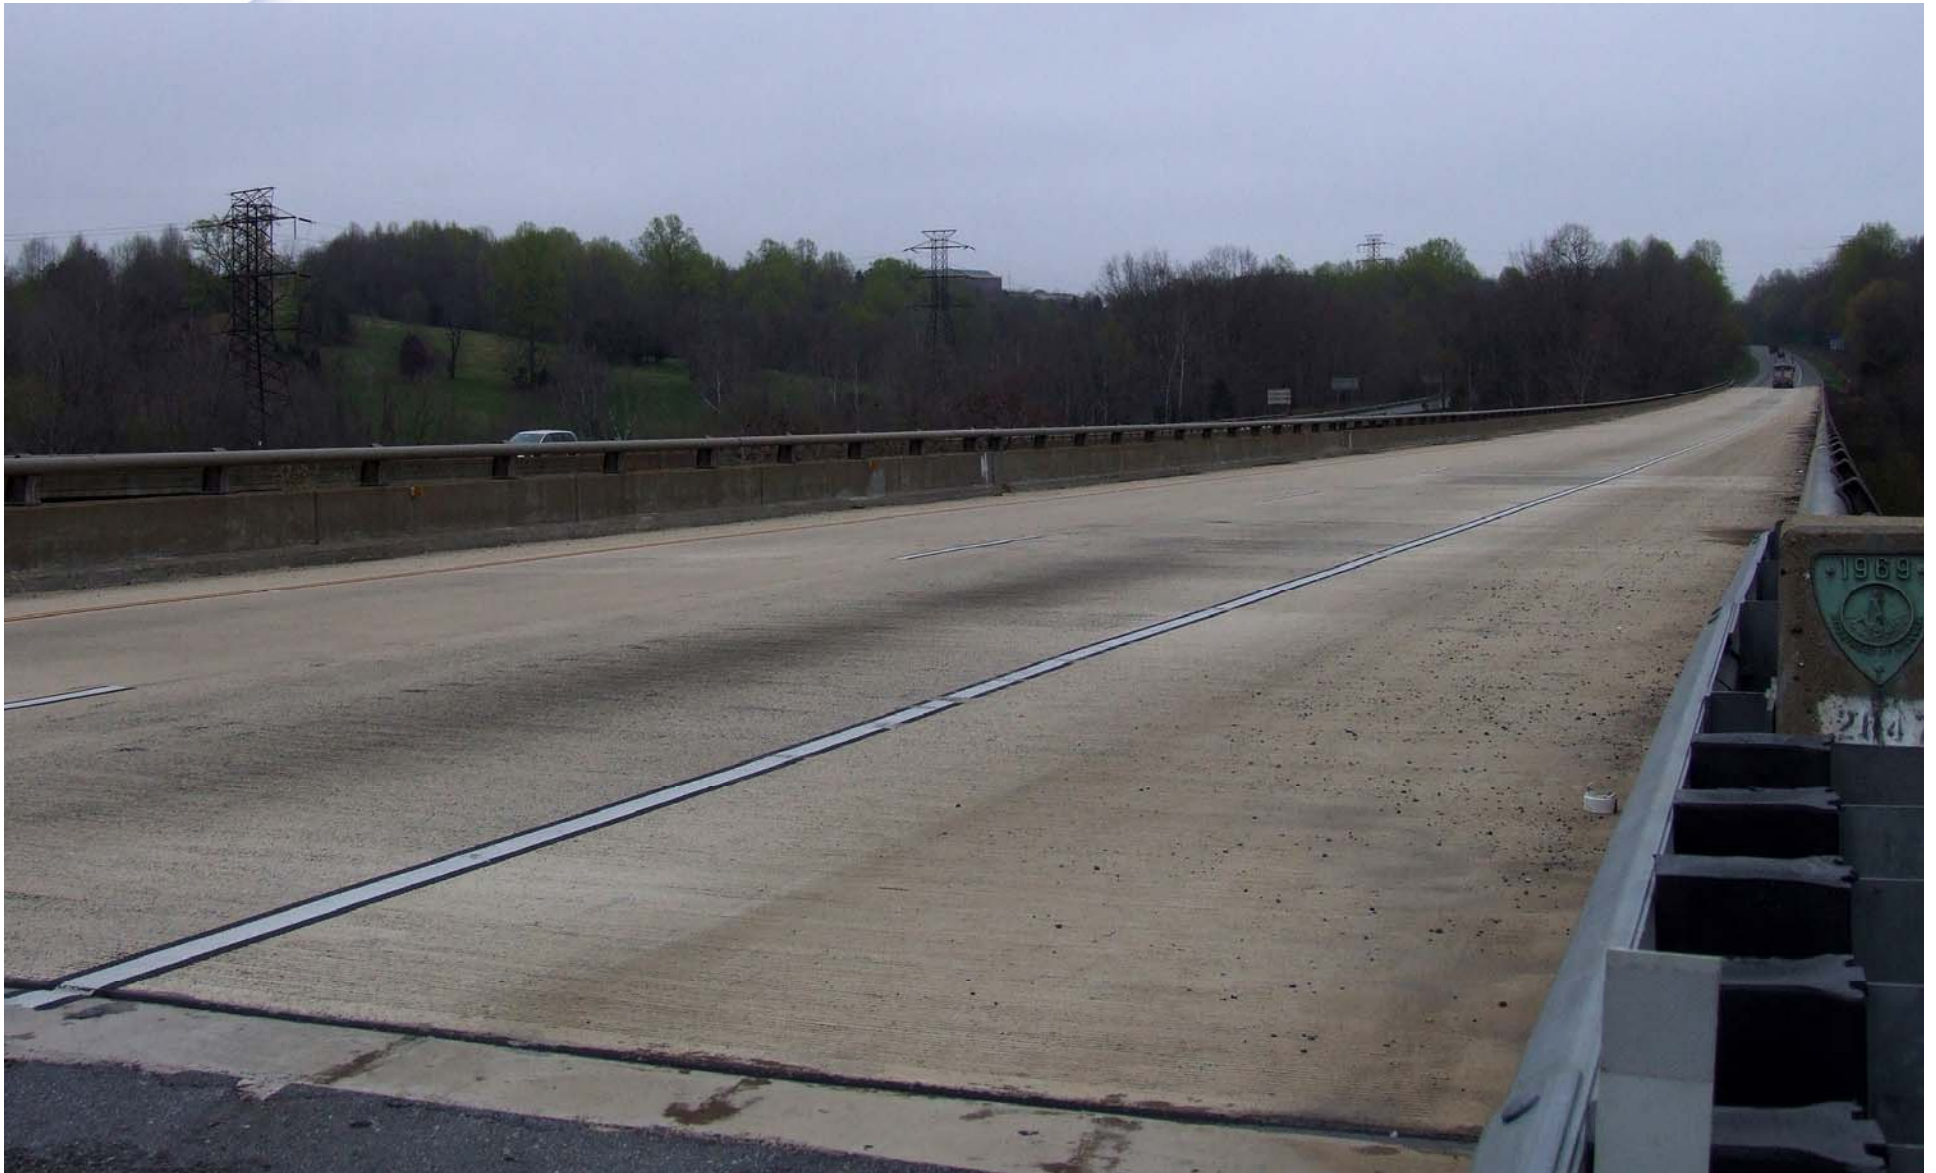
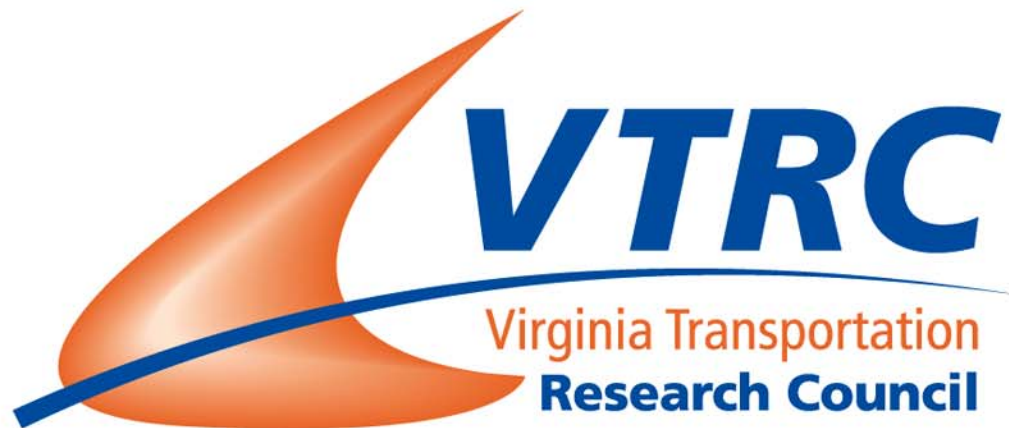
I64 Over Rivanna River, 2006

- **LMC prepared with very early hardening cement (LMC-VE) was used as an overlay in 1997 so that traffic could be placed on the overlay after 3 hours of curing.**
- **LMC prepared with Type K cement was used as an overlay in 2005 to help reduce the incidence of shrinkage cracking.**
- **Use of LMC-VE has become a standard overlay for situations in which lane closures cause major traffic congestion.**
