# Virginia Concrete Conference Lessons Learned

Coliseum Central Highway  
Improvement Project (CCHIP),  
Interstate 64 @ Mercury Blvd.

Thomas Druhot, P.E.  
Mohamed Elfino, PhD, P.E.

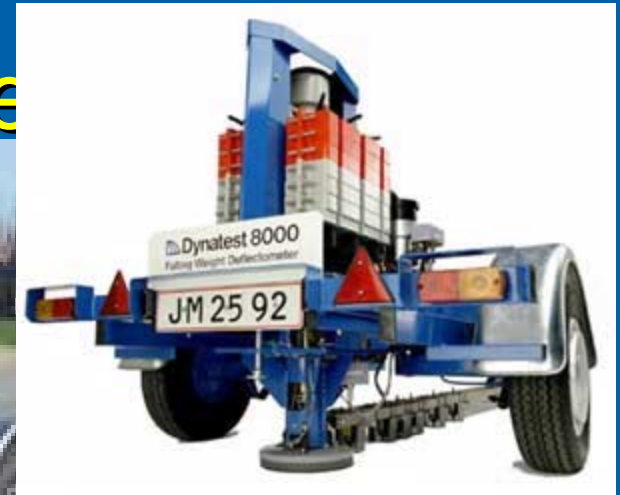
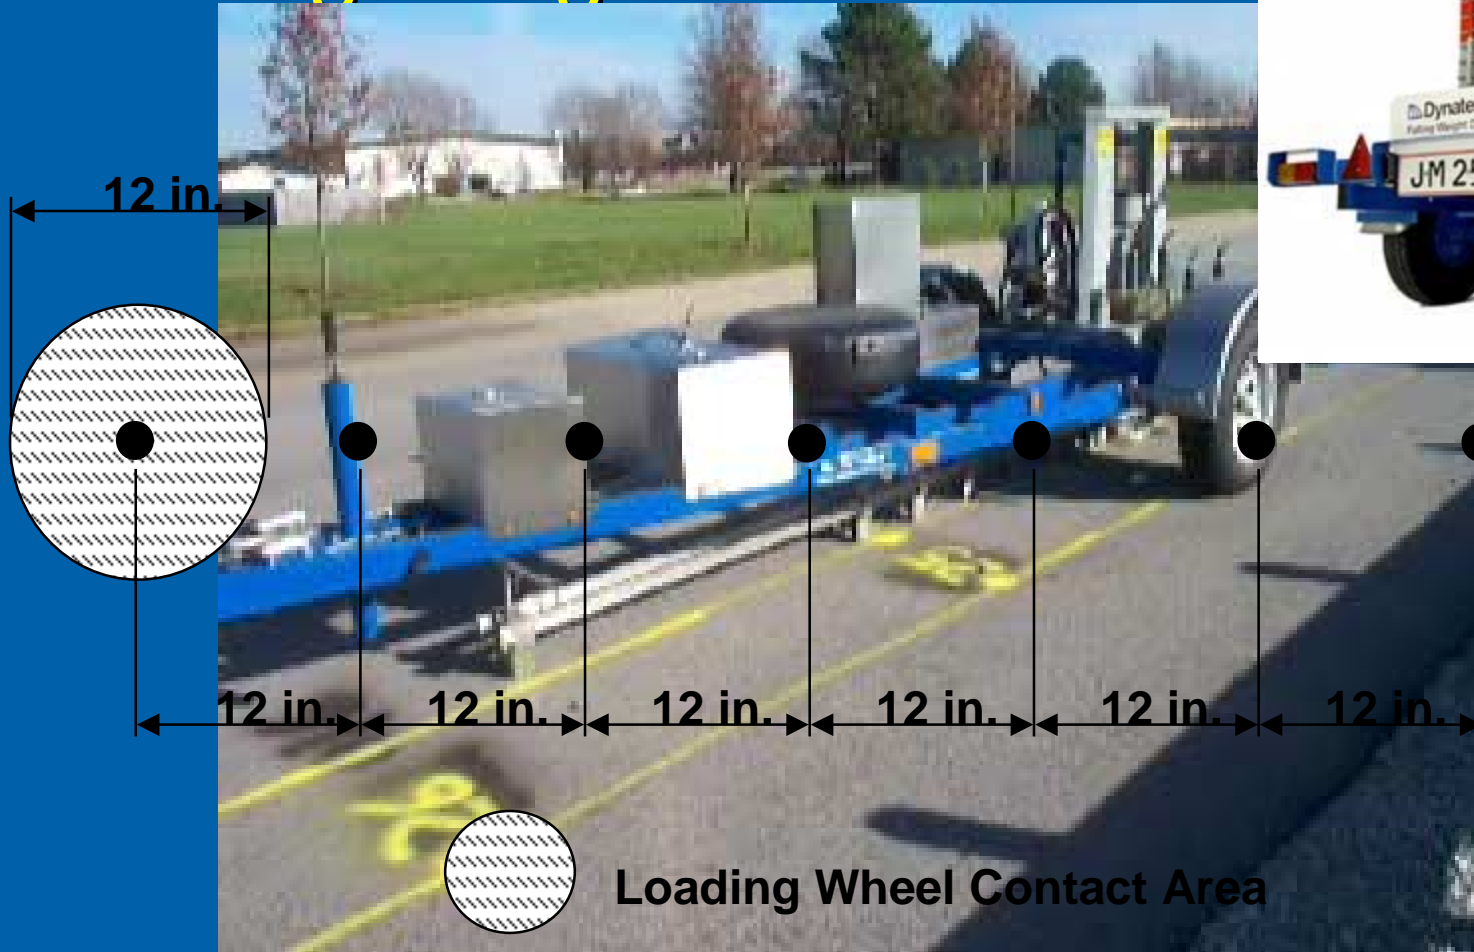
## Falling Weight Deflectometer

Loading Wheel Contact Area

Sensor

- FWD – Non-destructive Testing
- Testing Spacing Every 50 feet
  - Approximately 2 minutes per location
  - +/- 2 lane miles per night
- Coordinated with Inspector
  - Starting Location to Match a Station
  - Tracking/Mapping of Areas Tested
- FWD – Deflection Bowl Calculations

- Test Results Identify Potential Weaknesses
  - Measures Deflections and Can Calculate Deflections per Layer
  - Results Provide Limited Areas to Review
- Review Crack Pattern and Core

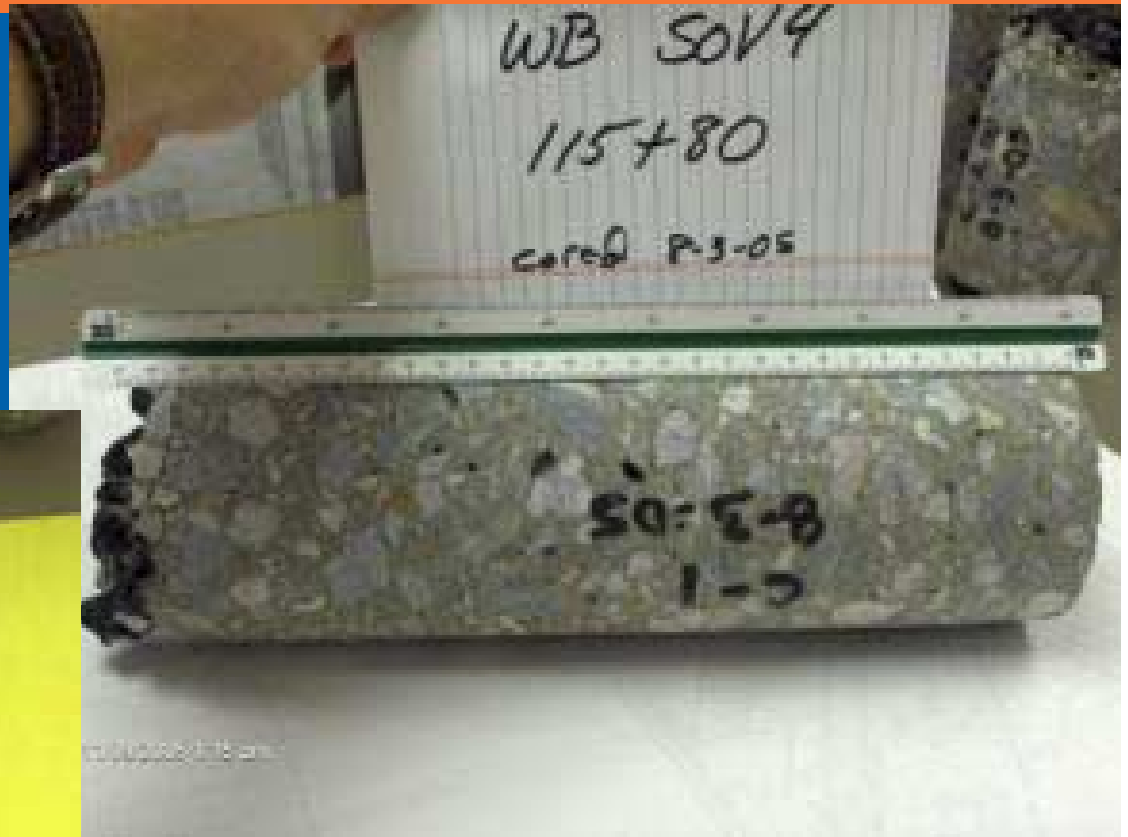
# SAMPLE CORES

Some Good
