Concrete Beams Prestressed Using Carbon Fiber Reinforced Polymer

Final Report VTRC 19-R29

FINAL REPORT
**CONCRETE BEAMS PRESTRESSED USING CARBON FIBER REINFORCED
POLYMER**

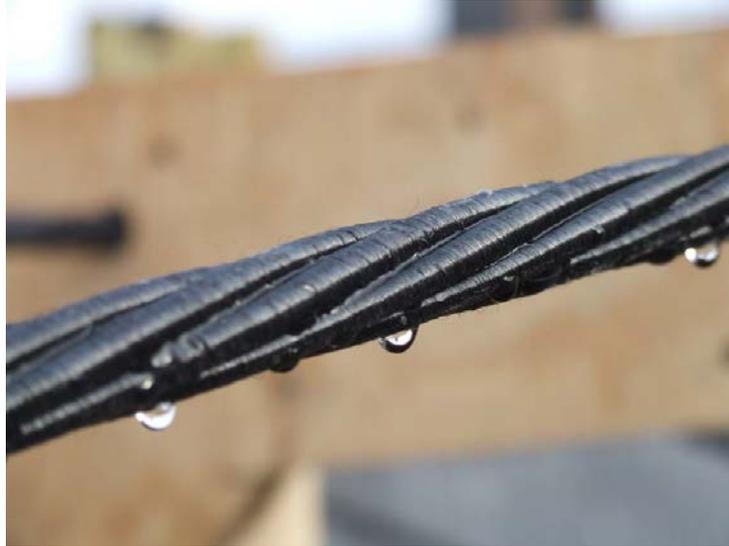
Figure 1. Water Drops on a Corrosion-Free Carbon Fiber Reinforced Polymer Strand

CFRP strands, called carbon fiber composite cable (CFCC) by the manufacturer, are manufactured by Tokyo Rope Mfg. Co, a Japanese company. Initially, this type of CFRP strand was manufactured only in Japan, but the company recently expanded and now produces CFRP in Canton, Michigan. There have been many applications of CFRP technology in Japan over the past 25 years (Enomoto et al., 2012). VDOT used these same CFRP strands in 18 piles of the Nimmo Parkway Bridge (AASHTO, n.d.; Ozyildirim and Sharp, 2014).

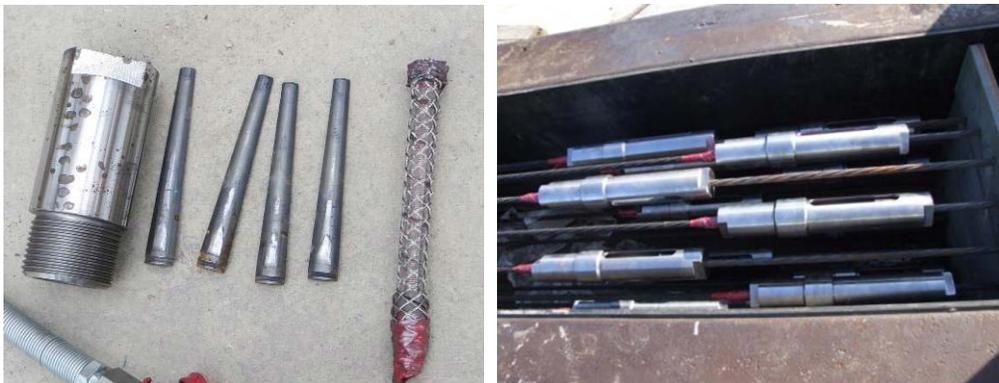
Figure 3. Elements of End Preparation: left, disassembled wedge, chuck, and braided grip; right, couplers in a pile

CFRP strands need special end preparation to avoid crushing of the ends during prestressing (Roddenberry et al., 2014). The end preparation involved wrapping the strand in a buffer material of mesh sheet and braided grip, attaching four wedges, placing the assembly in a chuck, and then threading together the couplers shown in Figure 3. The wedges and chucks used were longer than those used with steel strand so that the CFRP strand could be held without damaging it. The longer chuck was placed in one end of a coupler; the other end had a conventional chuck holding a steel strand. The prestressing force was applied to the steel strand.

The bed for the casting of two beams was 218 ft long. After prestressing, the strands were left in tension overnight to reduce the probability of failure during the concrete placement. The couplers were placed at the ends of the prestressing bed, and the temperature in those areas was kept below 122 °F to prevent slippage in the coupling.

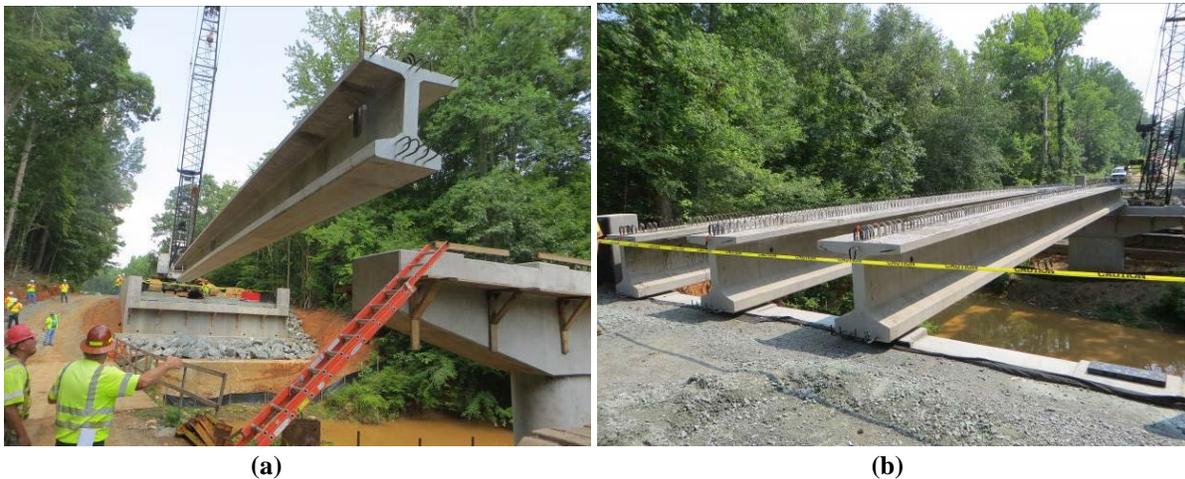
Figure 4. Bridge Construction: (a) beams being delivered to the jobsite and erection of first beam; (b) three beams in place

After the beams reached the minimum 28-day strength, they were delivered to the jobsite, with each truck and trailer transporting one beam. Two cranes were then used to place each beam. Figure 4 shows the erection and placement of the beams, with each span requiring four beams. The fabricator and contractor collaborated on a special connection to lift the beams that included blockouts in the flange and web to avoid conventional strand lifters being added to the beams and creating a corrosion issue. Conventional strand lifters using the CFRP strand were not used because of the reduction in strength when bent. The blockout is shown in Figure 4(a).

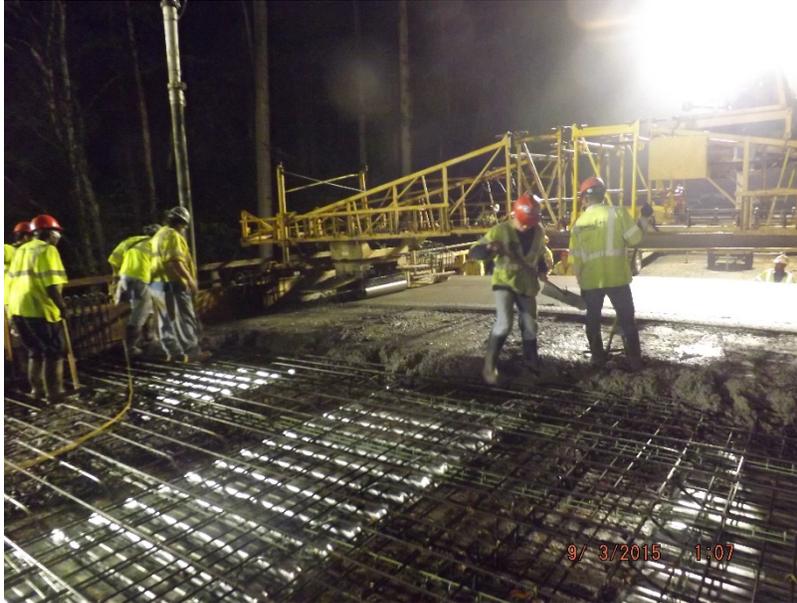
Figure 5. Bridge Construction Showing Nighttime Deck Concrete Placement

The results indicated that VDOT specifications were met; satisfactory strengths and very low permeability values were obtained. The deck has two spans, and both were placed on the same night. Figure 5 shows the night placement. The deck was placed at night since a reduced rate of evaporation would minimize the early cracking potential. The closure over the pier, with a length of 4 ft and a width of 32 ft 4 in, was placed during the daytime.
