# Route 5/Virginia Capital Trail

## Pedestrian Safety and Operational Assessment

### Henrico County, Virginia

**July 8, 2016**

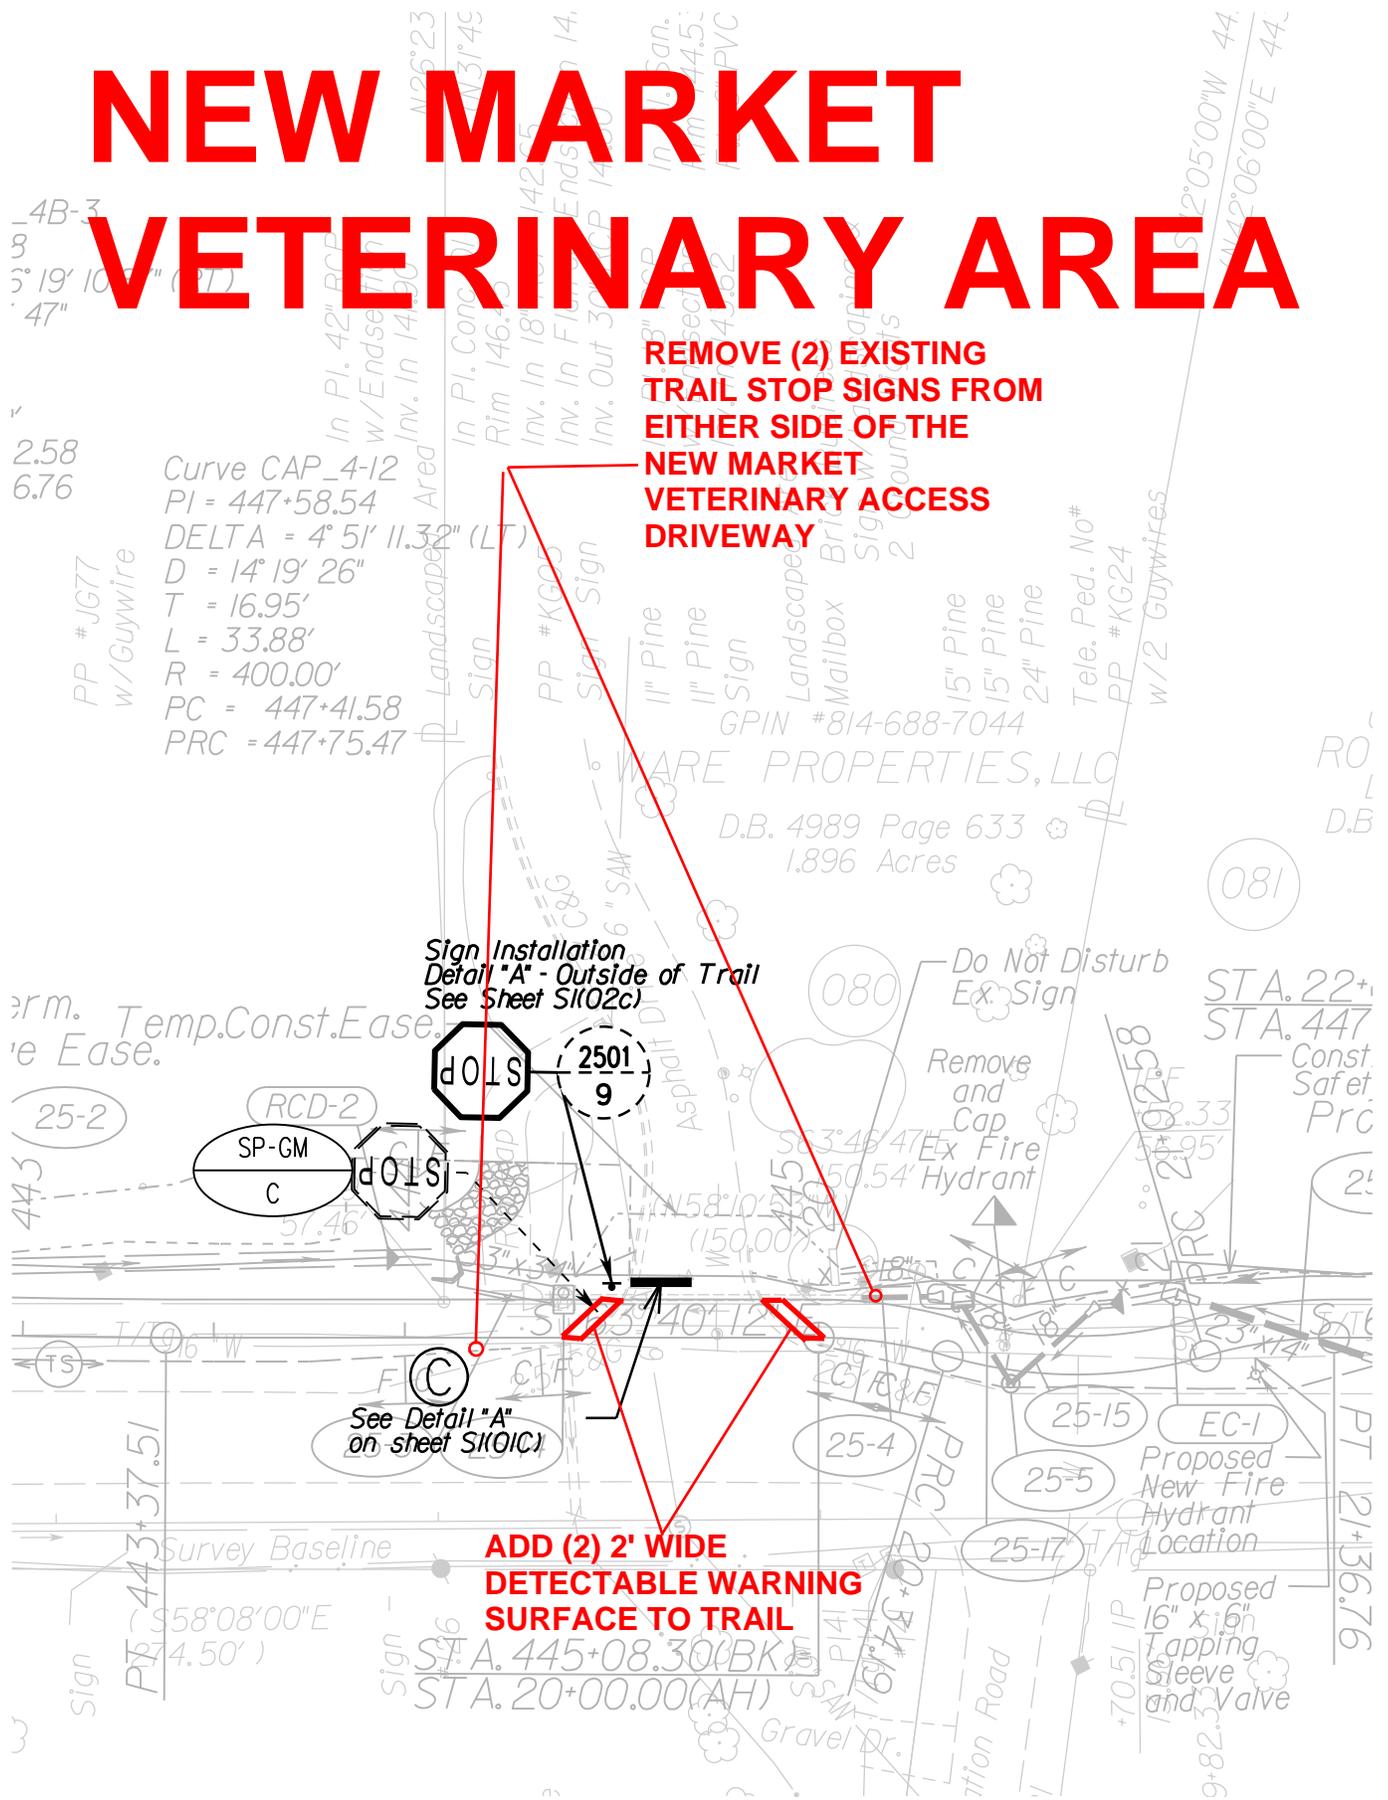
Sign Installation  
Detail "A" - Outside of Trail  
See Sheet S1(02c)

**ADD (2) 2' WIDE  
DETECTABLE WARNING  
SURFACE TO TRAIL**
