**Virginia Concrete Conference
March 7, 2008**

VDOT EXPERIENCE WITH GROUTED TENDONS IN
VARINA-ENON PRECAST SEGMENTAL
POST-TENSIONED BRIDGE

Michael Sprinkel, P.E.
Associate Director
VTTC

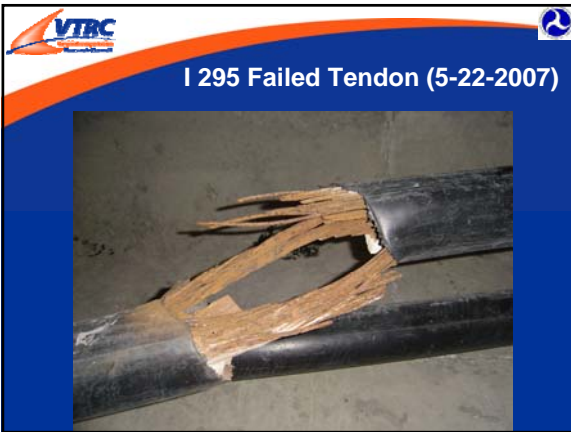
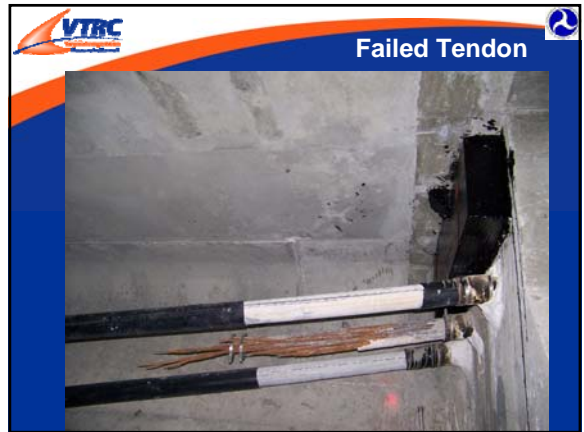
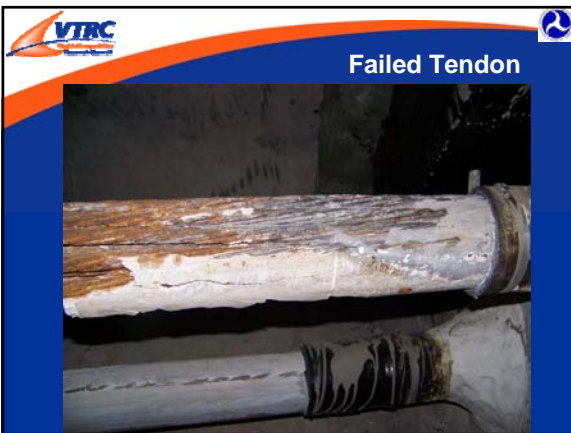
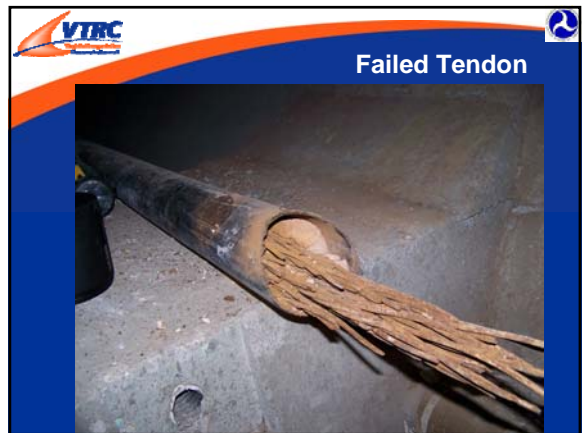
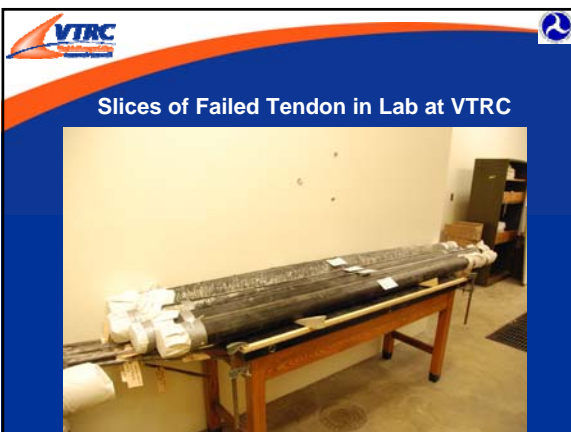
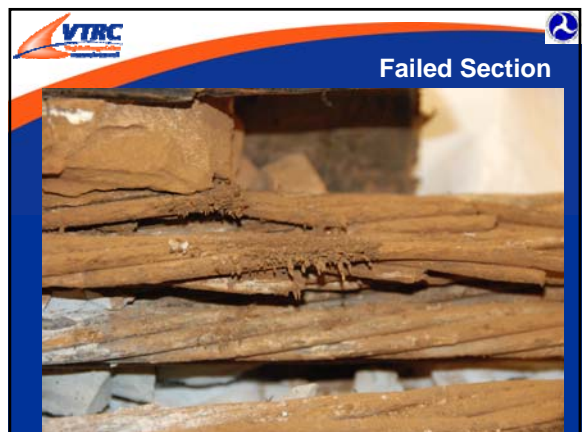
-
- Tendon Inspection and Repair**
- Inspected tendons for voids in grout, flaws in ducts, and corrosion of strands and anchors (visual, wire probes, sounding, and bore scope) (2001 and 2002)
 - Vacuum grouted some voids (2003 and 2004)
 - Sealed some tendons (2003 and 2004)
 - Replaced 2 tendons (1 failed, 1 with 3 broken wires) (2007)
 - Evaluated condition of tendons using Magnetic Flux (approximately 80 % of each duct) (2007)
 - Twenty tendons selected for detailed evaluation by removal of a 2-ft section of duct (18 because of corrosion in bore scope pictures, 1 because of Magnetic Flux measurements by Dr Al Ghorbanpoor and 1 because of his visual inspections) (2007)
 - Plan to monitor tendons representing 6 conditions (2008)

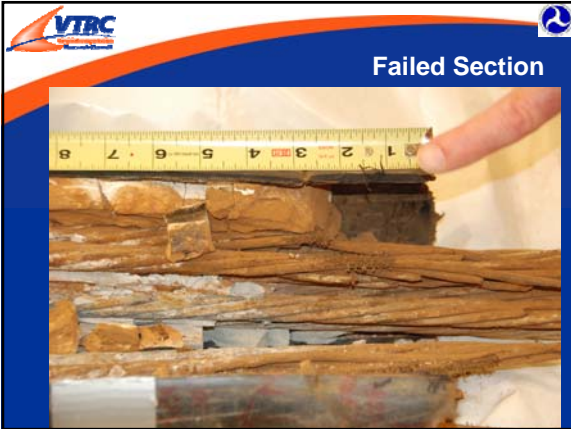
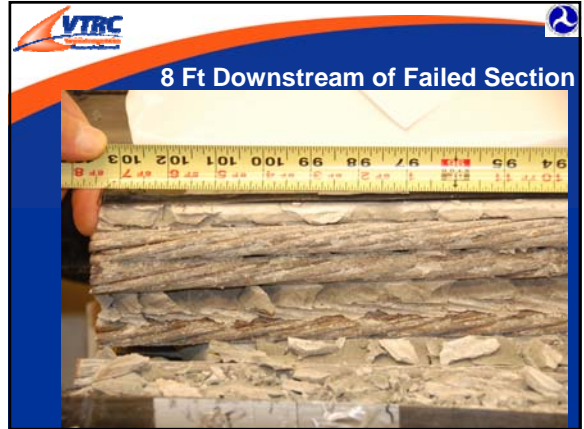
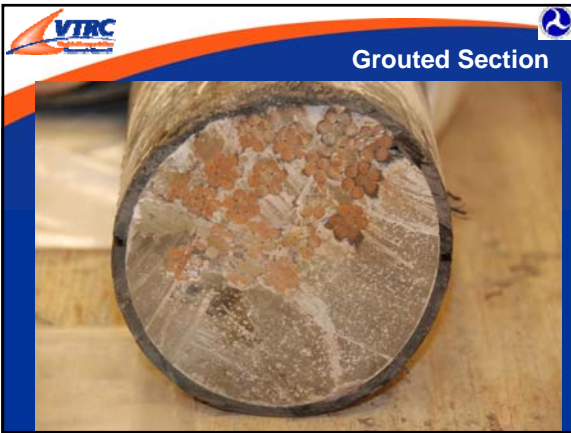
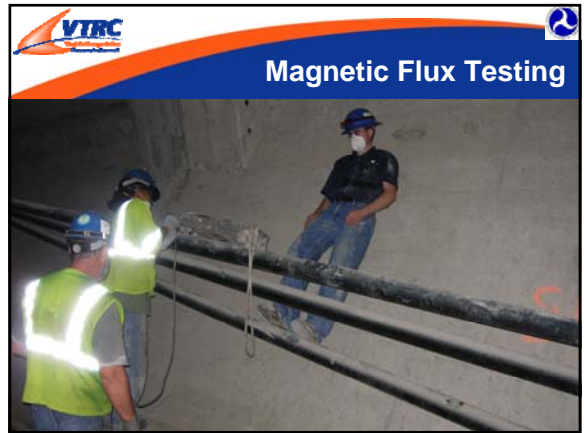
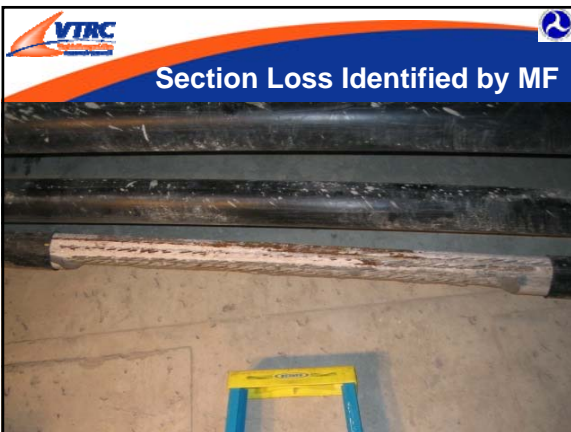
Grout Moisture Content					
Tendon	Broken wires	Section loss	color	Moisture content, %	Absorption, %
NP13T10	2	7 wires 5.3 %	Gray	32.8	35.5
SP12T9	1	4.8 wires 3.6 %	Gray (bottom)	36.6	39.5
SP12T9	1	4.8 wires 3.6 %	White (top)	21.6	36.5
