**Corrosion Evaluation of Post-Tensioned Tendons on Mid-Bay Bridge**

by
Siva Venugopalan
Principal
SCS, Inc.

Mid-Bay Bridge, Destin, Florida

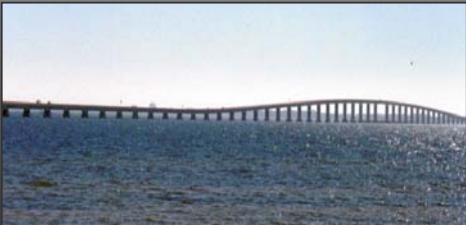
**The Mid Bay Bridge**

- Segmental precast concrete box girders - eight to nine segments held together by six post-tensioning tendons.

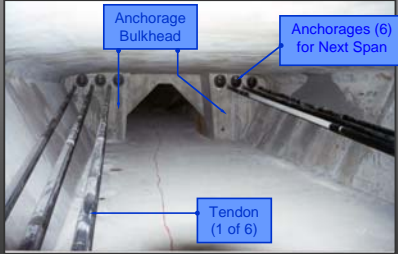
Typical View of the Anchorage

- Each tendon = 19 strands, each strand = 7 spirally wound 5/8 inch diameter wires.
