Virginia Transportation Research Council

Understanding the Environmental Implications of Cured-in-Place Pipe Rehabilitation Technology

May 2008
VTRC 08-R16

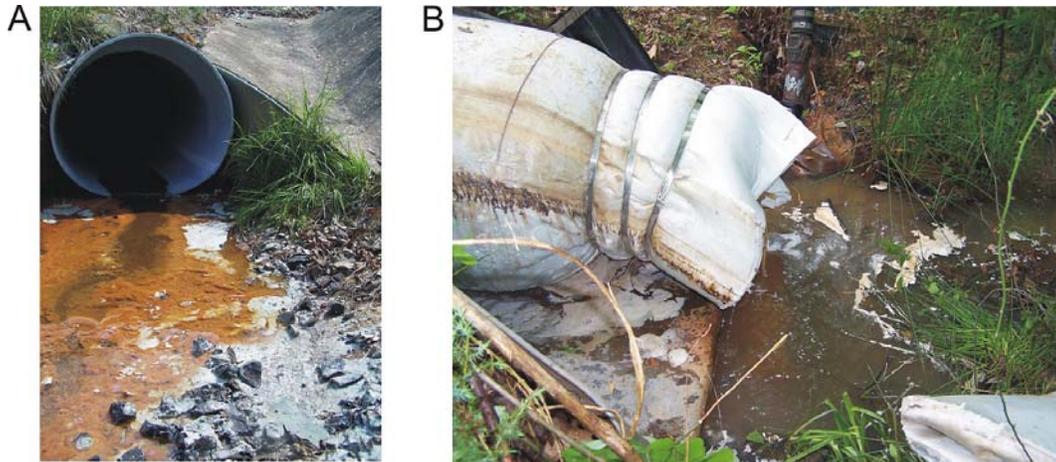
Figure 1. A: Uncured resin waste (gray substance adjacent to outlet and along rocks on right side of image) at Site 1, 1 week after installation; algal blooms (brown cloudy substance in water) also visible. **B:** Uncured resin waste (white substance adjacent to pipe liner and in water) extruded during installation, just before pipe end was cut.

The authors observed effluent from the steam condensate being discharged downstream by workers at Sites 2 and 3. At Sites 1, 3, and 4, the authors observed uncured resin residue waste immediately outside the pipe outlet or inlet. A sample of the uncured resin left in the stream bed at Site 1 (collected 1 day after installation) had a styrene concentration of 580 mg/L.

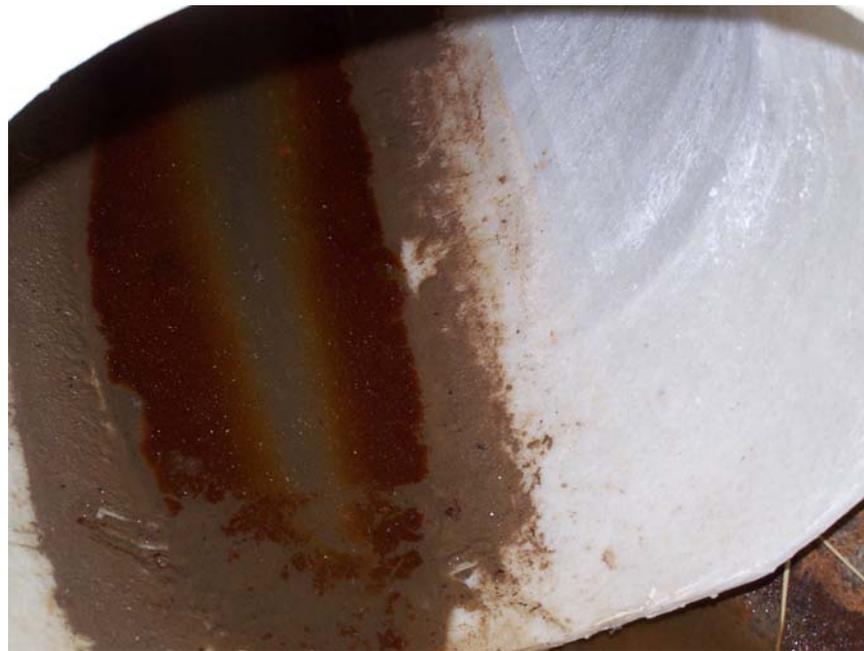
Figure 2. Residue on water surface in pipe at Site 2 between stormwater events, 24 days after installation.

Styrene concentrations in all control samples were below the reporting limit (0.005 mg/L) of the primary laboratory used in this study. Samples were collected until styrene concentrations were below the reporting limit at all sites. Samples collected at the pipe outlet often contained residue that was visible on the water surface after installation (Figure 2).

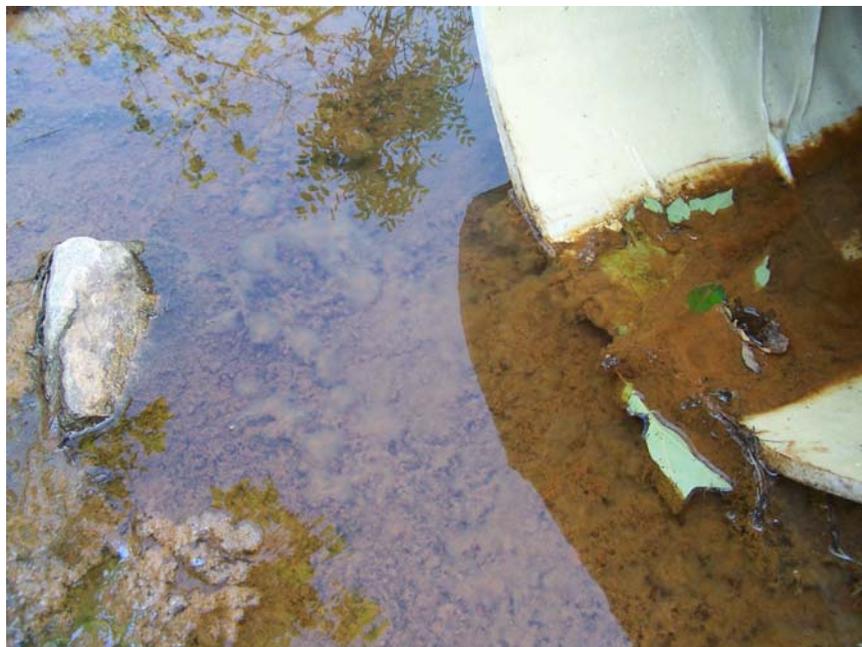
Figure 3. Algal blooms at Site 3, photographed 24 days after installation. Algal blooms appeared within 6 to 8 days after installation at Sites 1, 2, and 3 and were present up to 8 in below water surface near pipe outlet and up to 50 m downstream.

At Sites 1, 2, and 3, algal blooms were apparent within 6 to 8 days after installation (Figure 3; A. Mills, personal communication); algae were not visible at any of these sites when visited before the CIPP installation and were not present upstream of the installation. (The other three surface water sites in this study were not monitored until 15 and 16 days after installation; algal blooms were not visible at these sites.) Algae appeared most dense at the pipe outlet (occurring up to 8 in below the water surface), and the density decreased further downstream; the algae were present in clusters up to 50 m downstream from the repaired pipe section. Although the density of algal blooms appeared to decrease over time, blooms were observed 50 to 55 days after installation. Blooms were no longer visible 78 to 88 days after installation.

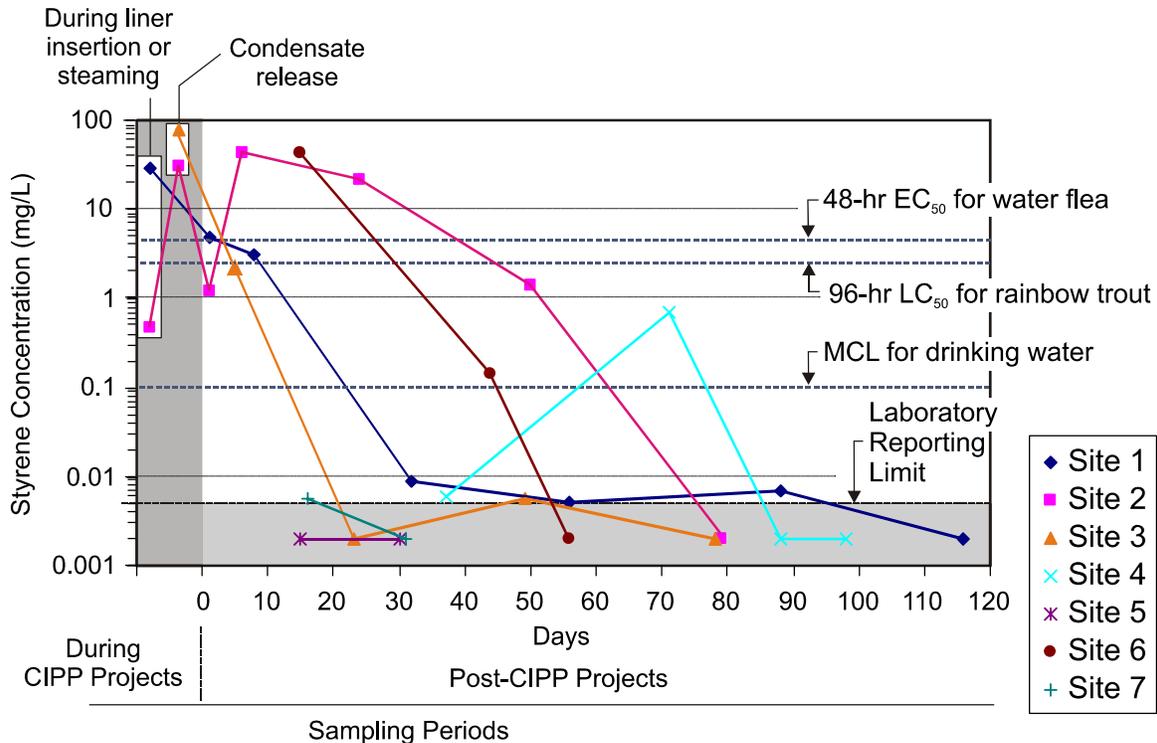
Figure 4. Styrene concentrations in water samples collected at pipe outlet during installation and at sampling periods up to 116 days after installation. Horizontal lines indicate the maximum contaminant level (MCL) of drinking water (0.1 mg/L), the EC₅₀ or LC₅₀ styrene concentrations for two aquatic species (as detailed in Table 2), and the laboratory reporting limit (0.005 mg/L). For styrene concentrations below the laboratory reporting limit, the data points shown merely indicate that sampling occurred and that the results were below the limit of 0.005 mg/L; they do not indicate the true concentration value.

Figure 4 provides styrene concentrations at all sites as compared with EC_{50} or LC_{50} values for two species (as detailed in Table 2). Samples for three sites were taken during installation, and samples for all sites were taken at various intervals after installation. No compounds other than styrene were detected in the laboratory analyses.

Styrene concentrations and the duration of its detectable presence were highly variable among sites. Samples from some sites did not show a consistent decrease in concentration, particularly at sites with low or intermittent water flow. Although none of the sites was directly linked to a source of drinking water, styrene concentrations exceeding the MCL for drinking water were measured at five of the seven study sites. The concentrations at Sites 1, 2, 3, and 6 exceeded the MCL for drinking water (0.1 mg/L) at sampling periods of 5 to 50 days after installation, and at Site 4, the concentration exceeded the MCL 71 days after installation during a period of very low flow. The maximum styrene concentrations at four sites (Sites 1, 2, 3, and 6) exceeded published EC₅₀ or LC₅₀ values (Table 2) for various aquatic species. At Site 2, the concentration exceeded these values for the water flea and the rainbow trout at the sampling period of 24 days.
