**John G. Lewis Memorial Bridge
Route 673 (Featherbed Lane)
Bridge over Catoctin Creek in
Loudoun County**

**Presentation March 26, 2015, July 23, 2015
& September 16, 2015**

Current Structural Issues

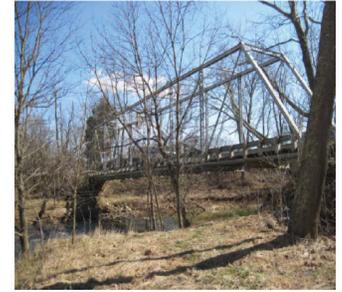
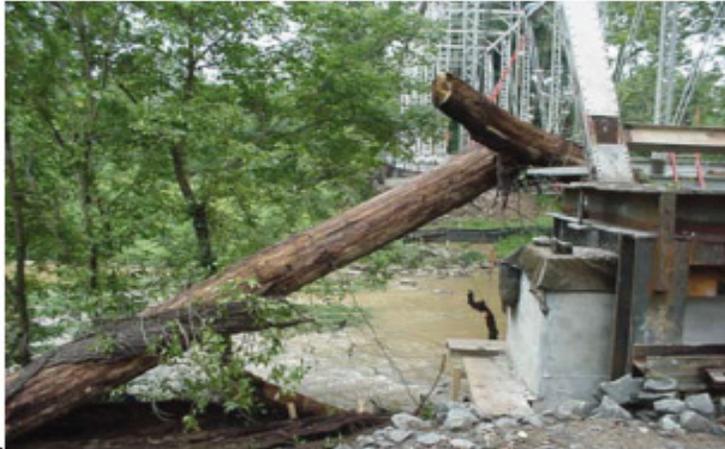
Tree Impact on Metalized Truss
(Reconstruction in 2003)

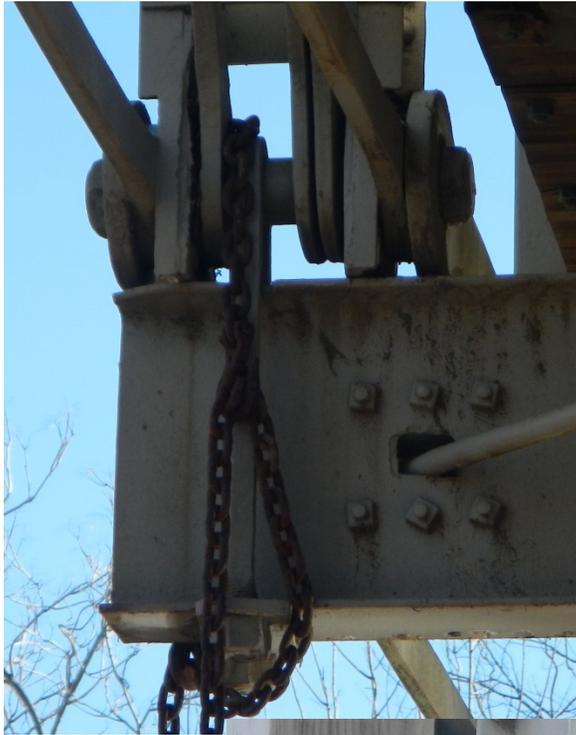
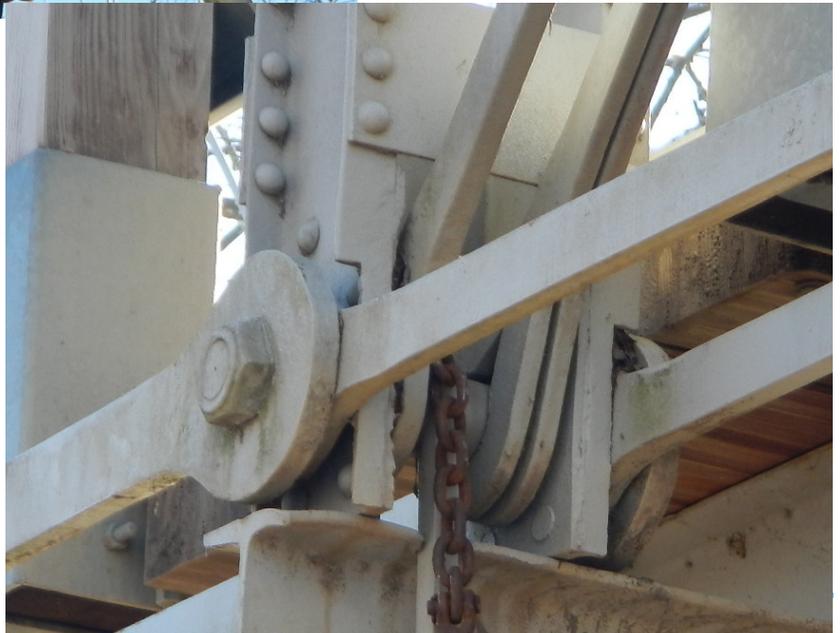
- Metalizing may have altered the surface metal properties.
- Inspection of the pin connections, is difficult for inspectors and requires additional inspections.
- The structure has noticeable loss of section (pitting)
- The structure has a mixture of rivets, machine bolts (unacceptable structurally) and H.S. Bolts. Some bolts have improper thread lengths.
- The abutments are/were stone masonry.

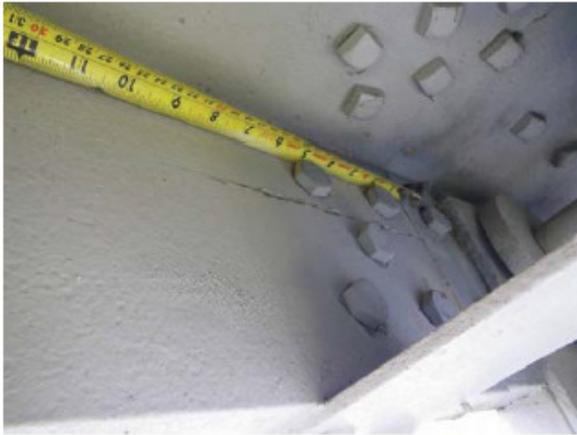
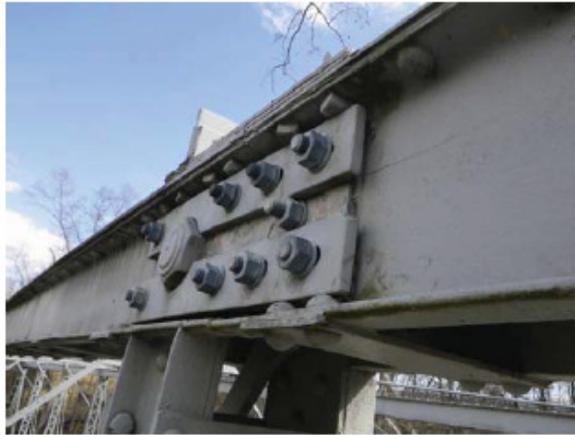
Location of Crack

Exhibit 11. Cracking in Upper Chord

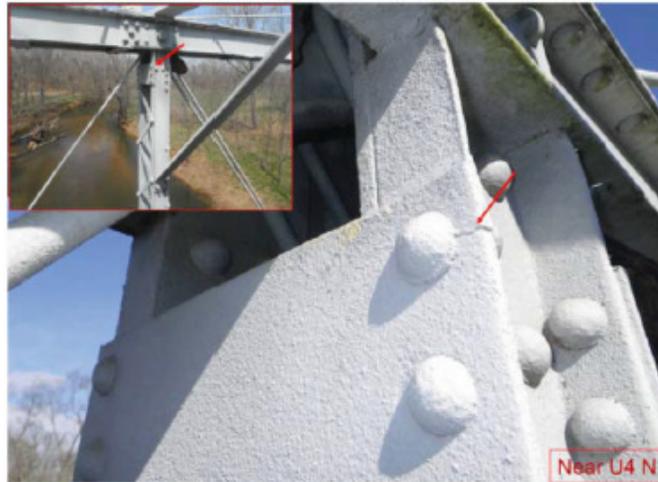
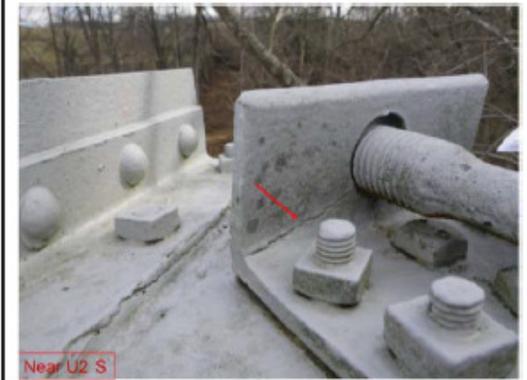
PHOTO 27 - CRACK IN LATERAL BRACING CONNECTION WASHER AT L4, UPSTREAM

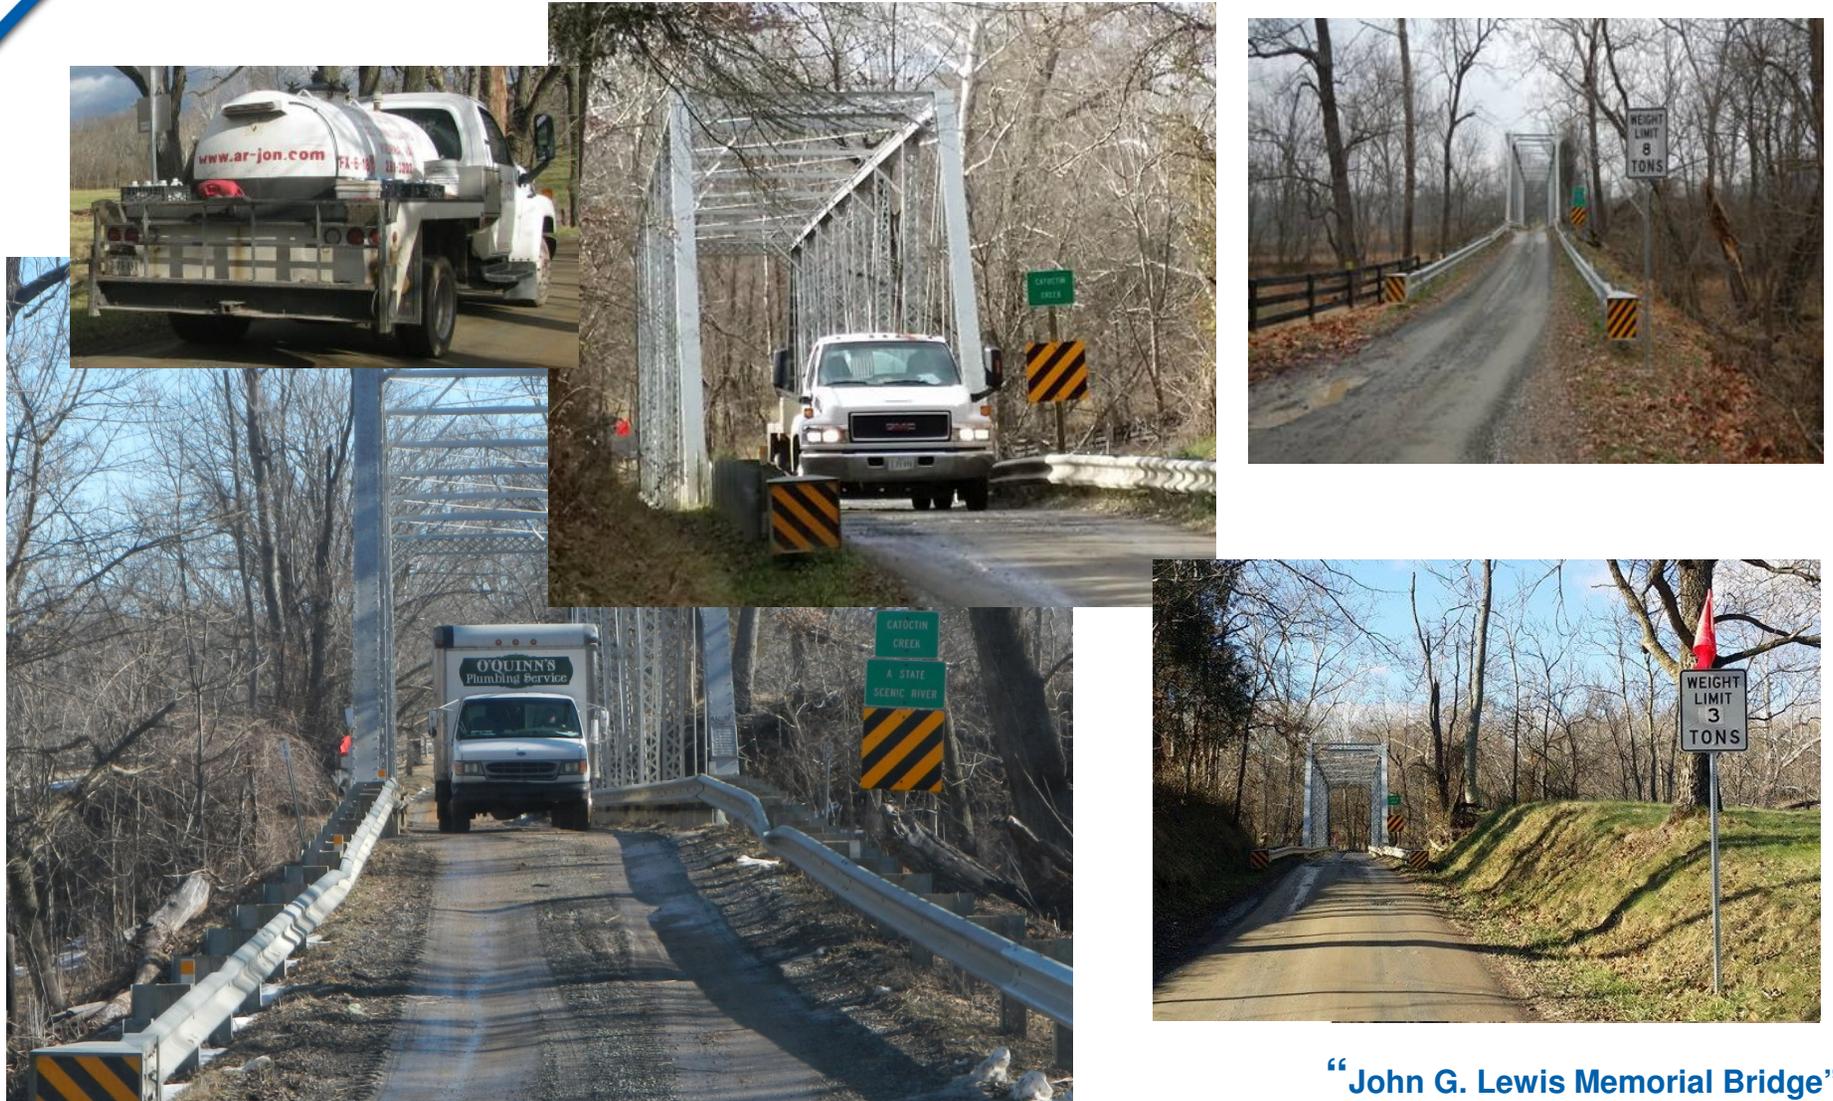
- **The existing roadway width is only 11' – 2"**
Thus making the structure...
Functionally Obsolete.
